RECAPP Facility Evaluation Report

St. Angela Catholic Elementary School

B3280A
Edmonton

Evaluation Company: Robert Irlam Consulting Inc.
Evaluation Date: November 9 2010
Evaluator Name: J. R. Irlam

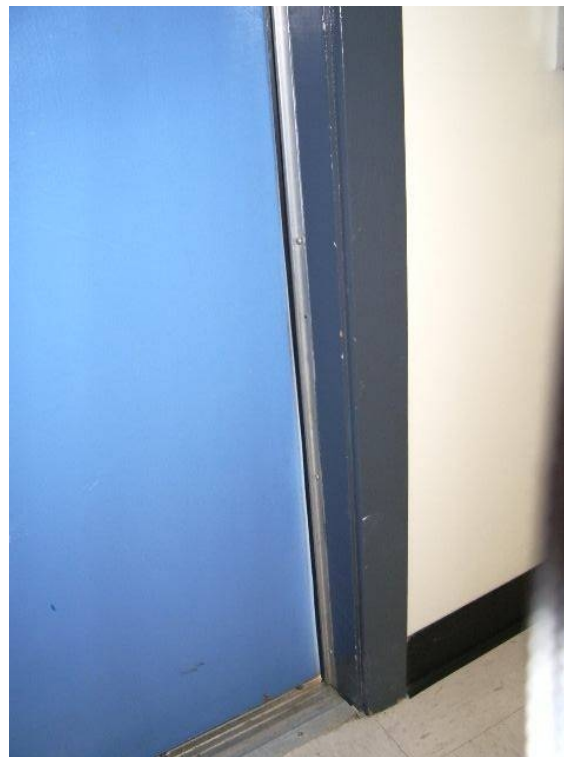
IMG0664.JPG

Door requires more than normal pressure to engage latch, could damaged wall.
It is an air leak and not energy efficient.
