# **RECAPP Facility Evaluation Report**

**St. Kevin Catholic Junior High School**

B3309A  
Edmonton

**Evaluation Company:** Asset Evolution Inc.  
**Evaluation Date:** October 15 2010  
**Evaluator Name:** Mario Plastina

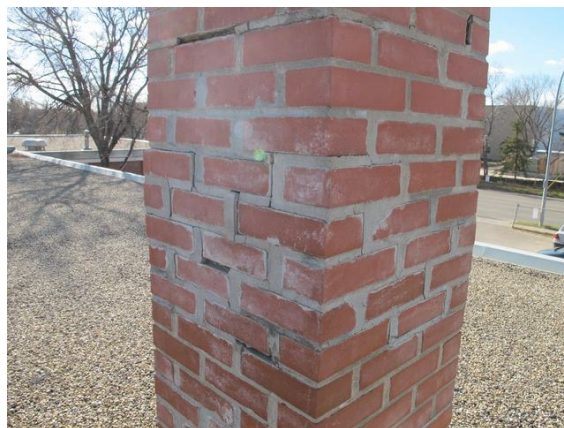
The mortar has deteriorated in several sections throughout the elevations and chimneys.

Deteriorated mortar on chimney - 1956 Section

Repair brick and mortar as required

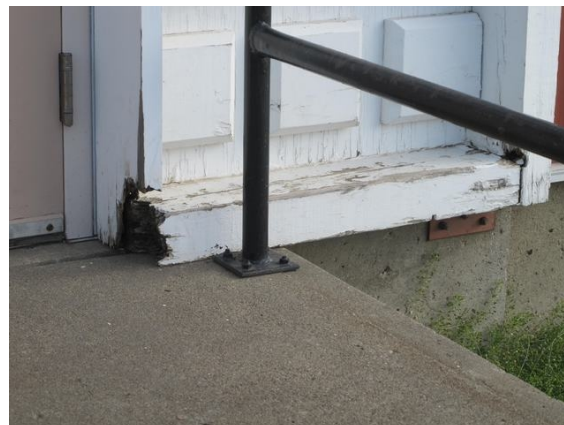
Several sections of the wood panels are rotted and deteriorated.

Deteriorated wood panels on 1974 Section - West elevation exit.

Repair and/or replace damage wood panels on 1974 Section

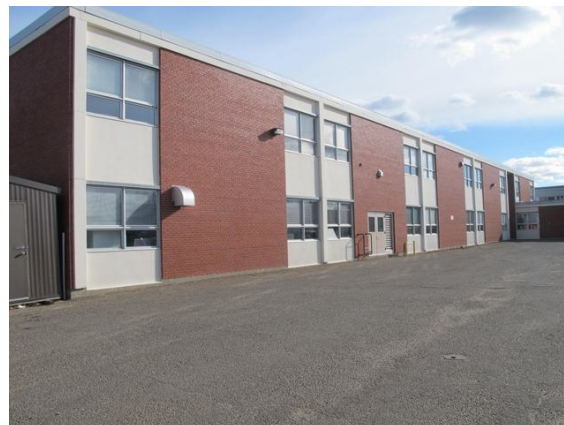
Original windows in 1966 Section.

Replace windows in 1966 sections - 81 Window Units

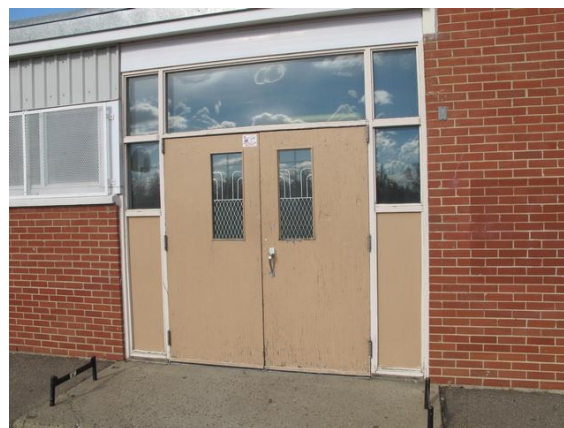
The doors are worn, deteriorated and no longer close properly. The hardware is original at most entrances.

Typical condition of wood framed entrance doors & assembly.

Replace all wood entrance doors, hardware and frame assembly - 22 Doors

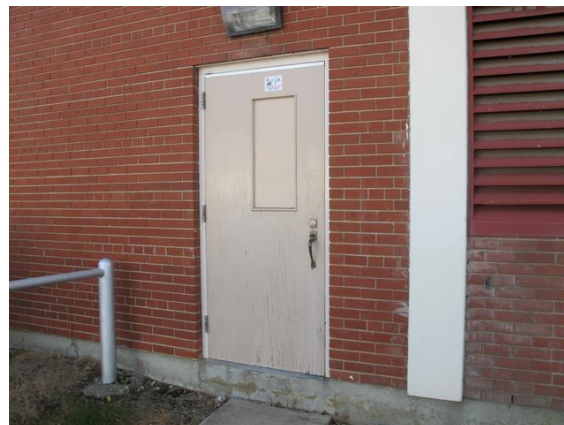
The existing wood door surfaces are worn and damaged. A majority of the hardware is original.

Deteriorated wood door and assembly.

Replace wood doors, frames and hardware (7 doors)

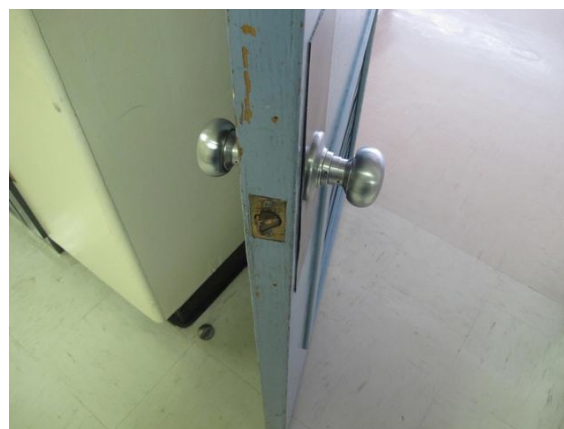
Several frames and doors are deteriorated throughout the school. Original hardware at interior doors difficult to operate, requiring frequent adjustment.

Typical hardware and original door assembly.

Replace hardware & door assembly as required (40 doors)

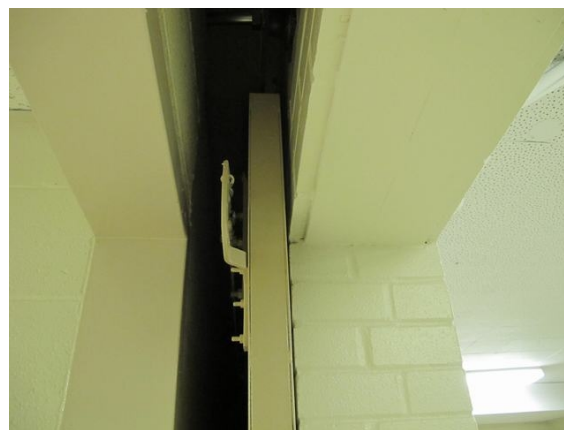
Pocket fire rated doors between the 1956 & 1966 Sections

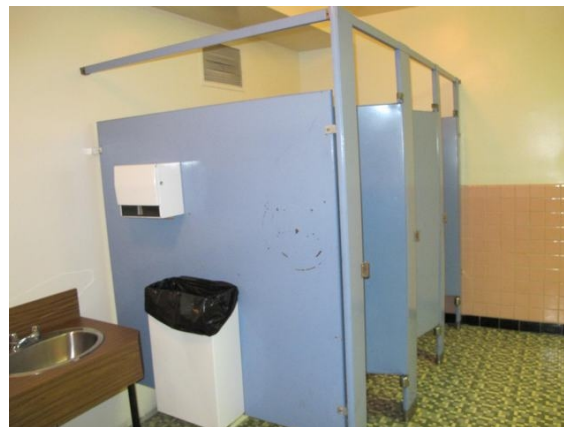
Several of the original toilet partitions are dented and scratched panels. The hinges are broken and loose fittings.

Damaged washroom partitions

Replace toilet and shower partitions - 30 Stalls

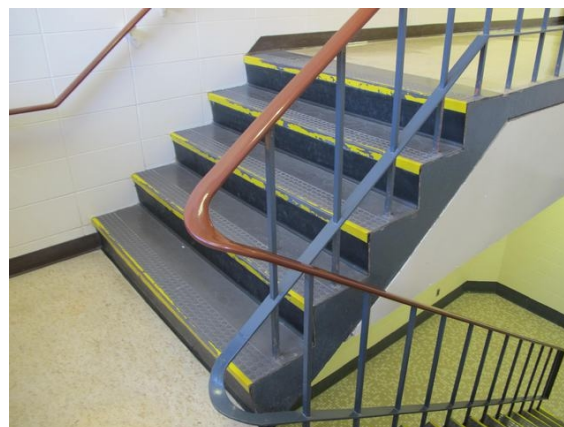
The height and width between the handrails do not conform to the current ABC code.

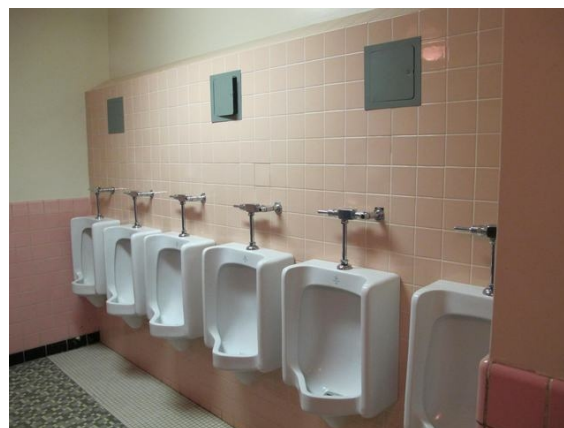
The grout is aged and stained. A few isolated tiles are broken.

Stained grout between the ceramic tiles in the 1956 washrooms.

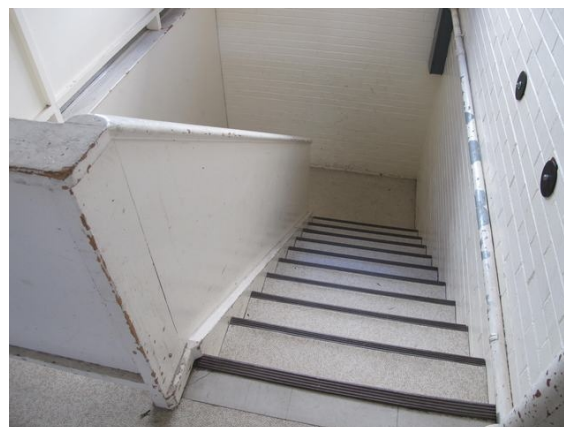
The paint finish is worn, stained and peeling in several areas throughout the school.

Deteriorated paint finish in the stair to the lounge area.

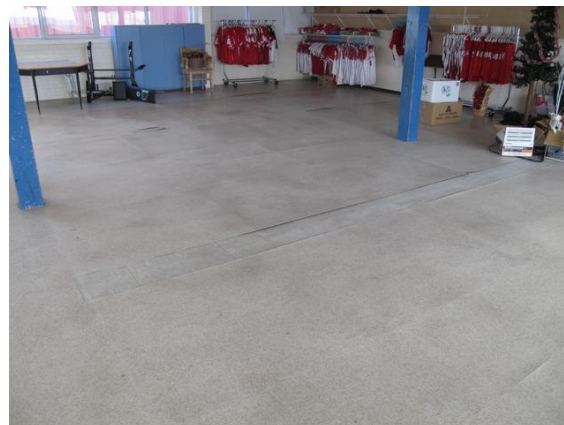
Deteriorated sheet vinyl in the 2nd floor lounge area.

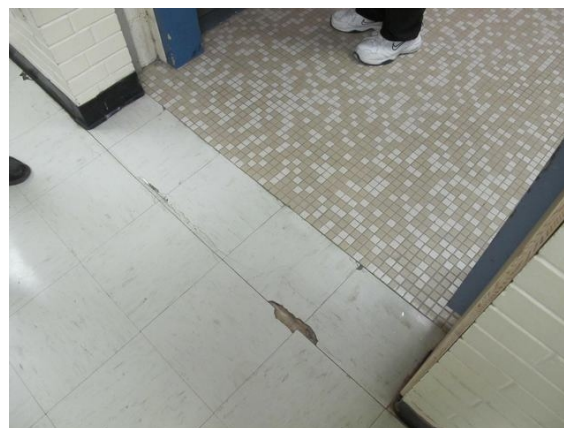
Broken and loose VAT tiles in the corridor.

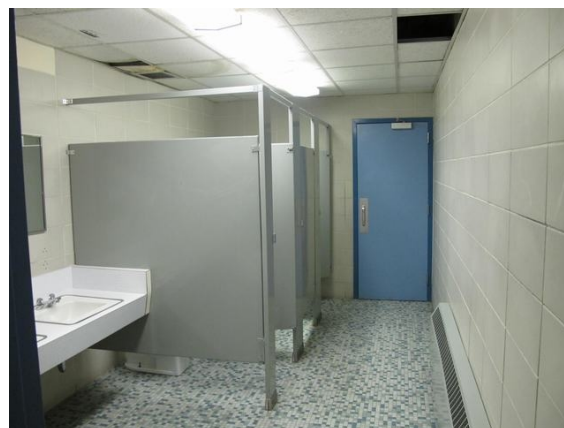
Stained and missing ceiling tiles in the washrooms.

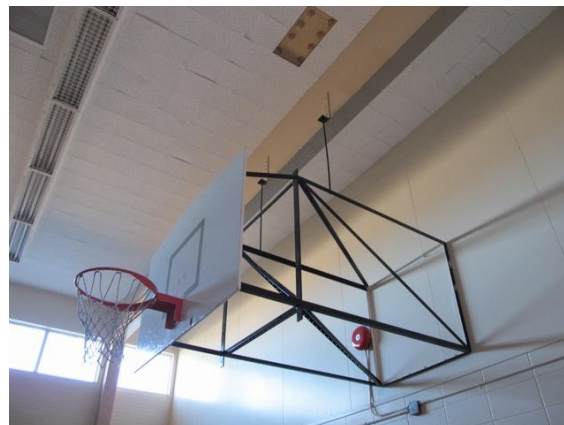
Missing ceiling tiles in the small gymnasium.

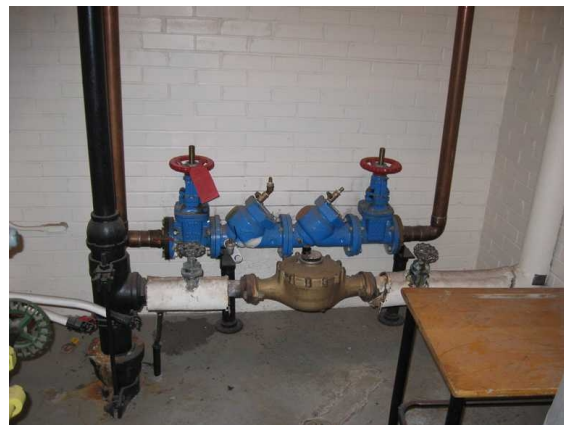
Domestic water meter with backflow preventor for standpipe system only.

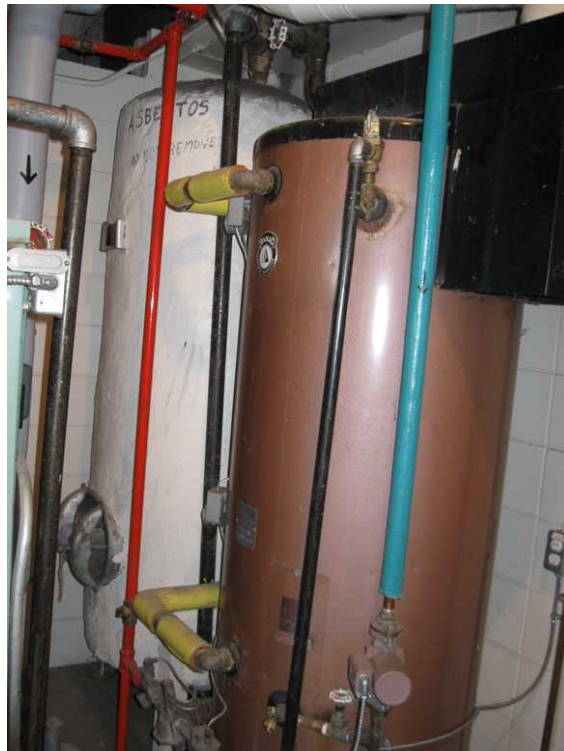
Domestic hot water heater and storage tank in Boiler Room

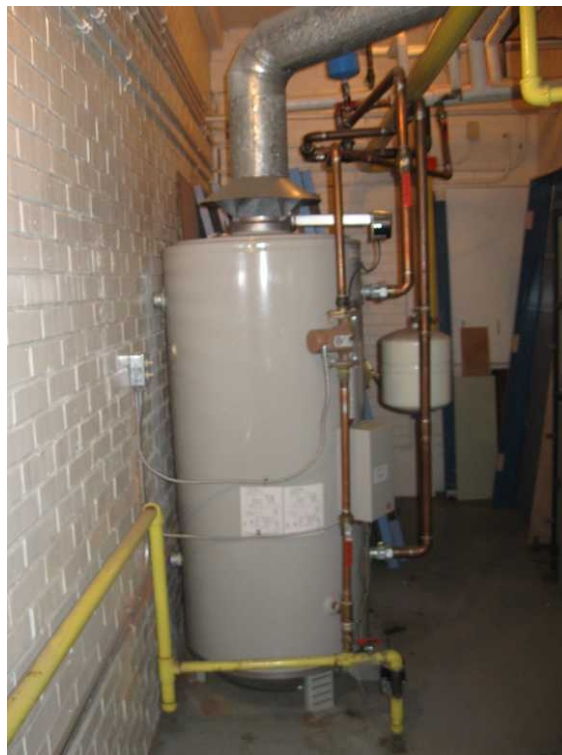
Uninsulated domestic water pipes in Mechanical Room #7

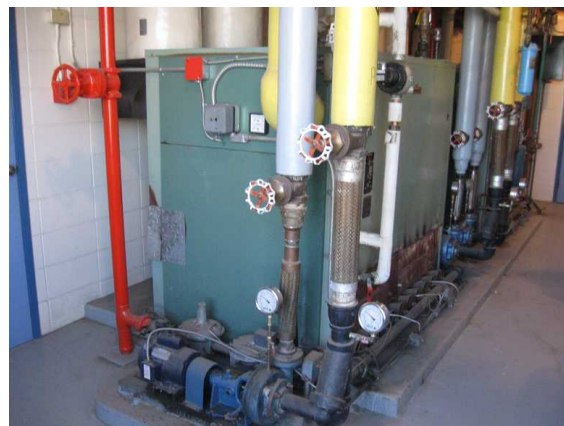
Hot water boilers in Boiler Room

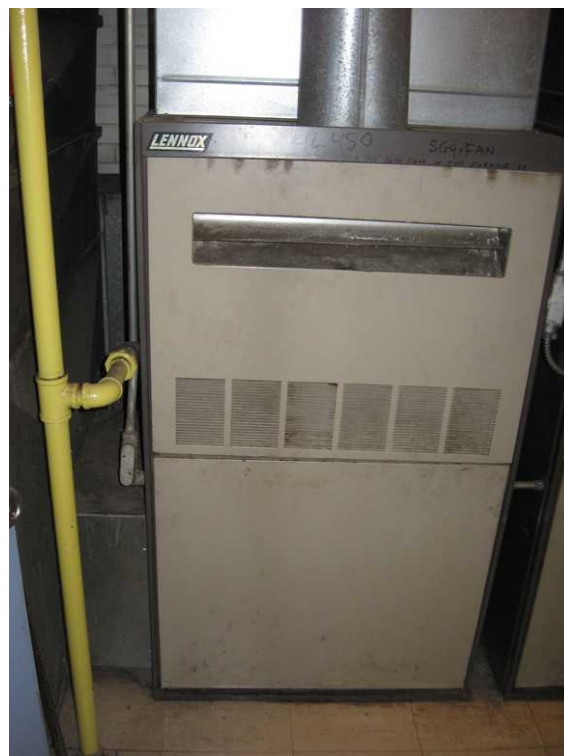
Typical gas fired furnace

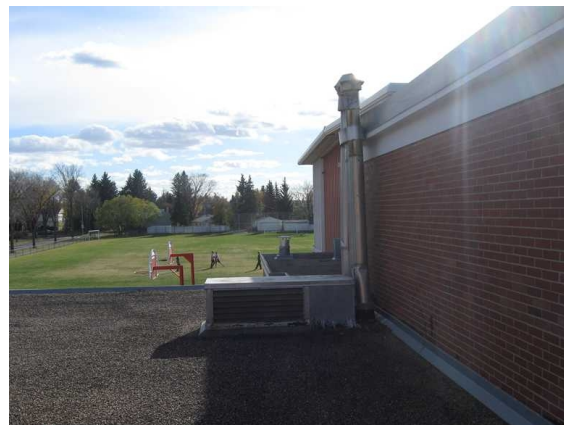
Three flue gas vents on roof from the furnaces in Mechanical Room #4

Replace 3 gas flue vents on roof from the natural gas fired furnaces in Mechanical Room #4 and provide proper support.

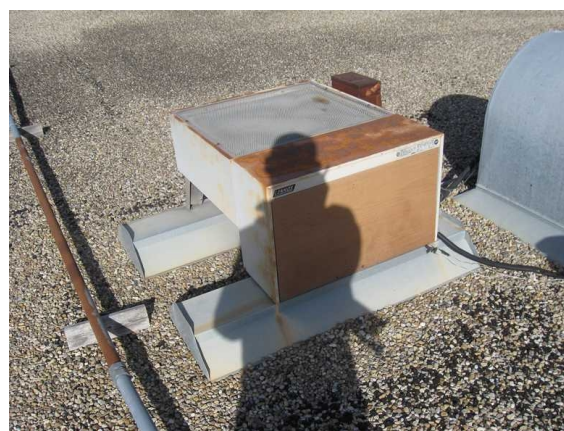
Old air cooled condensing unit on roof

Replace existing air cooled condensing unit with new.

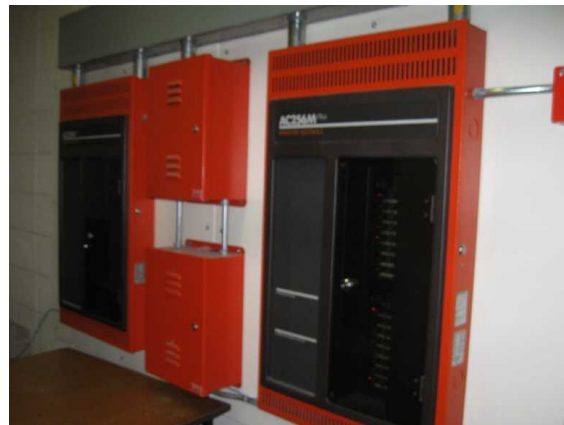
Andover model AC256 main control panel

Replace the Building Management and Control System (BMCS).

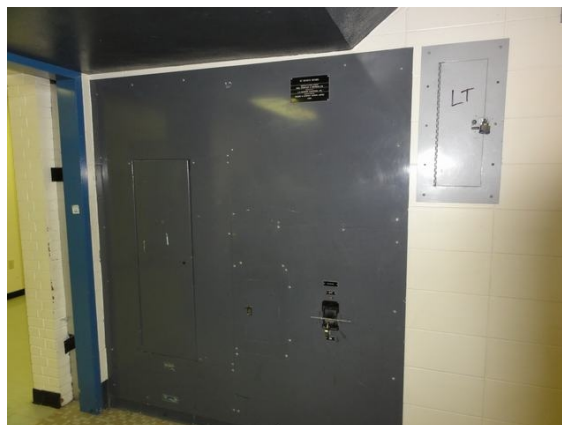
1200A main switchboard, located in corridor.

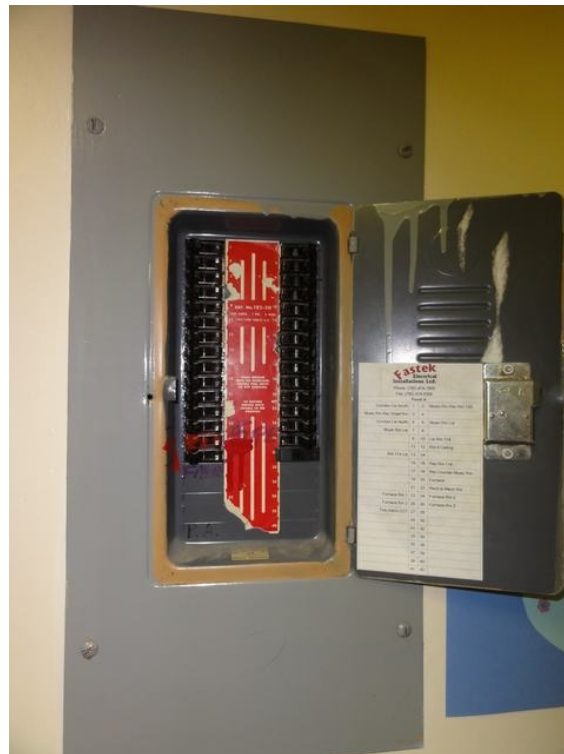
Federal Electric 120/240 branch circuit panel.

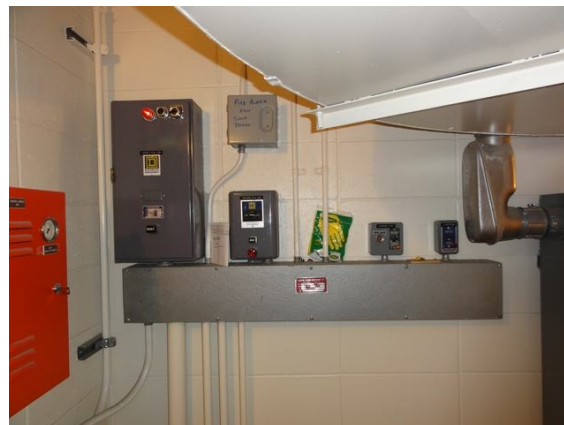
Aged motor starters in mechanical room.

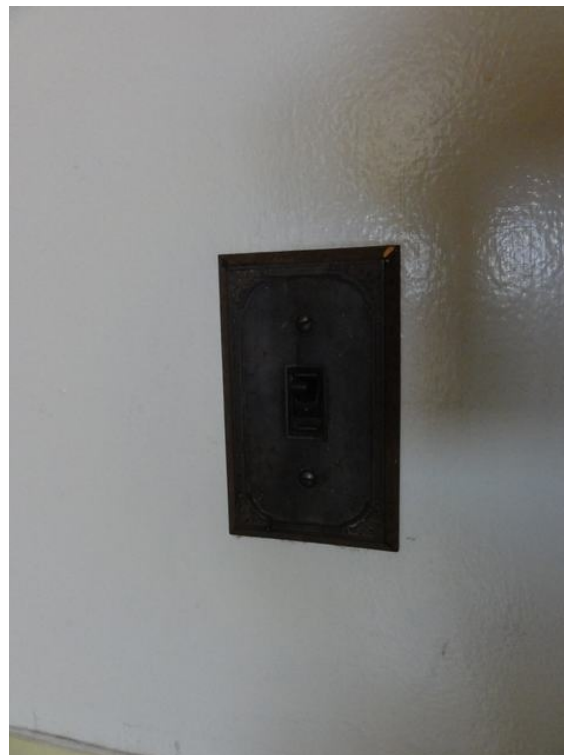
Aged light switch with bakelite coverplate.

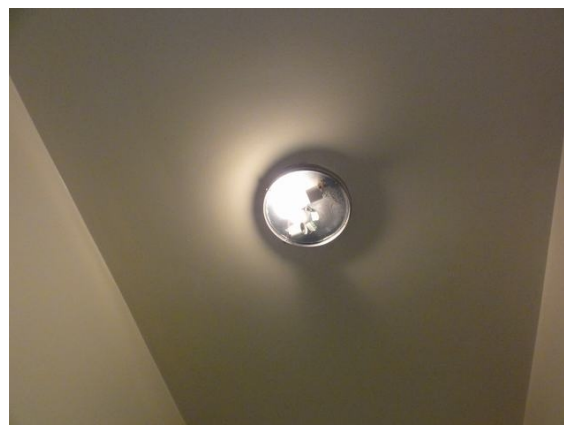
Incandescent fixture missing lamp housing.

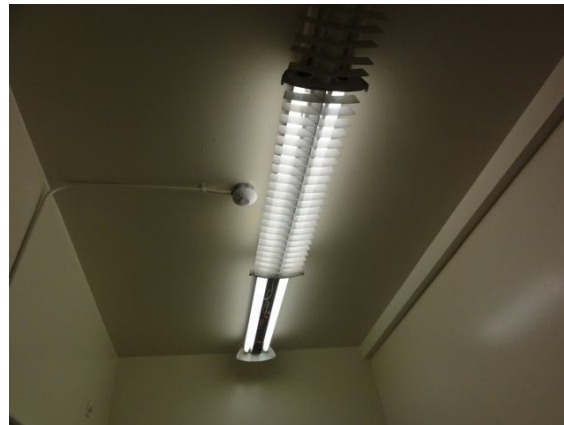
Louvered fluorescent T12 lighting.

Replace T12 fluorescent fixtures with new energy efficient T5 or T8 fluorescent lighting fixtures. Incorporate lamp reduction where possible.

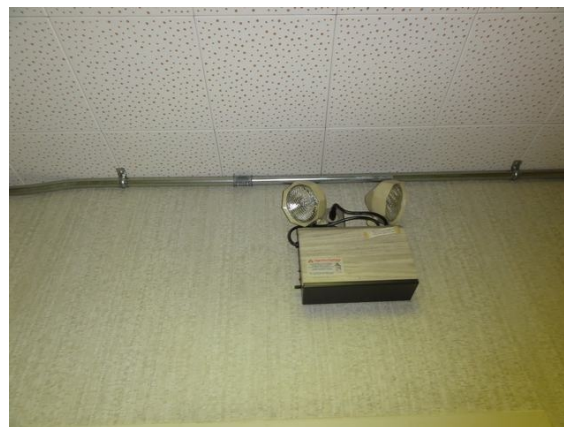
Aged emergency lighting battery unit.

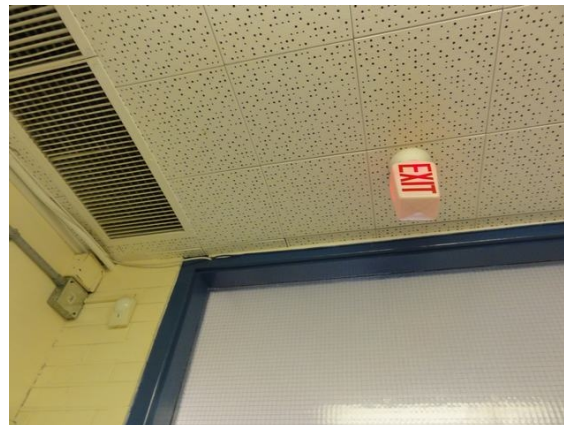
Exit sign is not code compliant.

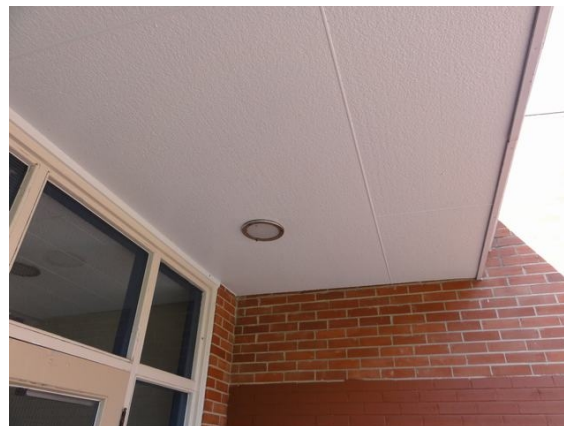
Recessed incandescent lighting installed in entrance canopy.

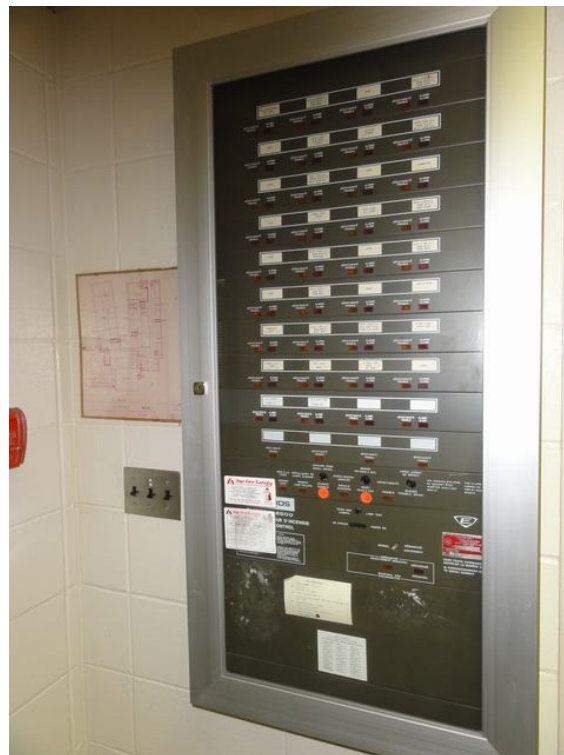
Edwards 6500 fire alarm control panel at main entrance.

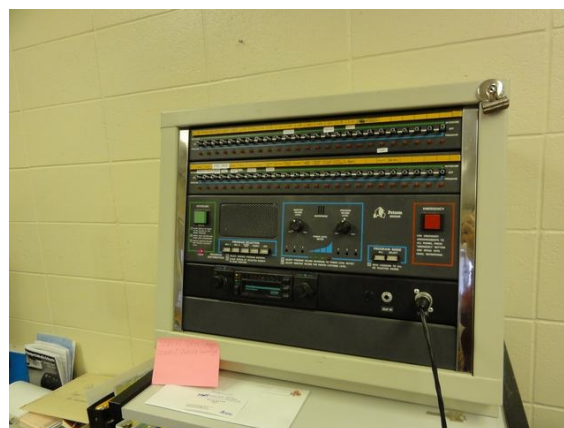
Obsolete Petcom 2200 P.A. System in general office.
