# RECAPP Facility Evaluation Report

**Winterburn Elementary / Junior High School**

B3367A  
Edmonton

<b>Evaluation Details</b>	
<b>Evaluation Company:</b>	Francis Ng Architect Ltd.
<b>Evaluation Date:</b>	June 11 2009
<b>Evaluator Name:</b>	Francis Ng

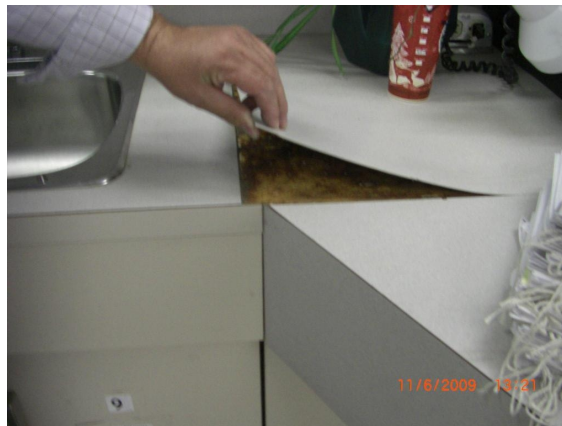
(1971) Addition Science 134) - has damaged countertops.

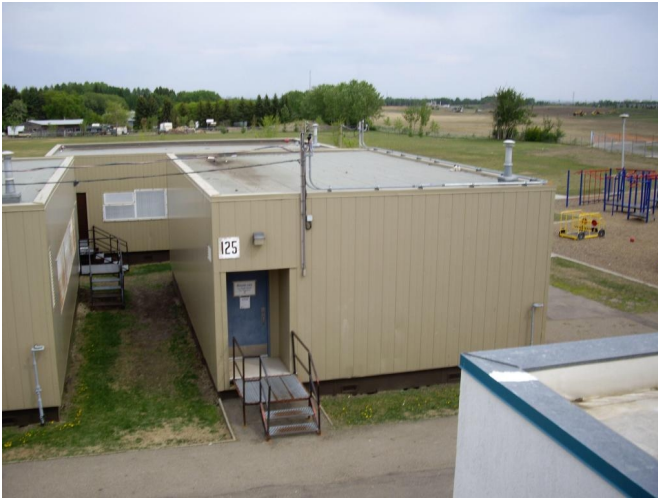
(1993) Portable Classroom No. 125 on site.

**Event: Replace building envelope. (approx. 84 square metres)**

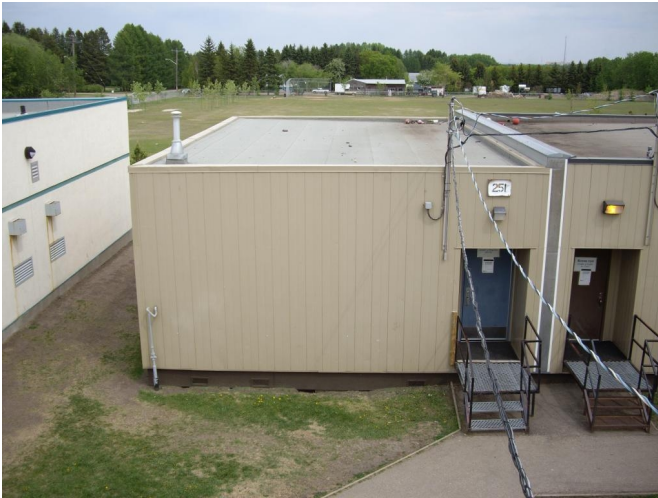
(1993) Portable Classroom No. 251 on site.

**Event: Replace building envelope. (approx. 84 square metres)**

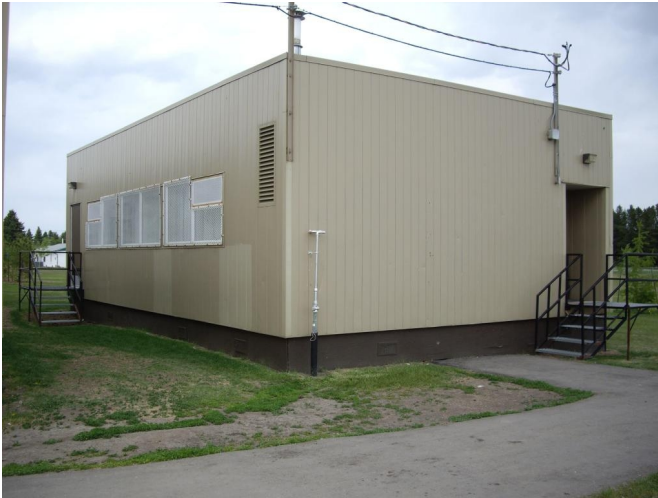
(1994) Portable Classroom No. 258 on site.

**Event: Replace building envelope. (approx. 84 square metres)**
