RECAPP Facility Evaluation Report

Timberlea School

B3438A

Evaluation Company: Halsall Associates
Evaluation Date: October 22 2012
Evaluator Name: Jonathan Maynard

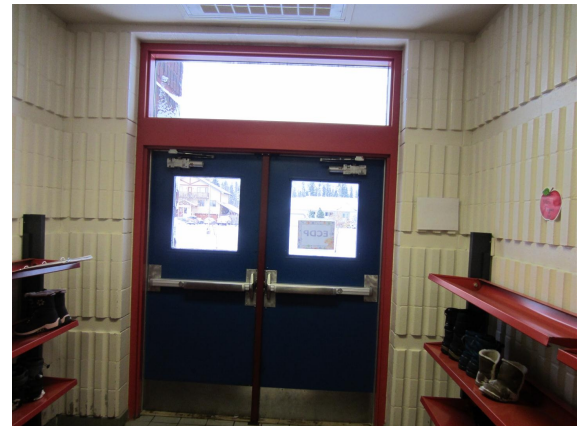
IMG_3153 (Large).JPG

The load bearing concrete block is cracked at the main entrance of the school.

The load bearing concrete block is cracked at the main entrance of the school. Requires engineered evaluation.

Requires repair pending engineering review.

Structural Investigation of Masonry at Main Entrance

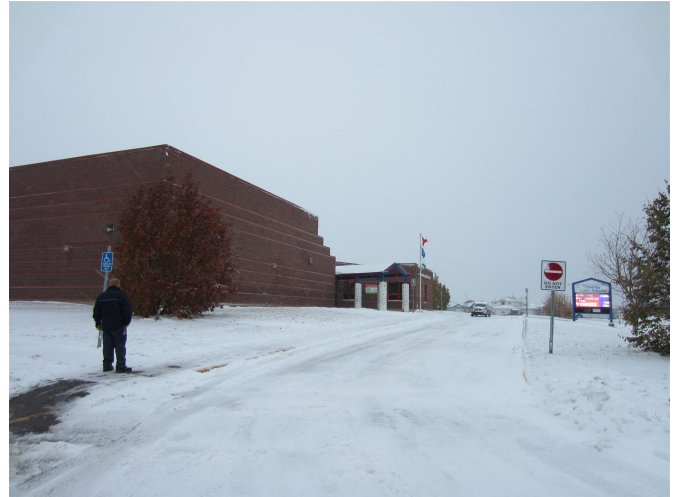
IMG_3115 (Large).JPG

Site Description: The site is large with a bus drop driveway to south of the school and a paved parking lot to the west. The school sits on the southeast corner of the lot.
