# **RECAPP Facility Evaluation Report**

## **Lethbridge School Dist #51**

**Nicholas Sheran Community School**  
B3693A  
Lethbridge

<b>Evaluation Details</b>	
<b>Evaluation Company:</b>	Stantec Consulting Ltd.
<b>Evaluation Date:</b>	November 30 2010
<b>Evaluator Name:</b>	Michael Just

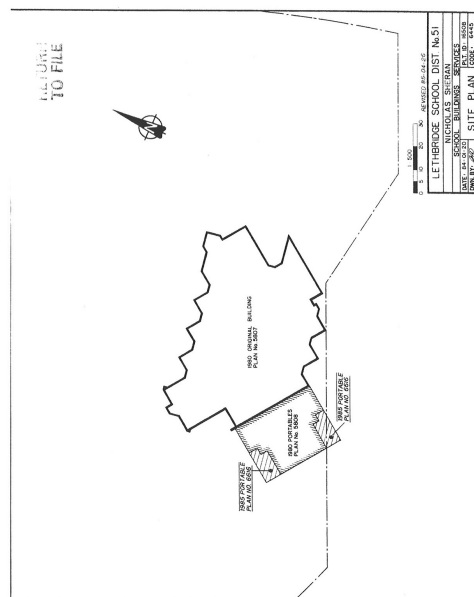
0929\_001.jpg

Floor plans submitted to Stantec Consulting Ltd.  
November 30/2010
