RECAPP Facility Evaluation Report

Lloydminster Pub Sch #1753

Barr Colony School

Evaluation Company: MAYCON Architectural & Engineering Services
Evaluation Date: August 18 2011
Evaluator Name: Vic Maybroda

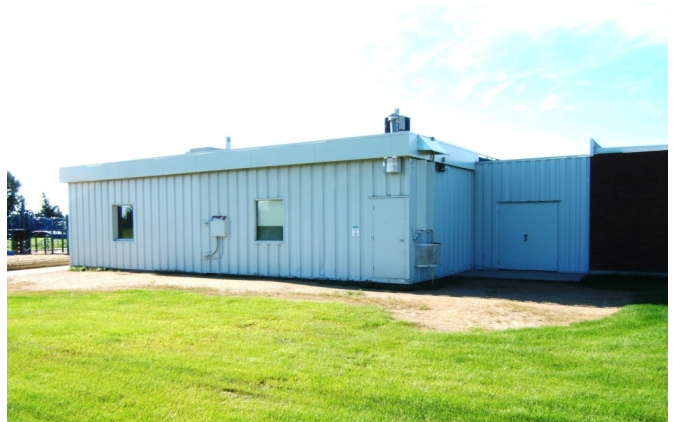
North Elevation of 1974 and 2003 Portable Units

Hot Water Tanks (3) LCR = 15,000.00

<u>Rating</u>	<u>Installed</u>	<u>Design Life</u>	<u>Updated</u>
4 - Acceptable	1974	30	JAN-12

Event: Building Envelope Replacement

<u>Type</u>	<u>Year</u>	<u>Cost</u>	<u>Priority</u>
Lifecycle Replacement	2015	\$77,000	Unassigned
