RECAPP Facility Evaluation Report

Lloydminster Pub Sch #1753

Martin Browne School

Evaluation Date: September 6 2012

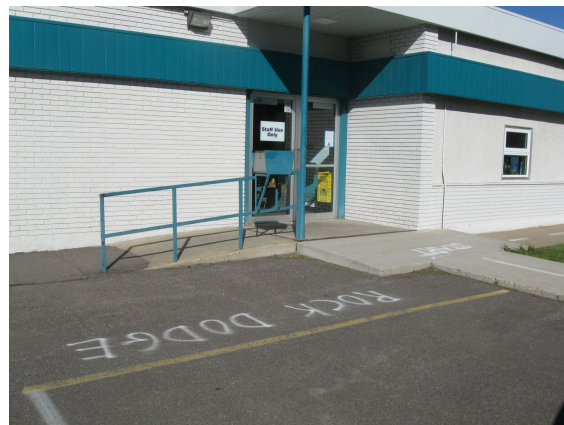
| <u>Rating</u> | <u>Installed</u> | <u>Design Life</u> | <u>Updated</u> |
|---|---|---|---|
| 3 - Marginal | 1958 | 0 | JAN-13 |

Ramp does not have a railing on both sides. No wheel guard at bottom of existing rail

Ramp does not have a railing on both sides. No wheel guard at bottom of existing rail.

Event: Install 3m of railing on wall and wheel guard at 50mm from ramp surface on existing railing

Provide steel tube railing on exterior wall and a wheel guard at 50mm above ramp on existing rail.

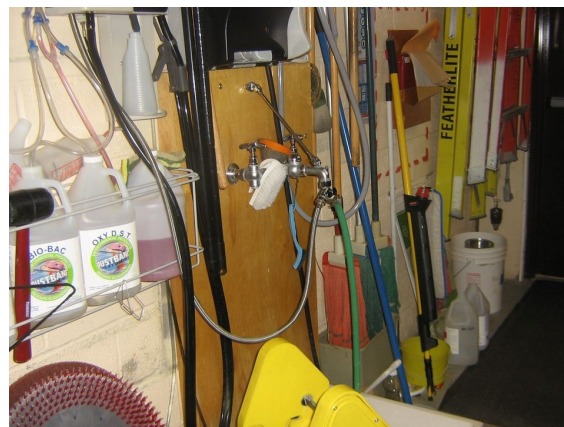
Service Sink in Mechanical Room.

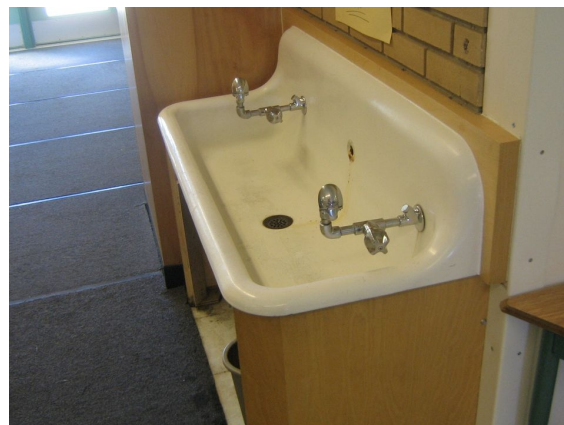
Drinking fountain is rusting and unsightly.

Double Bubbler drinking fountain is rusting.

Replace drinking fountain.
