RECAPP Facility Evaluation Report

Northern Gateway Reg Div #10

Mayerthorpe Jr. / Sr. High School

B3754A
Mayerthorpe

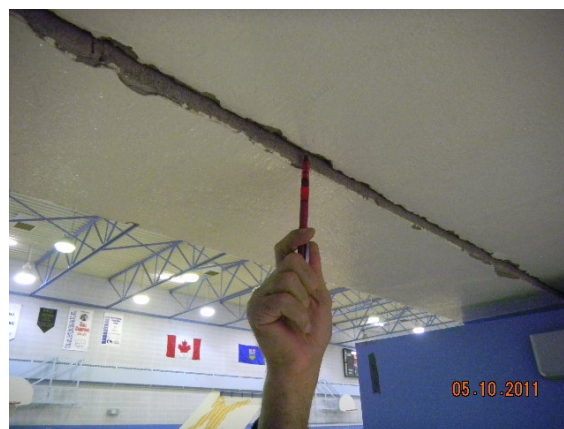
NW corner of 1992 addition has settling issues at link between the two gyms
