RECAPP Facility Evaluation Report

Medicine Hat S Dist #76

Central Park School

B3759A

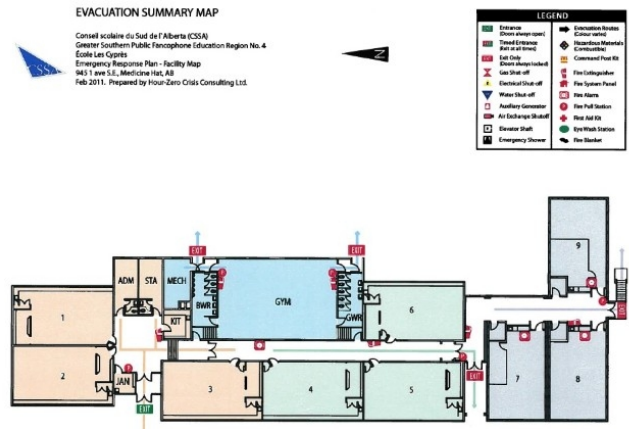
General view of the Central Park School. Classrooms 7, 8, and 9 are portables and therefore referenced in a separate report.
