RECAPP Facility Evaluation Report

Sturgeon School Div #24

Sturgeon Composite High School

Evaluation Company: Robert Irlam Consulting Inc.
Evaluation Date: August 16 2011
Evaluator Name: J. R. Irlam

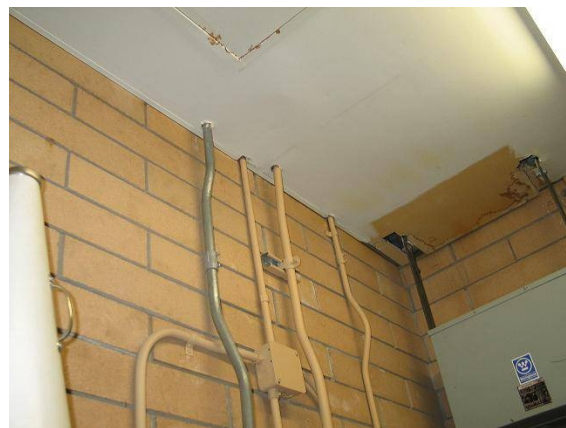
There are some locations where where fire stopping is missing where data and other communications systems have been installed subsequent to the original construction.

Missing fire stopping in electrical room

Install missing fire stopping.

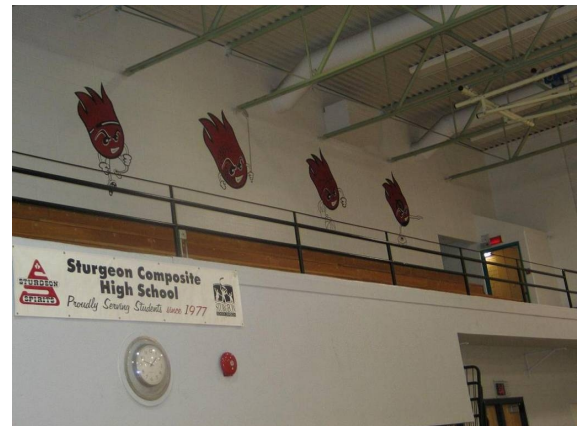
Steel guard rail

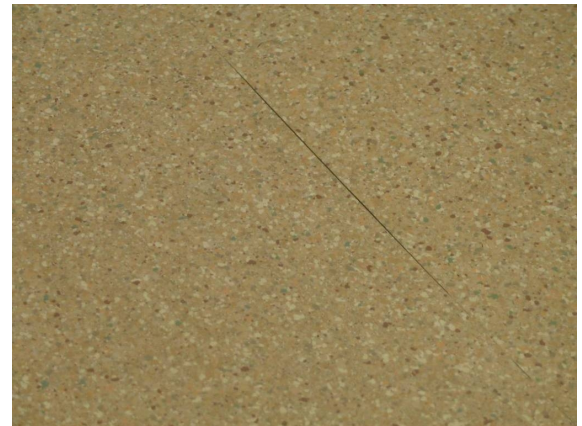
There is damaged and deteriorated resilient flooring throughout the school.

Split seam in resilient floor finish

Replacement of the damaged or deteriorated resilient flooring is recommended.

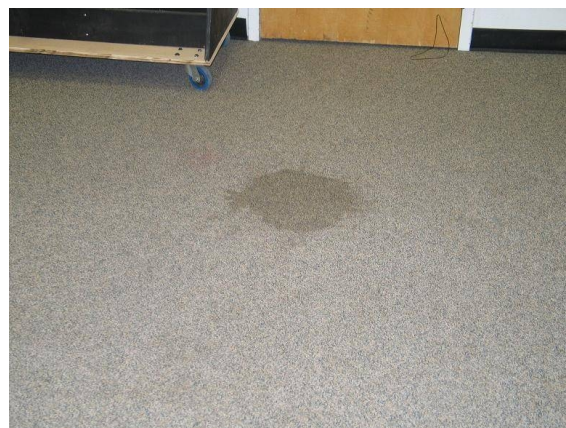
There is carpet throughout the school which has deteriorated, is damaged and requires replacement including the staff lounge, drama room and music room.

Stained and damaged carpet

Replace damaged and worn carpet.

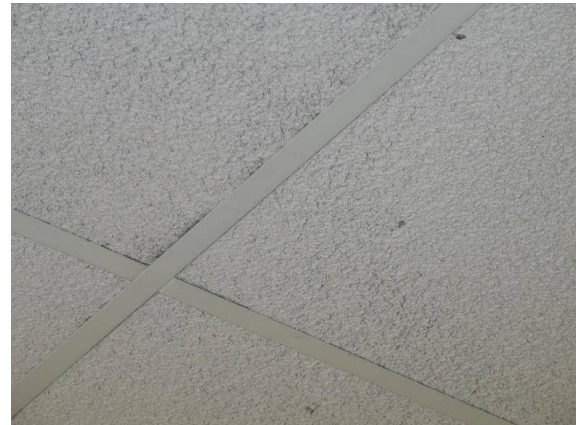
T-bar ceiling tiles throughout the school are damaged and require replacement including the main entrance corridor and cafeteria.

T-bar ceiling showing damaged area

Replace damaged ceiling tiles.
