RECAPP Facility Evaluation Report

Ecole La Prairie School

B3920A
Red Deer

Evaluation Company: Berry Architecture & Associates
Evaluation Date: November 16 2010
Evaluator Name: Angela Flinn

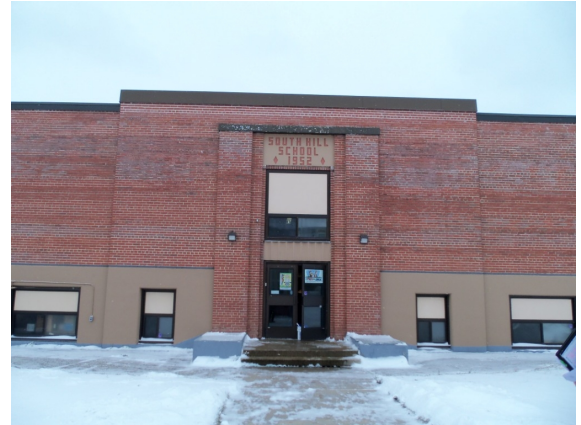
2010.02.10.JPG

Mortar needs to be repaired on about 50% of the brick walls. The brick has efflorescence on the north facade.

Mortar will continue to fail.

Replace damaged brick due to lack of mortar and clean brick. Repoint mortar joints on areas requiring new mortar.

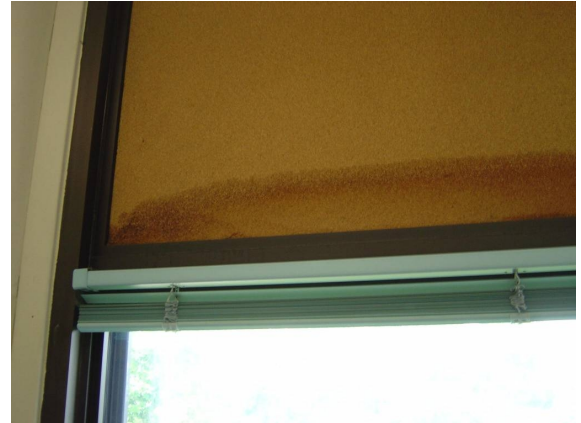
The interior surface of the cork, which has not been painted, is showing evidence of moisture damage from condensation. Also, the sandwiched rigid insulation may not be properly protected from fire exposure as required by Code.

Moisture staining on interior cork surface.

Remove all composite panels, replace with pre-finished metal insulated sandwich panels. Approximately 100 square metres of material at approximately \$250/m

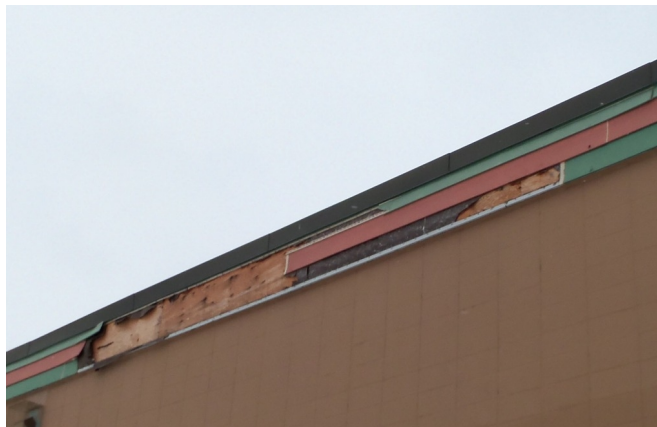
2010.01.06.5.jpg

(1972) Two to three rows of vinyl siding is on the top edge of the building face.

More pieces could fall off. Potential for moisture to enter the building at the top of the wall. Poor appearance.

Remove vinyl siding and replace with pre-finished metal siding.

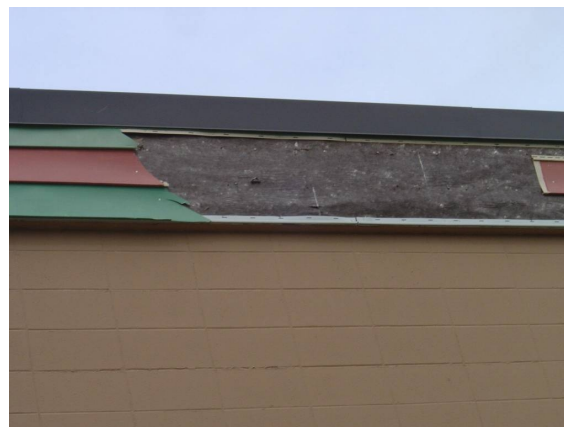
Top of gym wall, east side.

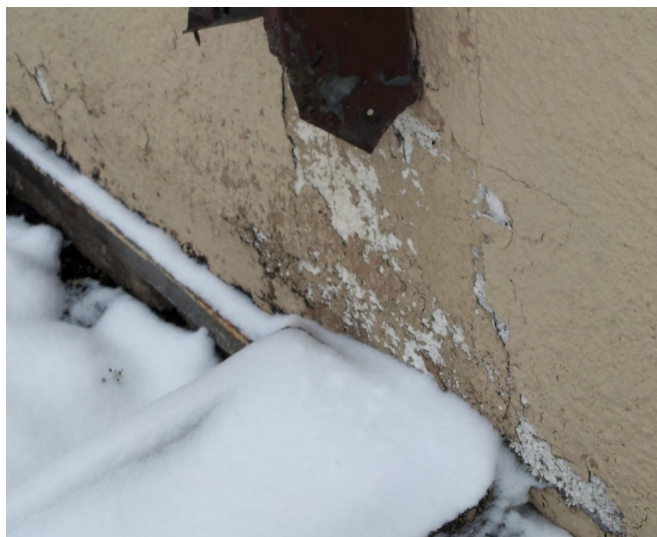
2010.01.08.JPG

There are hairline cracks along the bottom edge where the lower cementitious cladding is pushing up on the bottom flashing. Bottom flashing is damaged.

Patch cracks and paint stucco.

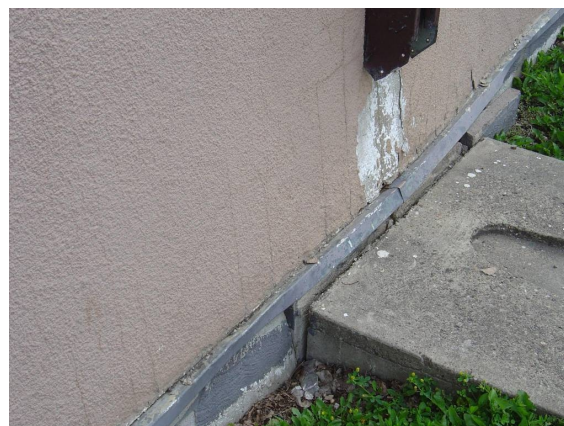
1972 - hairline cracks and water damage at base of 1972 addition.

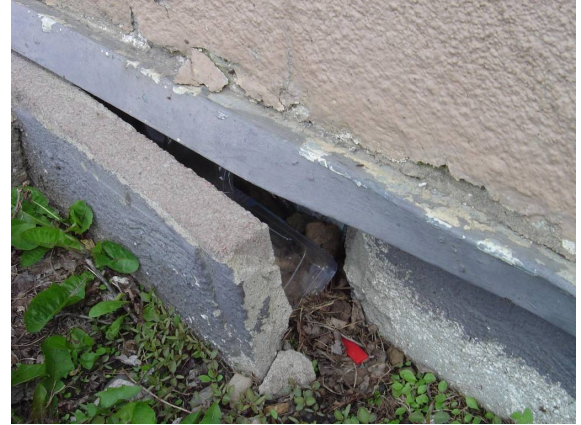
The cementitious skirting is getting dislodged, likely from ground water pressure, and is pushing up on the building base flashing, causing damage to stucco finish.

Cementitious cladding at base of 1972 addition

Remove all (approximately 140m) cementitious cladding, replace with parging on pressure treated plywood, strapped to the face of the foundation wall.

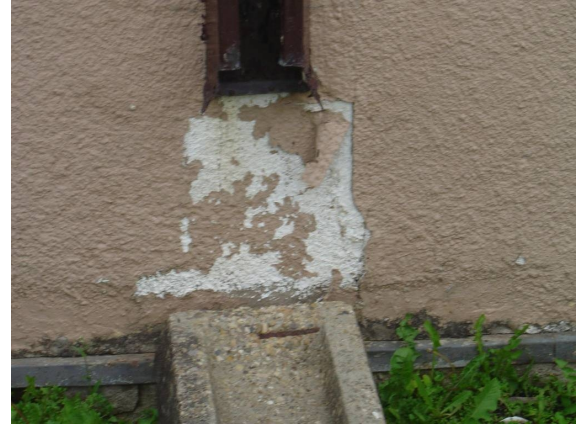
Paint is peeling off the gymnasium concrete block exterior wall and below rainwater leaders. There is evidence of moisture within the wall. Paint finish traps moisture and does not allow cementitious materials to breathe. Repainting is not viable, only cosmetic.

Paint finish peeling below downspouts.

Sandblast paint finish off all locations, apply cementitious stucco finish coat.

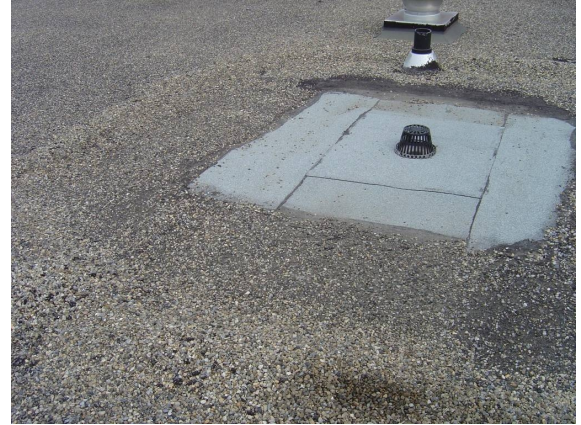
Built-up roof, patched with SBS

Replace built up roof with SBS roofing complete with sloped insulation and new flashing.

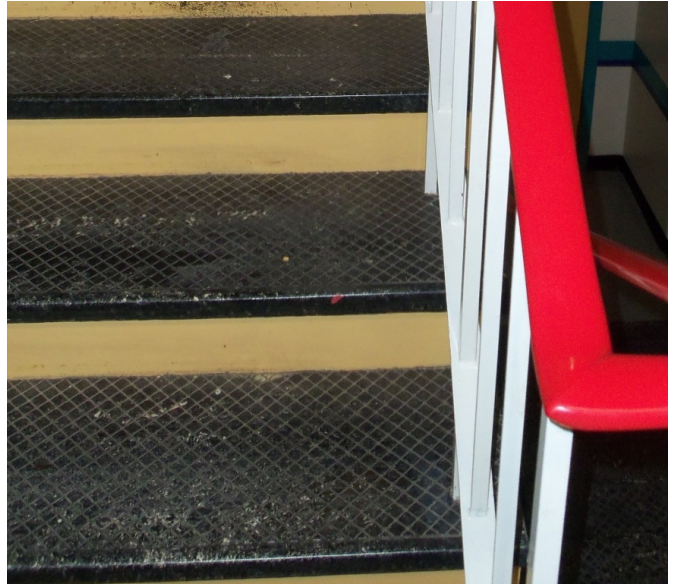
2010.08.JPG

Rubber treads are damaged and worn thin.

Very poor appearance and possible slipping hazard with wet footwear.

Remove existing rubber treads and replace with new rubber treads and risers.

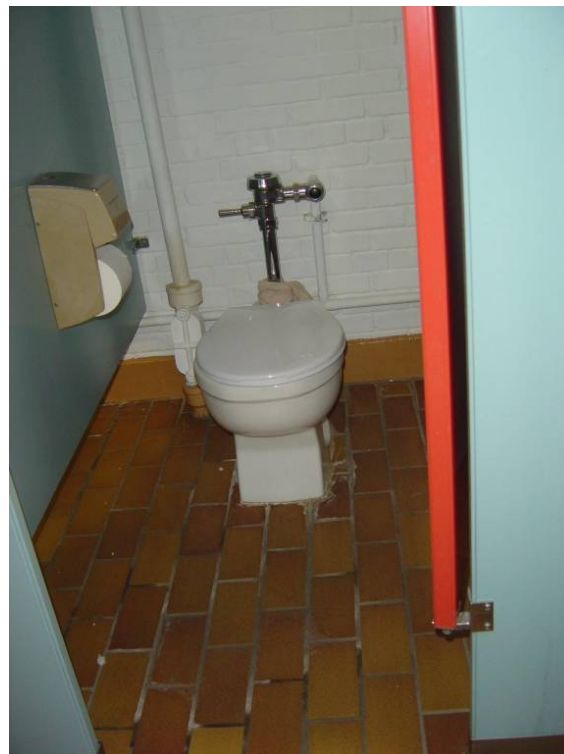
In 1951 washrooms, the grout joints are badly stained with efflorescence from leaking toilets.

Poor grout tile joints in washroom

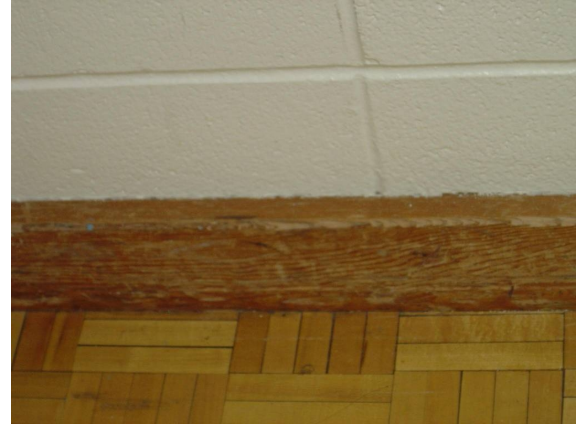
Gymnasium wood wall base.

Remove existing parquet flooring and fir baseboard. Provide new wood sports floor including sub-floor suspension with rubber base trim.

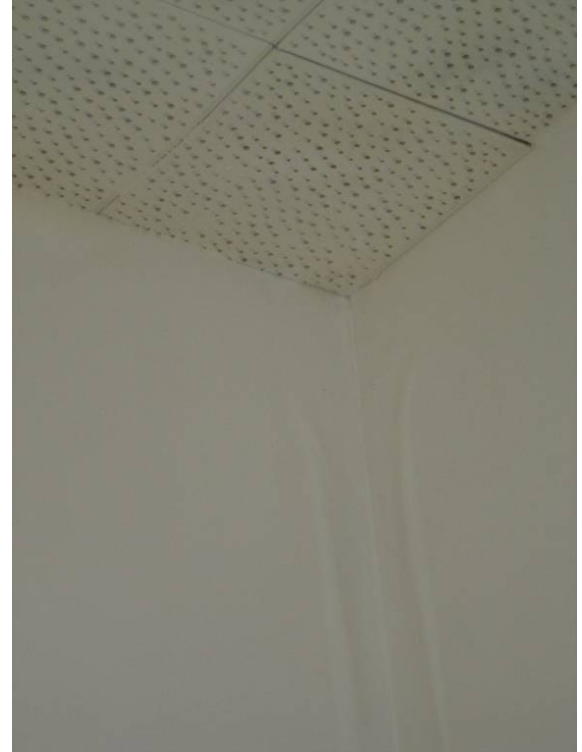
Glued-on acoustic ceiling tiles are sagging, stained, and falling off in locations.

Ceiling tile sagging.

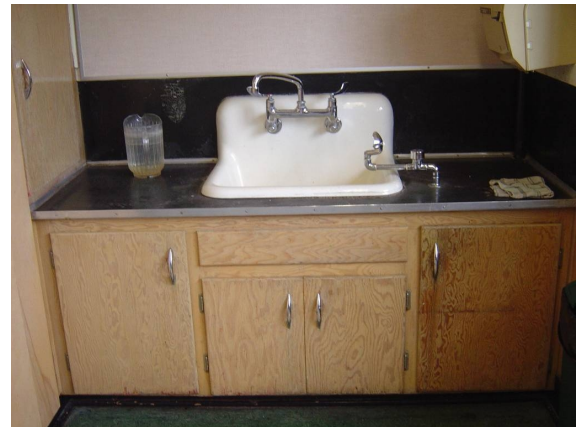
All millwork throughout the facility are damaged.

1951 classroom sink area

Replace cabinets in the entire school including the 11 classrooms, administration area, and library.
