# RECAPP Facility Evaluation Report

## St Albert Pss Dist #6

### William D. Cuts School

B4087A  
St. Albert

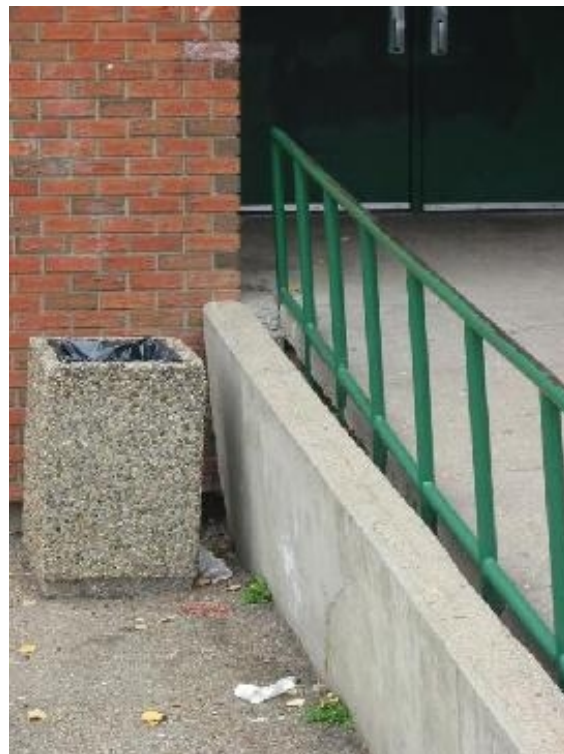
Failure at retaining wall ramp. Handrail too low.

Replace retaining wall and guard rail.

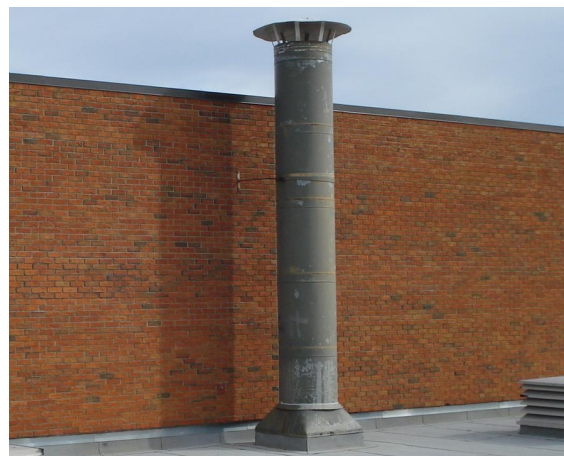
There is rust on the exterior of the Type 'B' gas vent above the building roof line.

Should pitting of the surface penetrate the exterior wall of the chimney, water could enter and cause rusting of the interior lining of the chimney.

Rust on the exterior portion of the boiler chimney.

Replace boiler Type 'B' gas vent above the roof.
