# RECAPP Facility Evaluation Report

**Holy Angels School**

B4900A

**Evaluation Company:** Quinn Young Architects  
**Evaluation Date:** September 25 2008  
**Evaluator Name:** Paul Tarbin

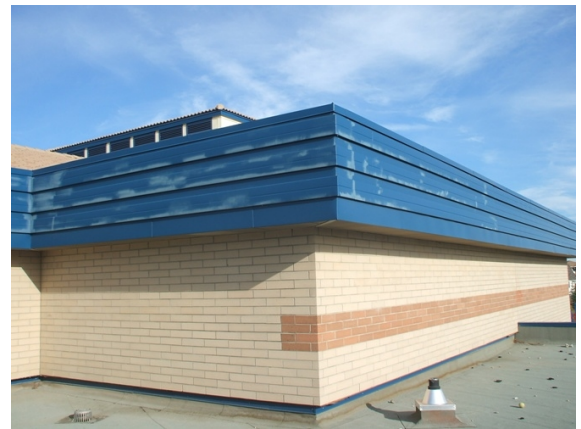
Oxidation on the blue metal siding has been found in several areas.

Metal siding showing oxidization taken from the SW roof level.

Repaint / refinish affected areas.

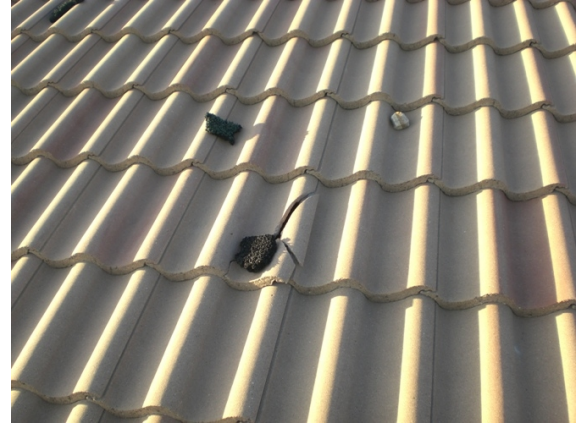
Damaged concrete tiles and grouting in various areas.

One of the areas with crack roof tiles

Replace damaged tiles and grout affected areas.

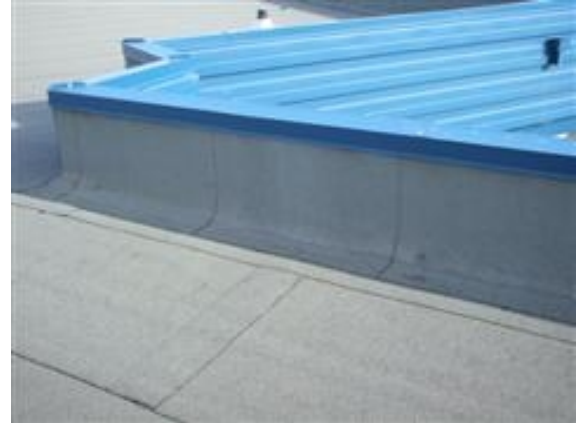
DSCF2034 (WinCE).JPG

**Concern:**  
Surface cracking found in capsheet at some parapet junctions.

**Recommendation:**  
Install new cap sheet to damaged areas.
