# RECAPP Facility Evaluation Report

## Parkland School Division #70

### Broxton Park School

B9128A

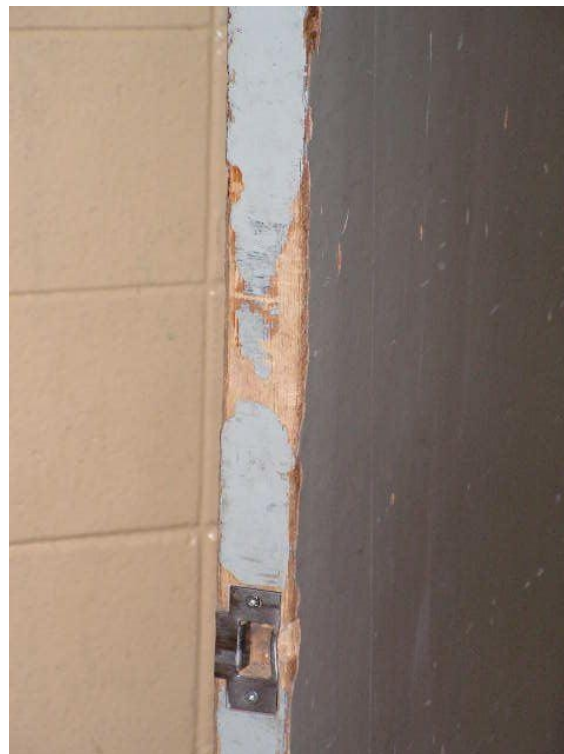
Interior doors are damaged and required replacement.

Typical damage to edges of wood doors

Replace damaged solid core wood doors.

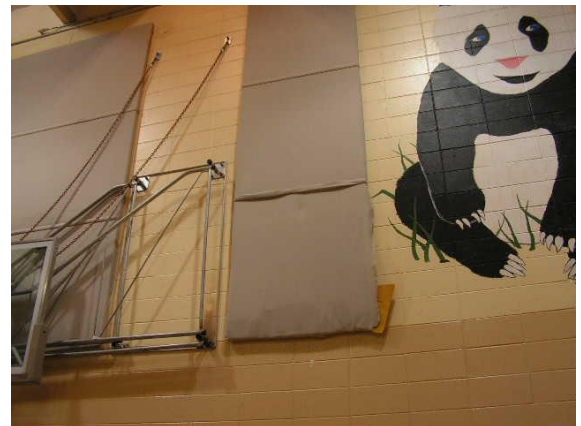
The fabric panels on the walls in the large gym are damaged, appear unsightly and require replacement.

Acoustic Panels in Main Gym

Replace fabric panels.

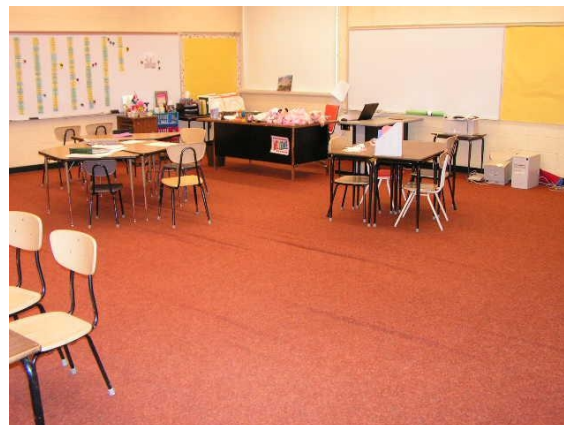
There are sections of carpet throughout the school which are stained and damaged and require replacement.

Deteriorated carpeting

Replace damaged carpet.
