RECAPP Facility Evaluation Report

Edmonton School District No. 7

Victoria School Of Performing And Visual Arts

B3351A
Edmonton

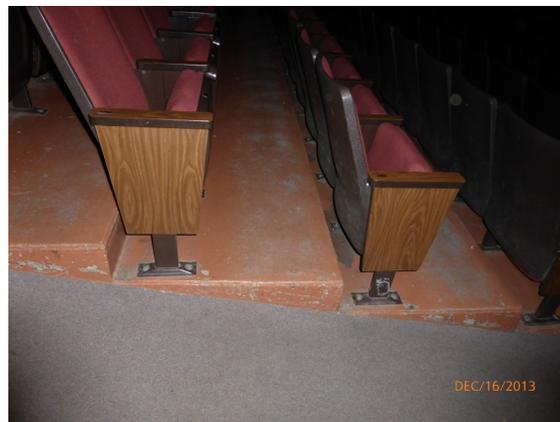
Aisles in Theater slope uniformly while the slab under seating is stepped resulting in triangular shaped steps at the end of each row. This step is a tripping hazard. Reported that a woman tripped and broke her leg within the past five years.

Triangular sloped steps at the end of each row in Theater.

Remove all seats and pour uniformly sloped slab below seating area to match sloped aisles. Modify bases of seats as required.
