# **RECAPP Facility Evaluation Report**

**Harry Collinge High School**

B3567A

**Evaluation Company:** Wade Engineering Ltd.  
**Evaluation Date:** October 25 2007  
**Evaluator Name:** Ron Shannon/Mike Pangman

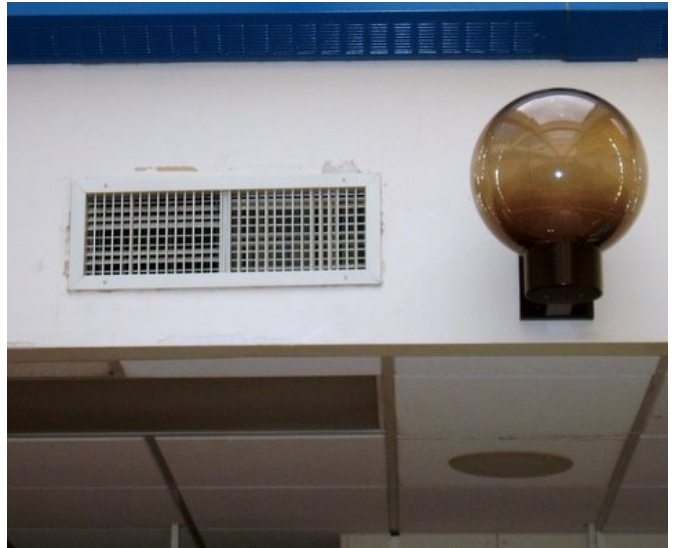
DSCF3997.JPG

There remain many incandescent lamps in the lower common area and upper gym workout area. Where not on a dimmer, lamps should be replaced by compact fluorescent lamps. Light levels should be increased as well.

<u>Rating</u>	<u>Installed</u>	<u>Design Life</u>	<u>Updated</u>
3 - Marginal	1988	30	MAR-08

Replace tinted fixtures with new, reuse others. Replace all lamps with bright compact fluorescent reflector lamps.

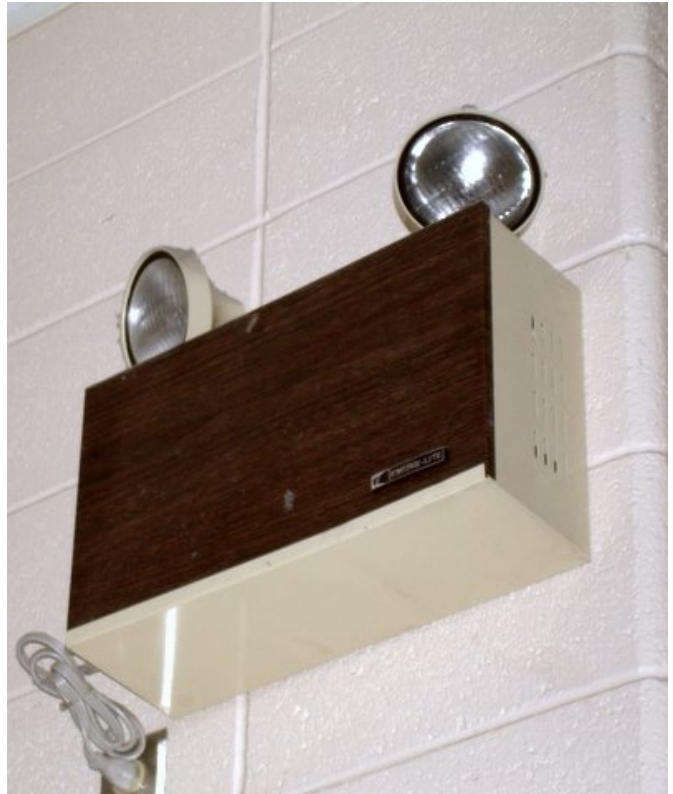
DSC01998.jpg

Some emergency lighting comes from battery packs with lamps, other from generator-backed lighting grid. Battery units working OK

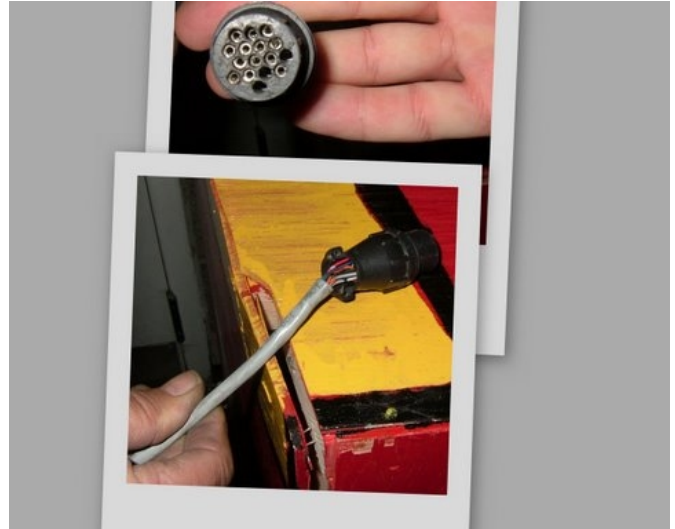
collage.jpg

Blackbox Theatre wiring needs upgrades.

<u>Rating</u>	<u>Installed</u>	<u>Design Life</u>	<u>Updated</u>
3 - Marginal	1969	0	MAR-08
