RECAPP Facility Evaluation Report

Radway School

B3898A

Evaluation Company: A&E Architectural & Engineering Group Inc.
Evaluation Date: June 14 2007
Evaluator Name: Vic Maybroda

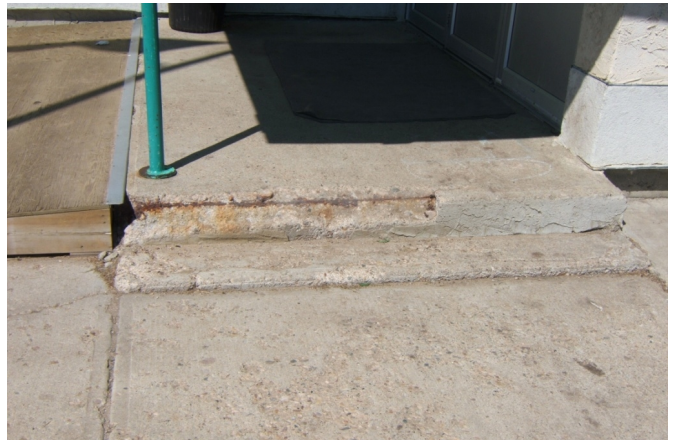
B1010.07 Exterior Stairs* - 1959 Section

Concrete stairs and landings at vestibule areas.
Wood framed landing and steps to access main level storage room.

<u>Rating</u>	<u>Installed</u>	<u>Design Life</u>	<u>Updated</u>
3 - Marginal	1959	40	JAN-08

Deteriorated condition presents tripping hazard.

Event: Replace riser and 2.4 Sq. M of Concrete landing

Replace all damaged concrete steps and landings.

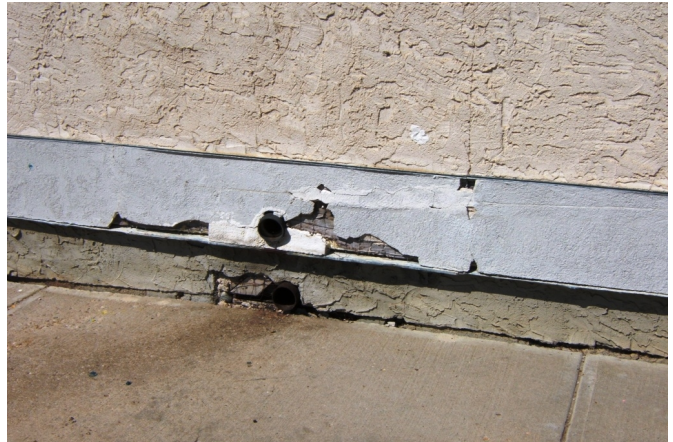
B2010.01.08 Cement Plaster (Stucco): Ext. Wall* - 1959 Section

Textured stucco requires isolated maintenance repairs.

<u>Rating</u>	<u>Installed</u>	<u>Design Life</u>	<u>Updated</u>
4 - Acceptable	1985	75	JAN-08

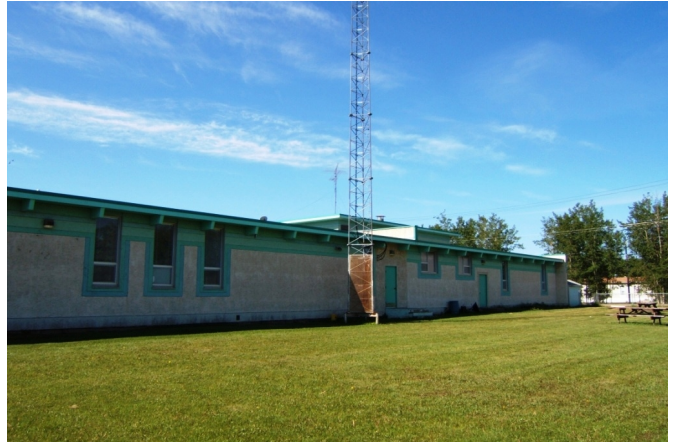
B2010.01.13 Paints (& Stains): Exterior Wall - 1959 Section**

Painted wood trim around perimeter of school.

<u>Rating</u>	<u>Installed</u>	<u>Design Life</u>	<u>Updated</u>
4 - Acceptable	1985	15	JAN-08

Event: Refinish Painted Exterior Wall Elements

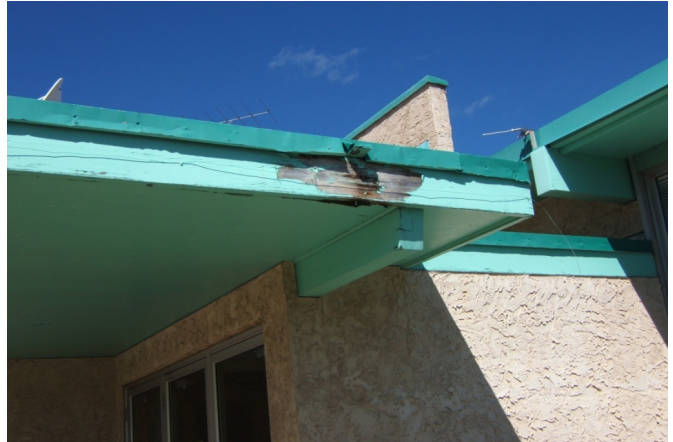
B2010.09 Exterior Soffits* - 1959 Section

Paint finished wood.
Refinishing cost include with B2010.01.13.

<u>Rating</u>	<u>Installed</u>	<u>Design Life</u>	<u>Updated</u>
3 - Marginal	1959	0	JAN-08

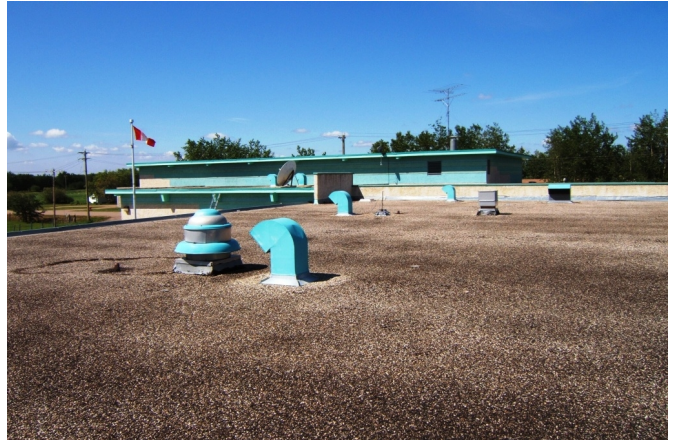
B3010.04.01 Built-up Bituminous Roofing (Asphalt & Gravel)**

Built-up asphalt gravel surfaces roofing

<u>Rating</u>	<u>Installed</u>	<u>Design Life</u>	<u>Updated</u>
4 - Acceptable	1985	25	JAN-08

Event: Replace

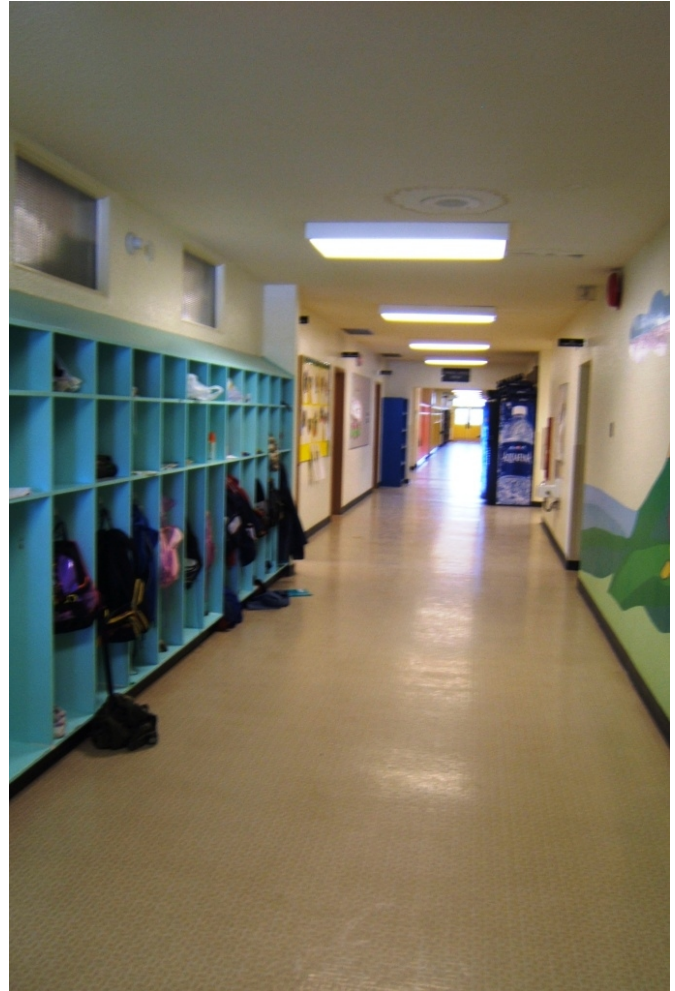
C1030.10 Lockers - 1959**

Painted wood open face lockers/storage units located in corridor.

<u>Rating</u>	<u>Installed</u>	<u>Design Life</u>	<u>Updated</u>
2 - Poor	1959	30	JAN-08

Event: Replace

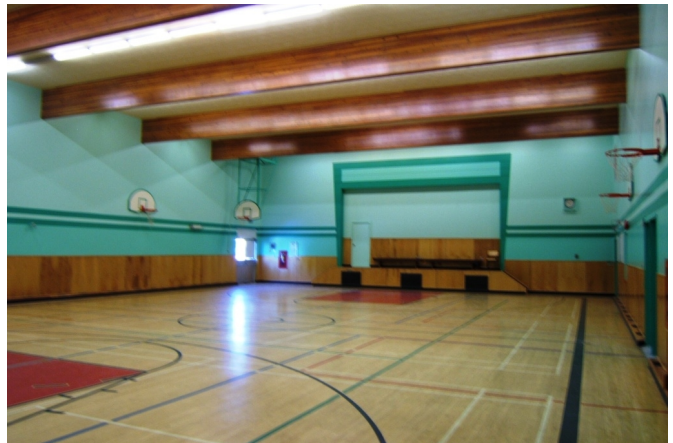
Dado height wood strip walls located in gymnasium.

<u>Rating</u>	<u>Installed</u>	<u>Design Life</u>	<u>Updated</u>
4 - Acceptable	1985	30	JAN-08

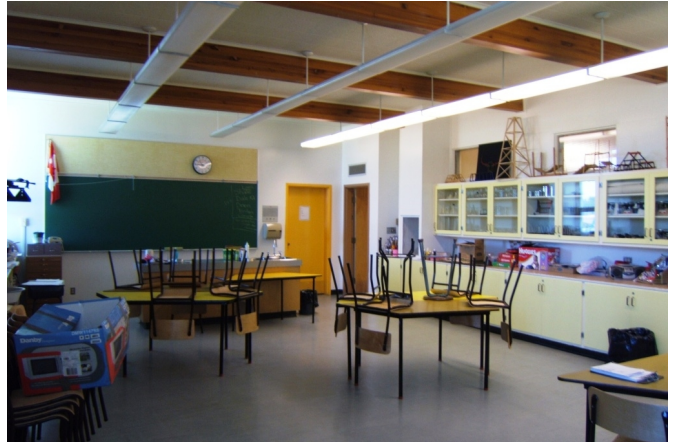
Majority of fixed casework consists of painted wood in marginal condition.
Areas which received 1985 upgrade are in acceptable condition.

<u>Rating</u>	<u>Installed</u>	<u>Design Life</u>	<u>Updated</u>
4 - Acceptable	1959	35	JAN-08

**Event: Replace**

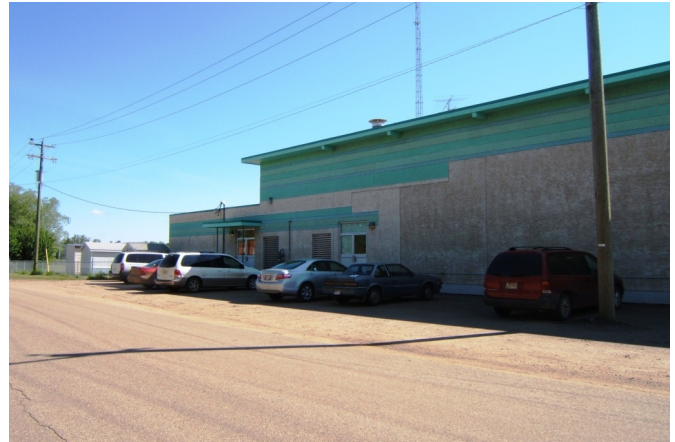
G2020.02.02 Flexible Paving Parking Lots(Asphalt)** -

<u>Rating</u>	<u>Installed</u>	<u>Design Life</u>	<u>Updated</u>
4 - Acceptable	1959	25	JAN-08

Event: Replace Paved Parking Area.

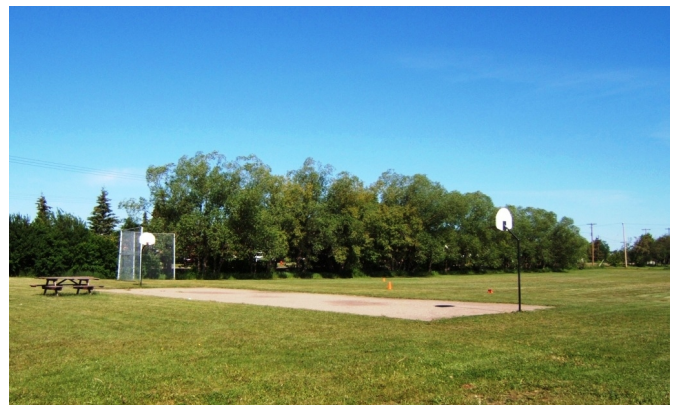
Asphalt surfaced basketball court, sand surfaced creative play area and grassed baseball and soccer fields.

<u>Rating</u>	<u>Installed</u>	<u>Design Life</u>	<u>Updated</u>
4 - Acceptable	1959	25	JAN-08

Event: Replace Recreational Surfaces

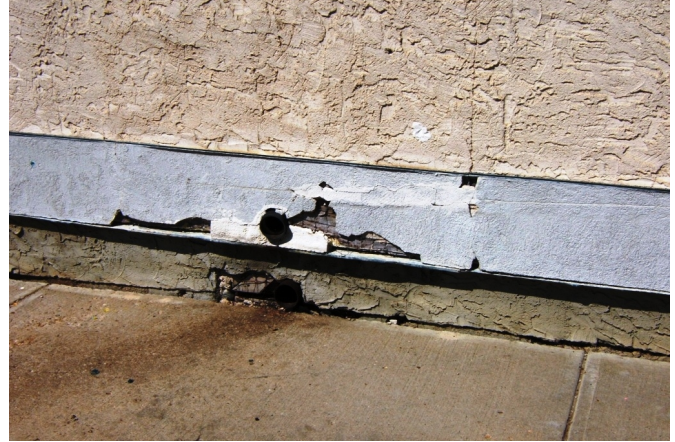
Roof drains to internal down pipes exiting above grade.

<u>Rating</u>	<u>Installed</u>	<u>Design Life</u>	<u>Updated</u>
3 - Marginal	1959	0	FEB-08

Water damage to wall/foundation surfaces.

Event: Repair

Extend down pipes and repair damaged surfaces.
