RECAPP Facility Evaluation Report

Bev Facey Community High School

B4004A
Sherwood Park

Evaluation Company: Kenneth M. Lee Architect
Evaluation Date: July 17 2007
Evaluator Name: Ken Lee

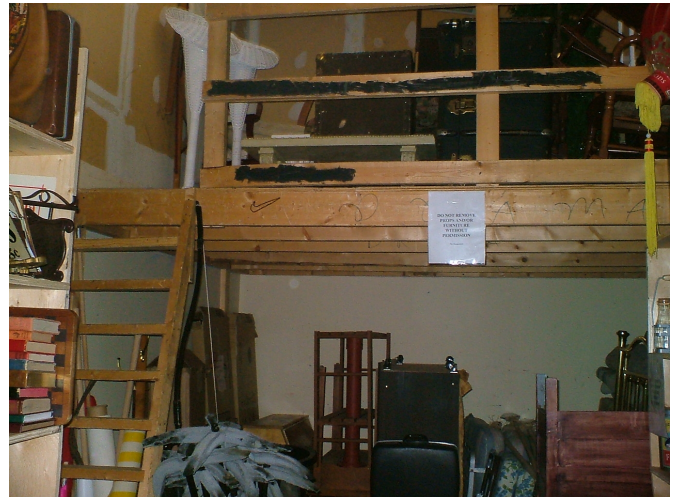
| <u>Rating</u> | <u>Installed</u> | <u>Design Life</u> | <u>Updated</u> |
| 3 - Marginal | 1980 | 0 | FEB-08 |

Event: Replace the exposed wood mezzanine.

Replace the mezzanine with non-combustible construction or remove.

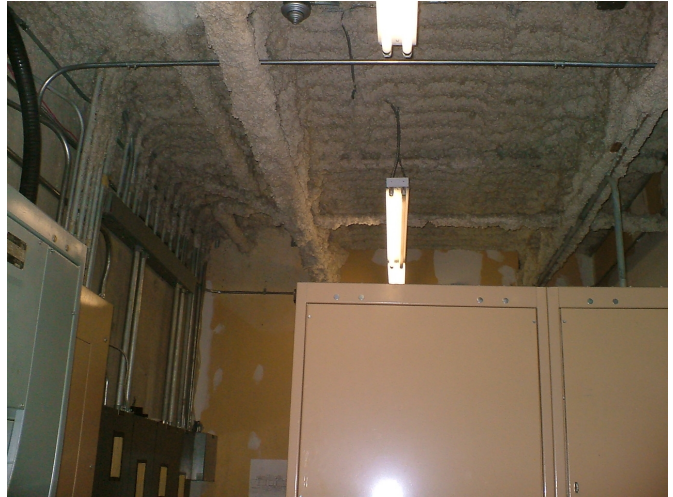
B1020.06 Roof Construction Fireproofing* - 1980 Section

Fire reduction sprayed material on steel deck, steel joists and steel beams of the roof and 2nd floor in areas that require fireproofing. Some fire reduction sprayed material has peeled off.

| <u>Rating</u> | <u>Installed</u> | <u>Design Life</u> | <u>Updated</u> |
|---|---|---|---|
| 3 - Marginal | 1980 | 0 | FEB-08 |

Event: **Repair fire reduction sprayed material.**

Repair fire reduction sprayed material. (185.00 sq.m.)

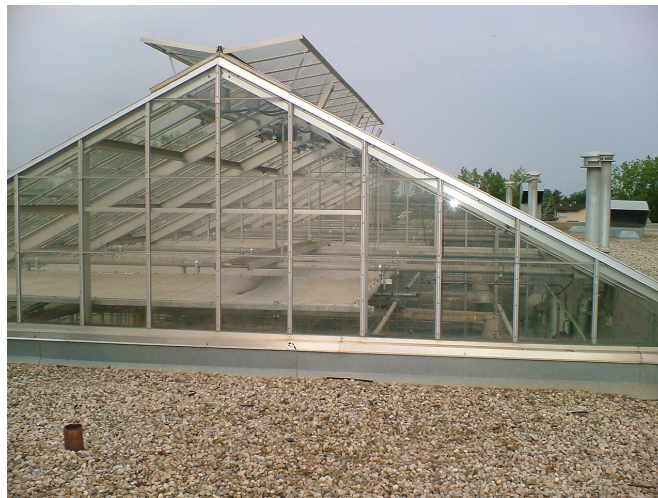
A greenhouse on the 2nd floor at the south end of the building for the horticulture workshop. It is divided into two sections and is constructed of vertical & sloped metal frames with single glazed glass completed with venting windows at the top and at the front. The shades were replaced in 2003. It is hot in the summer and is difficult to find leakage. (Note: It is typical to have icicles in the spring during snow melting period. It does not interfere the function of the building.)

| 4 - Acceptable | 1980 | 0 | FEB-08 |

Event: **Replace greenhouse.**

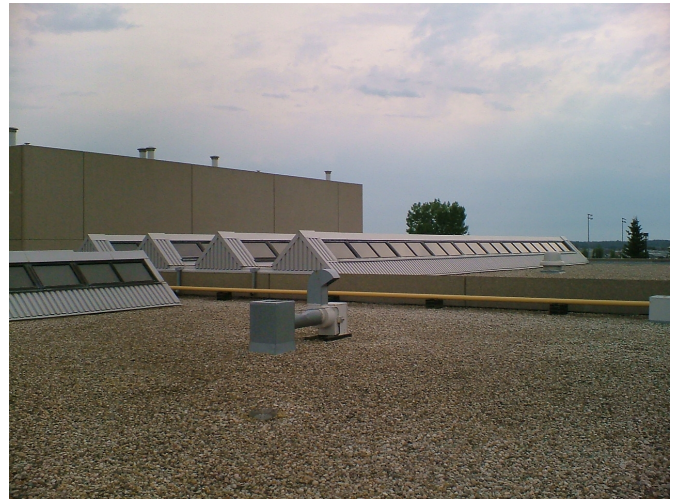
| <u>Rating</u> | <u>Installed</u> | <u>Design Life</u> | <u>Updated</u> |
|---|---|---|---|
| 4 - Acceptable | 1980 | 25 | FEB-08 |

Event: Replace skylights. (4 long rolls, 12 short rolls.)

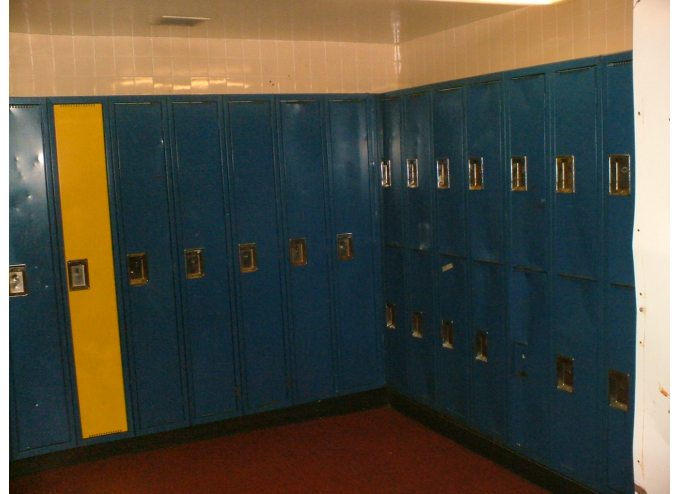
(Note: Some locker doors were replaced in 1996, 1997, 1998, 2001 and 2003. Some lockers were replaced in 2004.)

| <u>Rating</u> | <u>Installed</u> | <u>Design Life</u> | <u>Updated</u> |
|---|---|---|---|
| 4 - Acceptable | 1980 | 30 | FEB-08 |

Event: Replace lockers. (Approx. 1490 single, 260 double)

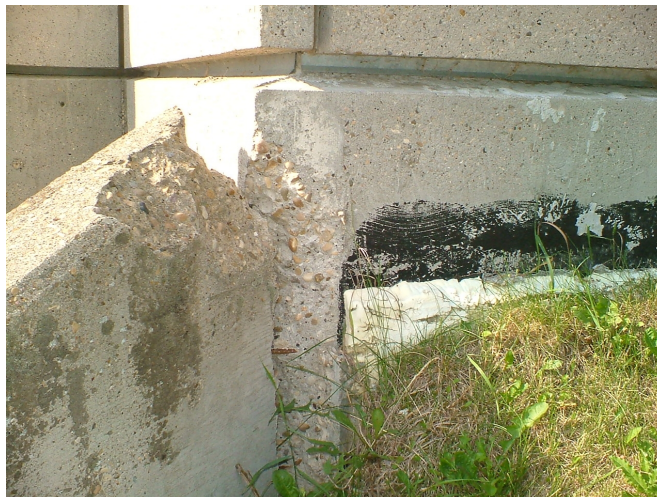
| 3 - Marginal | 1980 | 50 | FEB-08 |

Event: **Re-grade the soil along the east foundation wall.**

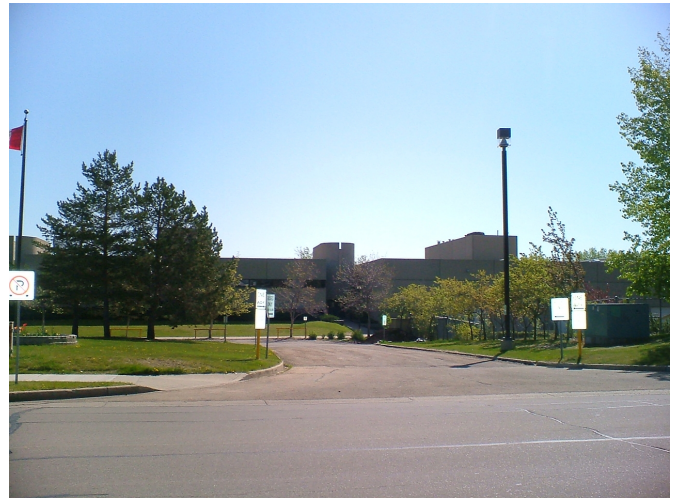
| 4 - Acceptable | 1980 | 25 | FEB-08 |

Event: Re-pave roadway. (3,355.00 sq.m.)

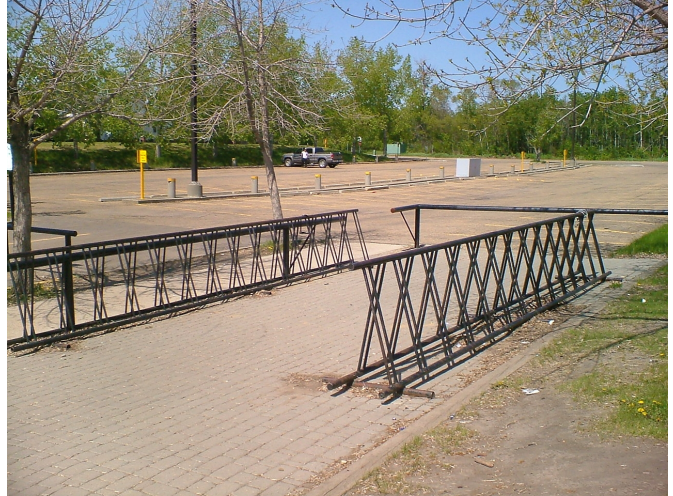
| 4 - Acceptable | 1980 | 20 | FEB-08 |

Event: Replace unit pavers. (127.27 sq.m.)
