# RECAPP Facility Evaluation Report

Black Gold Regional Div #18

## Thorsby Elementary School

**Evaluation Company:** John Murray Architectural Associates  
**Evaluation Date:** August 15 2007  
**Evaluator Name:** John Murray

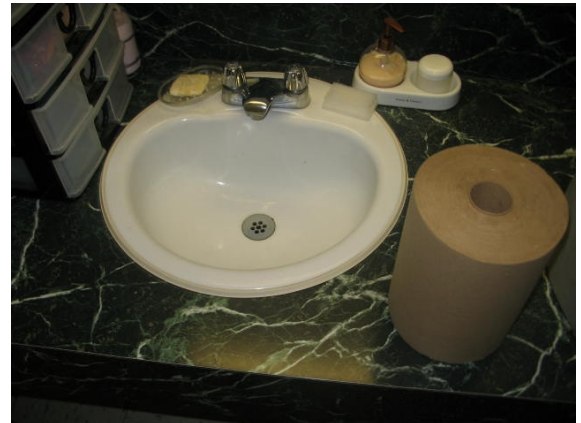
IMG\_4537.JPG

Majority of lavatories were recently replaced ( approx. 2000) - stainless steel, countertop. Enameled steel, countertop lavatories in staff washrooms (approx. 1968).

#### **Event: Replace 2 Lavs from 1968**

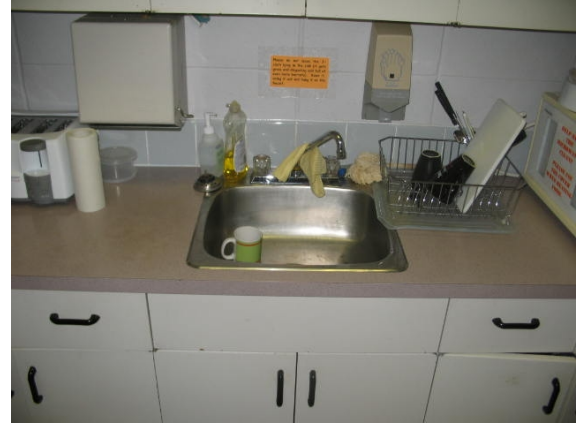
IMG\_4539.JPG

All sinks are aged and deteriorate.

Replace 4 Sinks

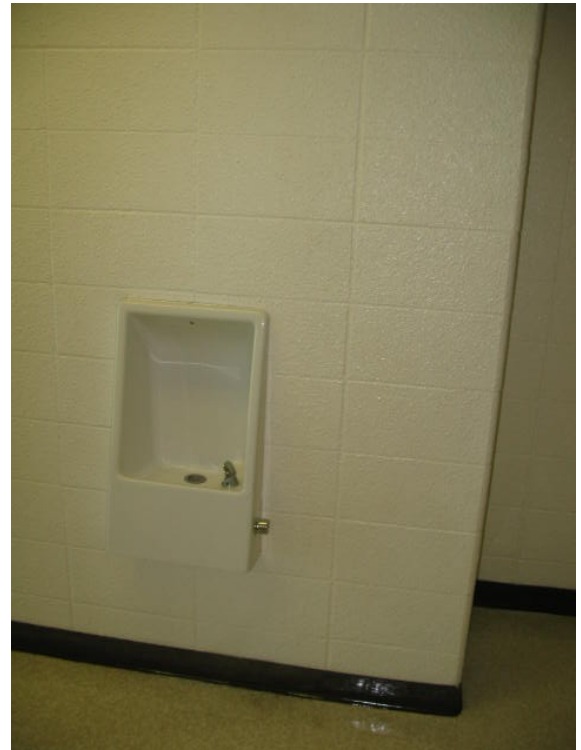
IMG\_4503.JPG

Drinking Fountains are old and deteriorate.

Replace 3 DF.

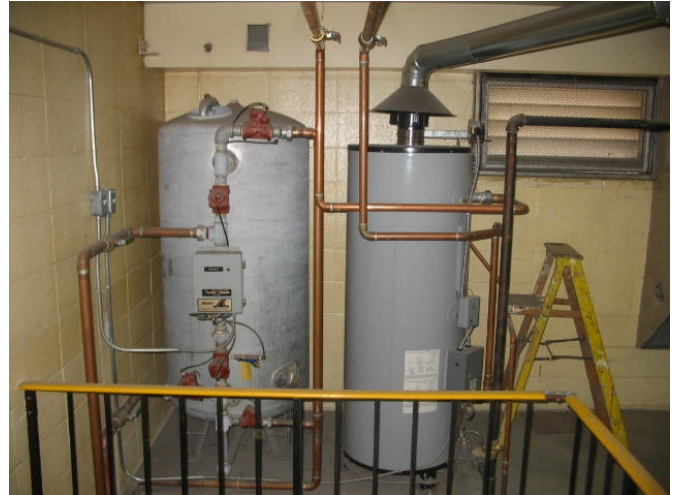
IMG\_4553.JPG

Domestic water lines not insulated in Mechanical Room.

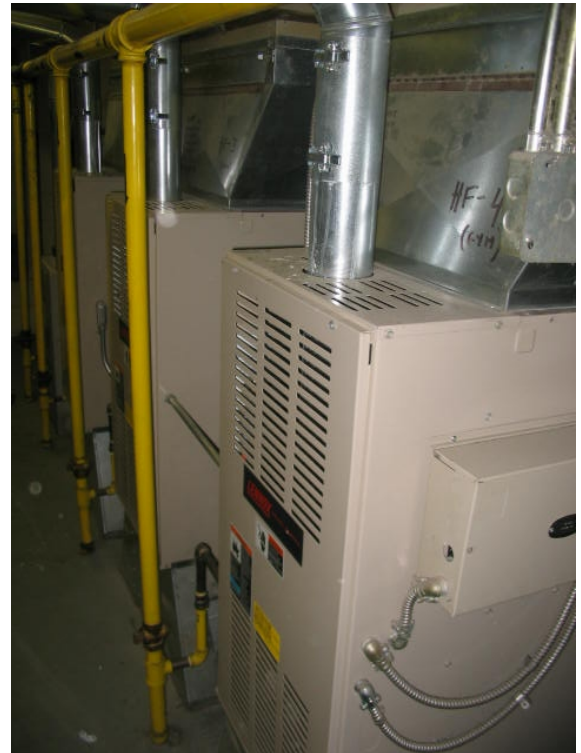
The existing heating and ventilation system is deteriorated. System cannot provide backup heating. The existing furnaces and multizone units do not provide sufficient amount of fresh air to the building. Classrooms are stuffy and do not have adequate ventilation. The existing air units does not meet present ASHRAE code: 62.1-2004 - Ventilation for Acceptable Indoor Air Quality. Very poor air circulation.

Furnaces serving Gymnasium.

- 1) Replace existing furnace system with an independent central air handling system complete with glycol heating coils. New units should equipped with glycol coils to provide greater quantities of outdoor air.
- 2) Install new boiler plant which should consist of:
  - a) Two boilers to provide 60% hot water heating capacity, each complete with two base mounted pumps.
  - b) Plate heat exchanger complete with glycol circulation pumps.
  - c) Glycol fill assembly.
  - d) Expansion tanks.
- 3) Install reverse return hot water heating piping loop in ceiling space serving perimeter radiation and force flow heaters.
- 4) Install perimeter base board radiation serving classrooms, gymnasium and all common areas.

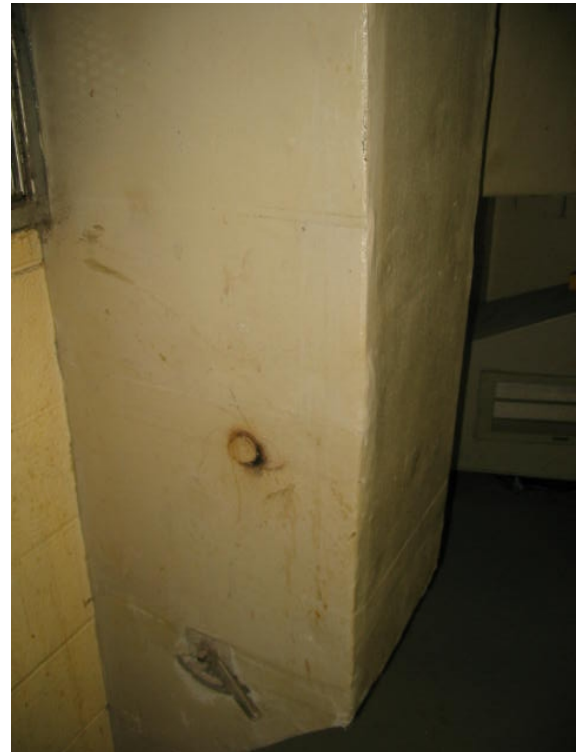
Combustion air duct.

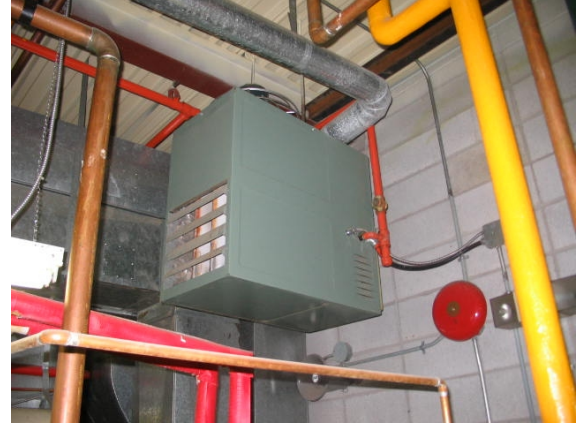
Unit Heater in Mechanical Room.

**Event: Unit Heater Replacement**

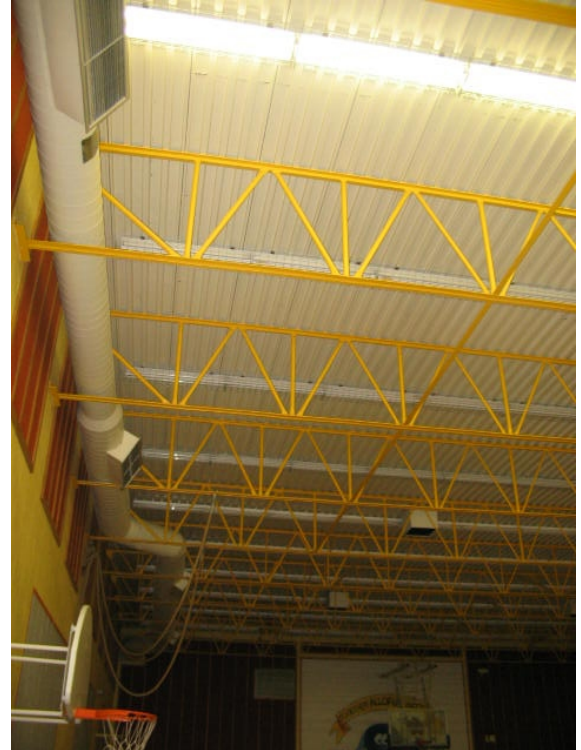
Gymnasium supply air duct.

Replace existing air distribution with new galvanized steel ducts up to recent SMACNA standards. Ducts should be properly sized to match new ventilation load.

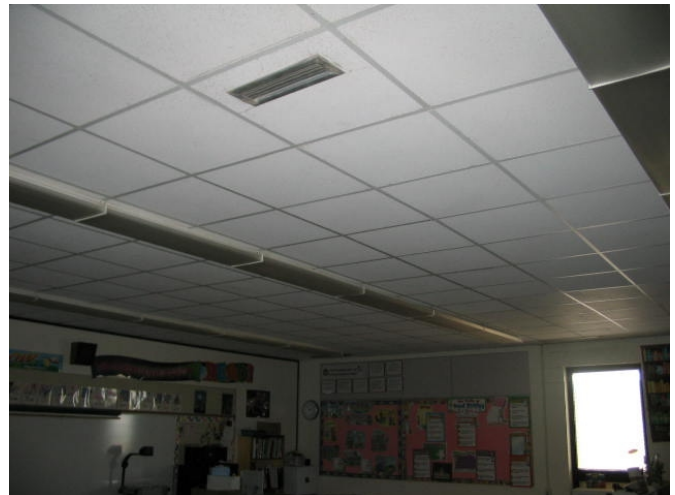
<u>Rating</u>	<u>Installed</u>	<u>Design Life</u>	<u>Updated</u>
2 - Poor	1968	0	DEC-07

Supply air grille in classroom.
