RECAPP Facility Evaluation Report

Bellerose Composite High School

B4063A
St. Albert

Evaluation Company: Wilson Architects Ltd.
Evaluation Date: May 29 2006
Evaluator Name: J. R. Irlam

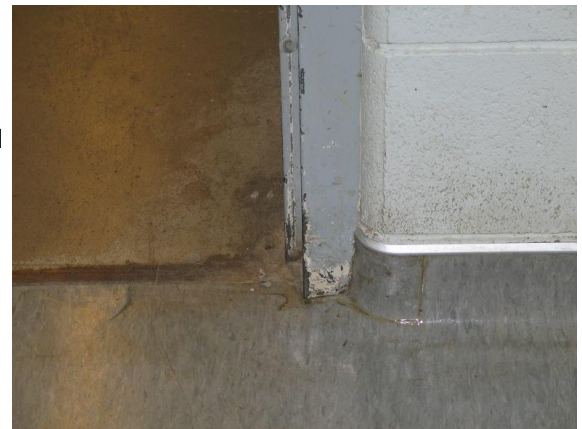
Event: Replace overhead doors

The concern is that the overhead doors in the automotive shop are damaged due to prolonged usage and the affects of ice and snow.

The overhead doors will continue to deteriorate if not replaced.

Replacement of the overhead doors is recommended.

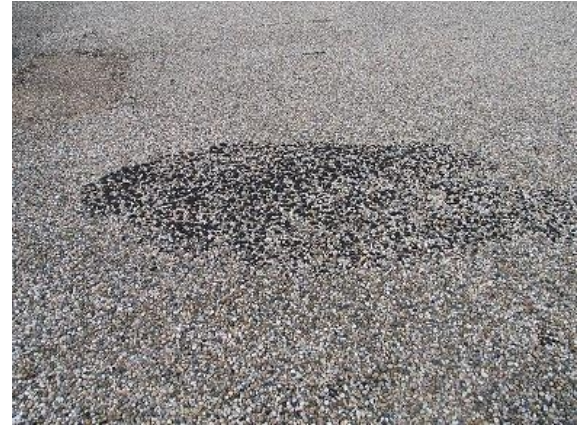
Event: Replace roof

The original 1986 built up roof is showing signs of deterioration and will reach the end of its design life in 2011.

The roof will continue to deteriorate if this recommendation is deferred.

Replacement of the majority of this roof is recommended.

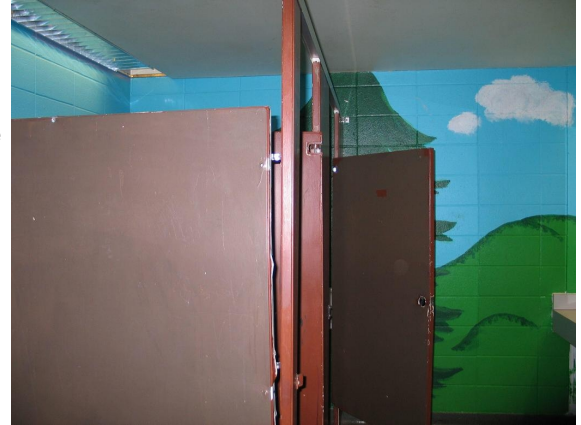
Event: Replace toilet partitions

There are steel toilet partitions in student wash rooms on both floors of the school which are damaged due to prolonged usage and abuse.

The toilet partitions will continue to deteriorate.

Replacement of steel toilet partitions is recommended.

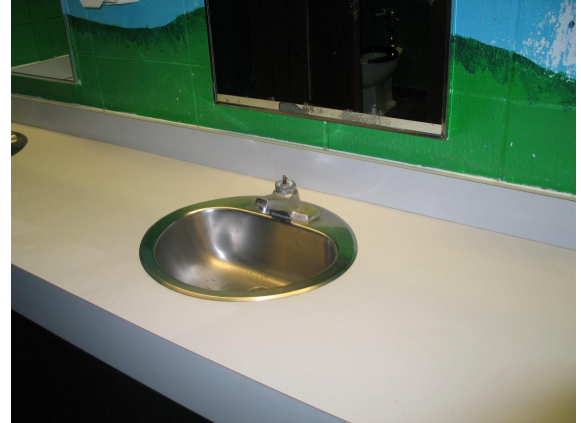
Event: Replace mirrors

There are mirrors in student and staff wash rooms which have deteriorated and require replacement.

Wash room mirrors will continue to deteriorate.

Replacement of deteriorated mirrors is recommended.

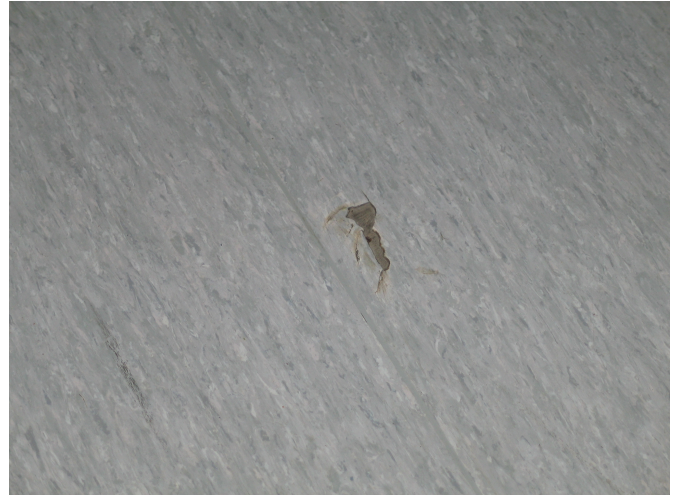
Event: Replace sheet vinyl floor

There is sheet vinyl throughout the school in corridors and classrooms.

The sheet vinyl reaches the end of its theoretical design life in 2006. The sheet vinyl is also damaged and split in some locations.

Replacement of the damaged sections is recommended.

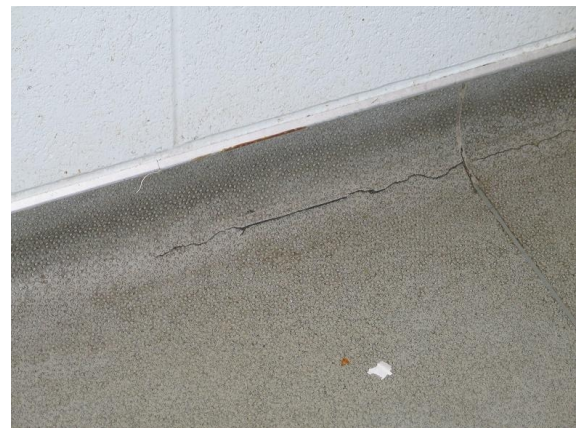
Event: Replace damaged floor

The other floor finishes reach their design life in 2006. They are damaged, appear unsightly and require replacement.

The floor will continue to deteriorate.

Replacement of the damaged areas is recommended.

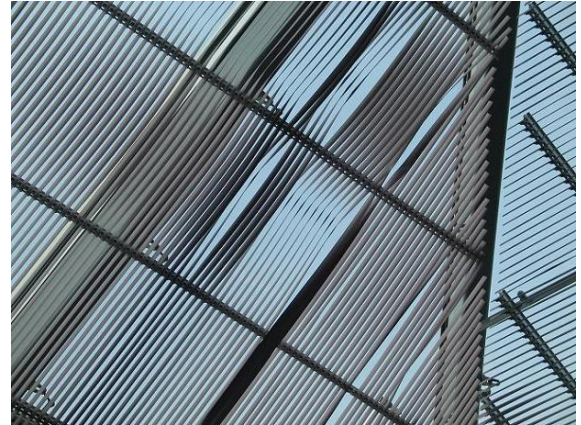
Event: Replace blinds

Several sections of Venetian blinds beneath the skylights are damaged and require replacement.

The blinds will deteriorate further if there is a deferral of this item.

Replacement of damaged blinds is recommended.

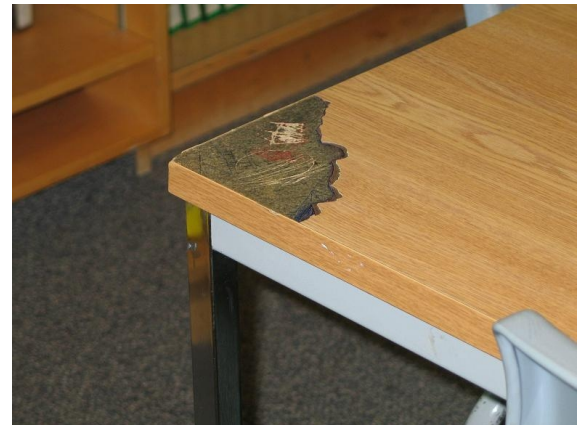
Event: Repair desks and tables

There are desks and tables with damaged plastic laminate which appears unsightly and requires replacement.

Desks and tables will continue to deteriorate.

Re-laminating damaged desks and tables is recommended.

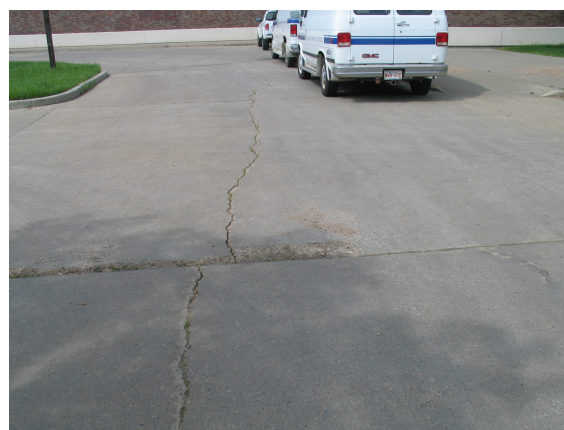
Event: Replace flexible roadways

The concern is that damaged and deteriorated asphalt roadway requires replacing.

The asphalt roadway will deteriorate further.

Replacement of asphalt roadway is recommended at the end of its design life.

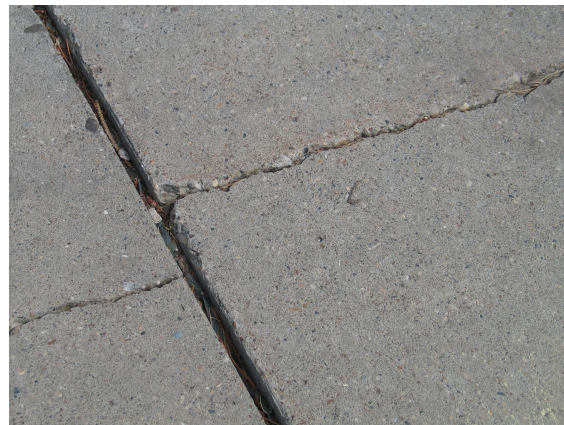
Event: Replace concrete road

The concrete service road is cracked and expensive to repair.

The concrete road will continue to deteriorate.

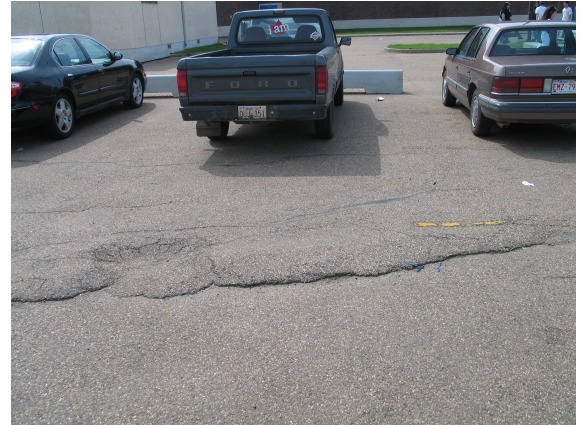
The asphalt parking lots will continue to deteriorate.

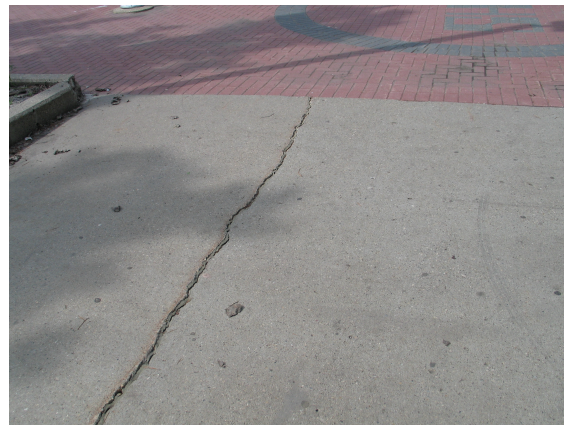
The pavement will deteriorate further.

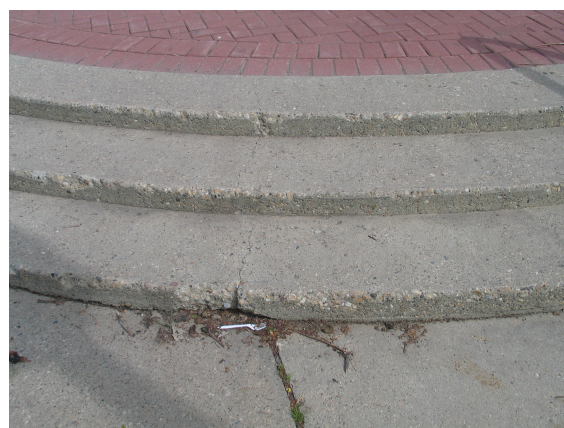
The steps will deteriorate further.
