RECAPP Facility Evaluation Report

Chinook's Edge School Div #73

Delburne Centralized School

B2992A

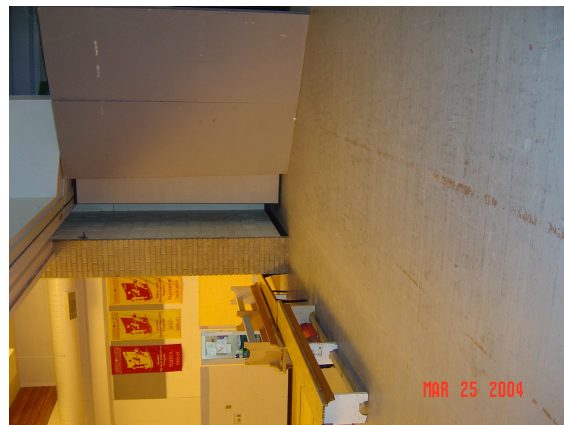
C1010.03 Interior Operable Folding Panel Partitions*

(1958) 1200mm acoustic panels on large rail. Awkward for theatrical events.

<u>Rating</u>	<u>Installed</u>	<u>Design Life</u>	<u>Updated</u>
3	0	30	October 2004

Concern:

Large folding partition no longer required with relocation of music room.

Recommendation:

Replace with stage drapery for drama productions

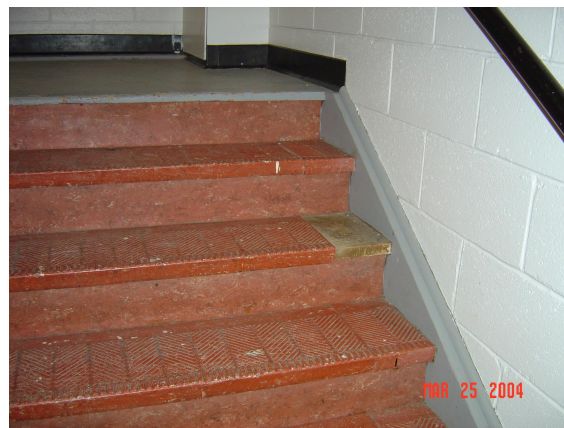
C2020.05 Resilient Stair Finishes*

(1958) To stage area.

<u>Rating</u>	<u>Installed</u>	<u>Design Life</u>	<u>Updated</u>
3	0	20	October 2004

Concern:

Stair treads and risers are worn out with some sections missing

Recommendation:

Replace with new rubber treads and risers

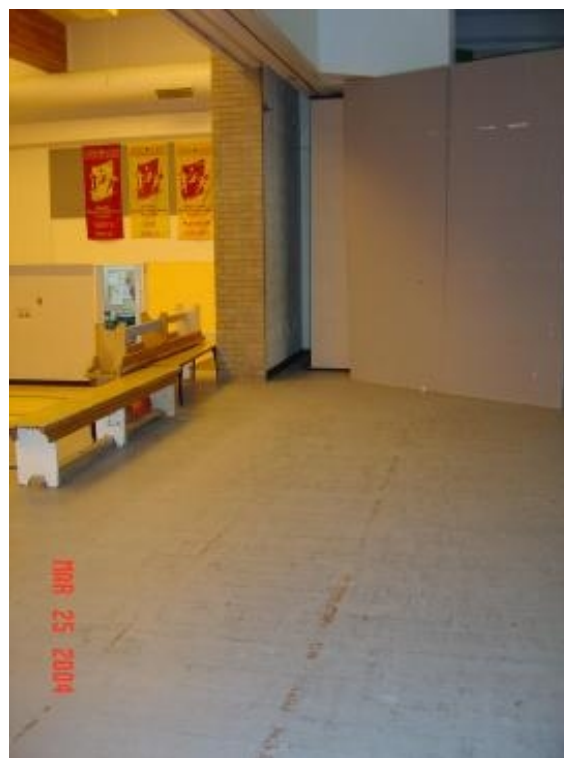
C3020.04.01 Wood Strip Flooring

1986 Stage floor

<u>Rating</u>	<u>Installed</u>	<u>Design Life</u>	<u>Updated</u>
2	0	0	October 2004

Concern:

Stage floor is worn. Finish is gone.

Recommendation:

Refinish existing hardwood floor 92.3 m2
