RECAPP Facility Evaluation Report

Mayerthorpe Jr. / Sr. High School

B3754A
Mayerthorpe

Evaluation Company: Francis Ng Architect Ltd.
Evaluation Date: October 4 2006
Evaluator Name: Francis Ng

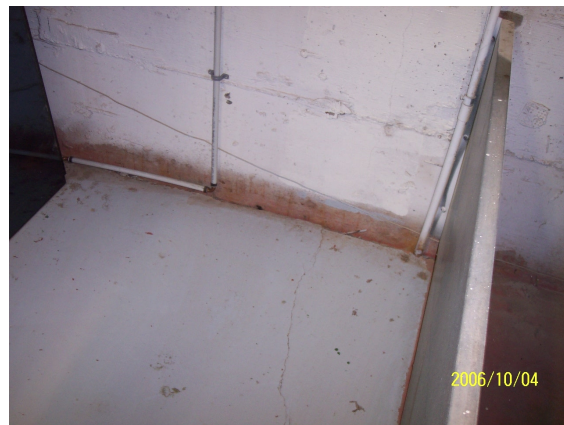
(1967) Addition - (MEC 139) has settled and cracked concrete slab.

Replace concrete slab. (approx. 100 square metres)

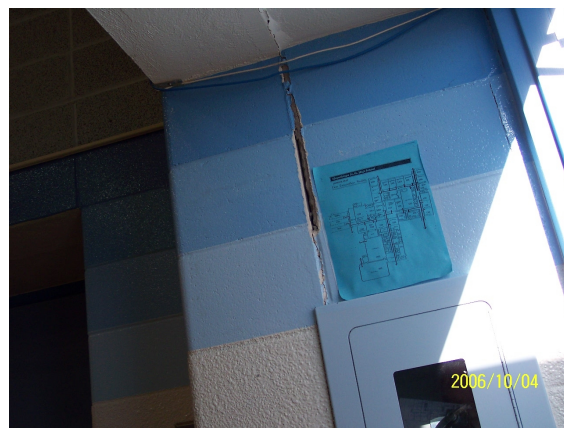
(1992) Addition - (wall opening connecting GYM 116) has cracked concrete blocks.

Further engineering study on concrete block wall cracks.

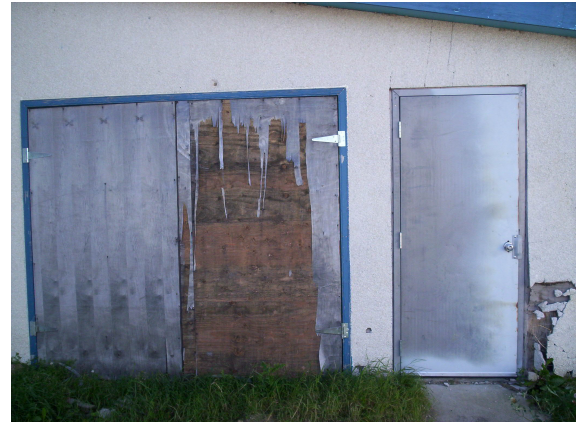
(1984) Addition - has damaged stucco.

Repair stucco. (approx. 80 square metres)

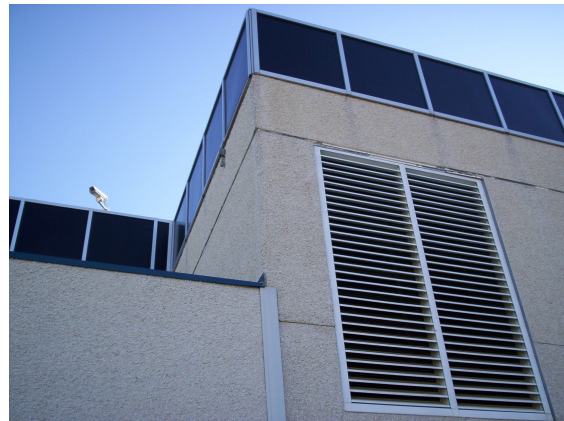
Caulking at control joints are dried up or loose.

Replace joint sealers.

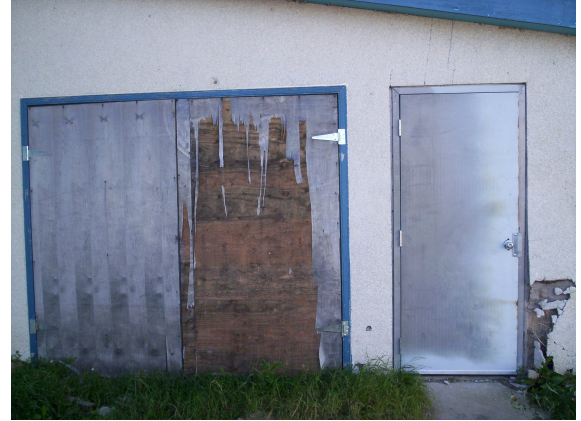
(S 159) has damaged plywood doors.

Replace large doors. (2 doors)

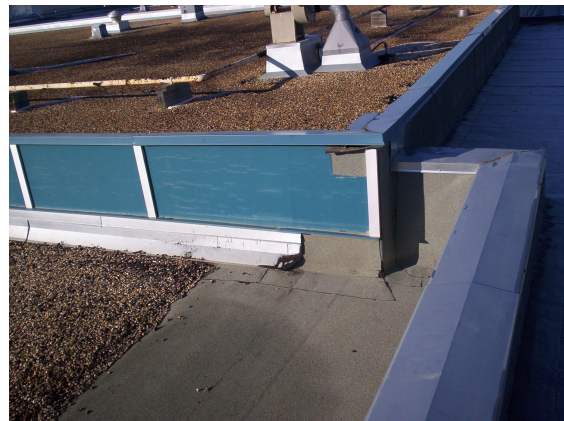
School has damaged metal flashing and roof caps.

Repair metal flashing and roof caps. (approx. 100 metres)

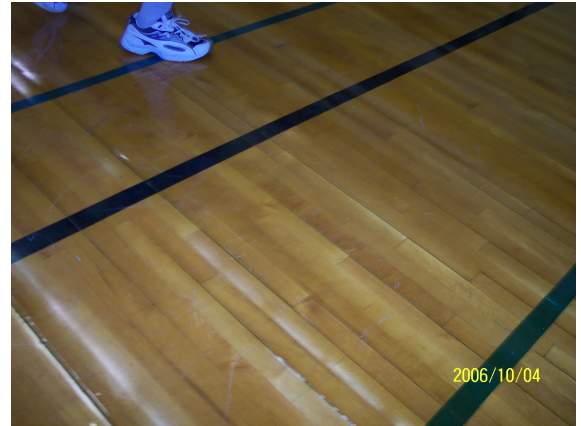
(1967) Addition - (GYM 116) has damaged wood strip flooring.

Repair wood strip flooring. (approx 220 square metres in 1967)

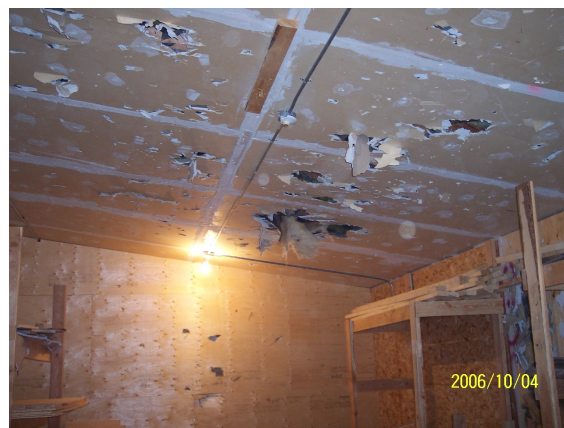
(1967) Addition - (Storage Room near GMS 117) has damaged gypsum board ceiling finish.

(1992) Addition - (GMS 167) has missing gypsum board ceiling finish.

Repair gypsum board ceiling. (approx. 80 square metres)

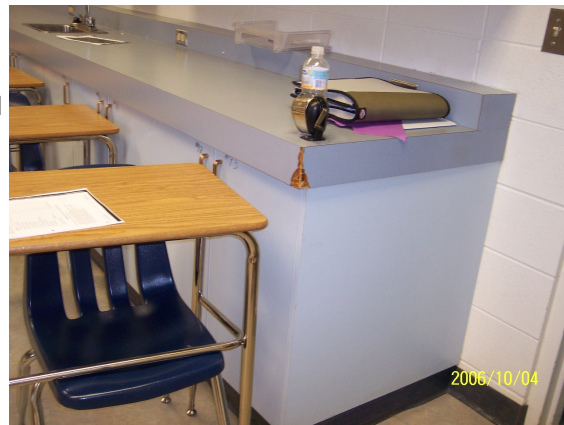
(1967) Addition - (SCI 151, 155, ANC 118) have damaged countertops.

Replace countertops. (3 metres)
