RECAPP Facility Evaluation Report

Parkland School Division #70

Memorial Composite High School

B4114A
Stony Plain

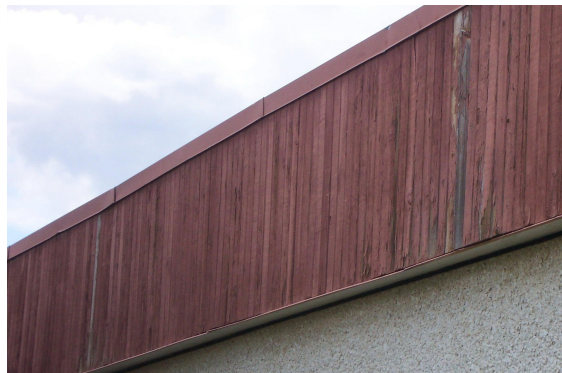
B2010.01.06.05 Vinyl Siding*

Exterior of cold storage room.

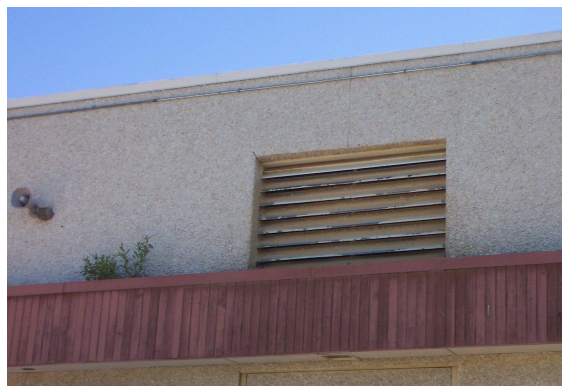
B2010.06 Exterior Louvers, Grilles, and Screens* - 1981

Cold canopies and overhangs have soffit vents.

Replace with vented soffits typical of entire school.

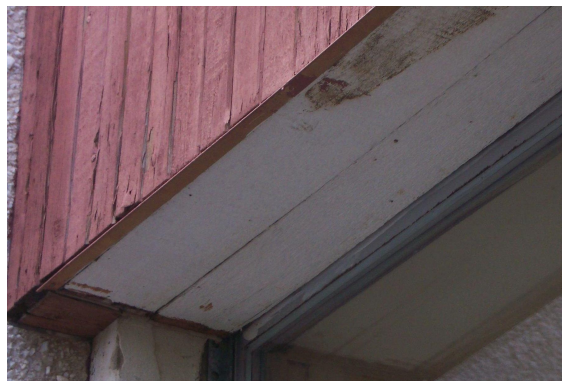
B2010.09.01 Finsh Carpentry:(Plywood/T&G)Soffits - 1962

Existing wood decking runs through from interior to exterior soffit.

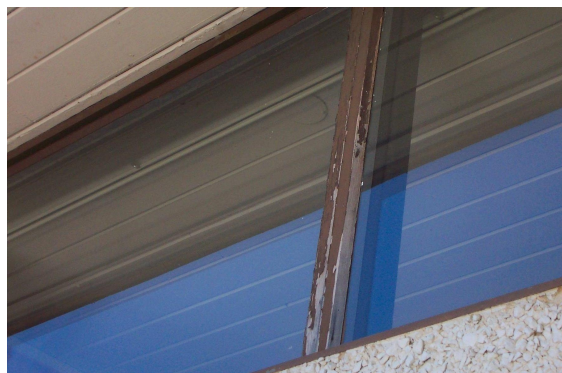
B2010.09.04 Portland Cement Plaster:Soffits - 1981

In 1981 addition exterior soffits are stucco on k-lath with soffit vents. The north elevation of the 1962 abd 1963 buildings were modernized to have stucco soffits with vents.

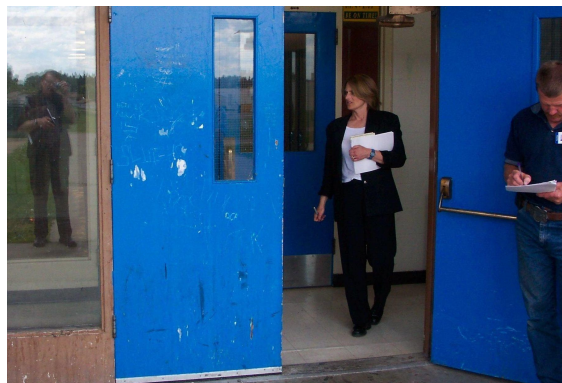
B2030.01.06 Automatic Entrance Doors*

Automatic entrance door located at parking south east corridor H107.

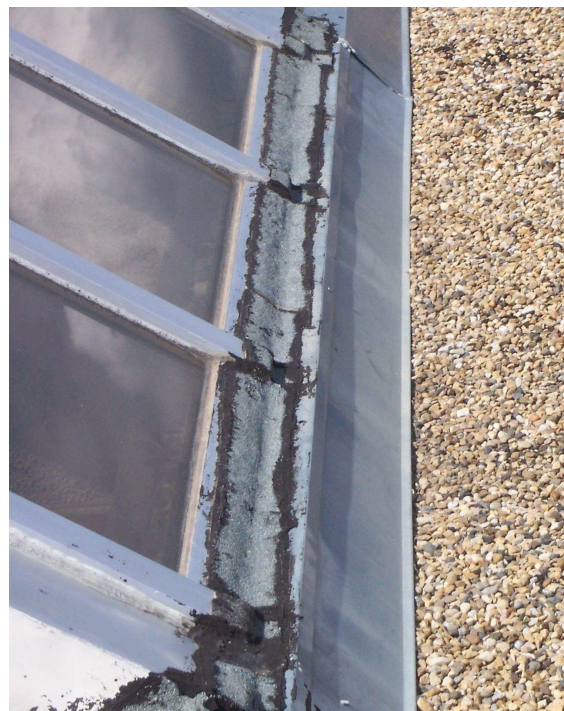
B3020.01.02.05 Vaulted Metal-Framed Skylights - 1981

Curtain wall glazed sealed skylight frame for skylight at 1145 Seminar Room.

Vaulted skylight seals and flashings require replacement. Leaks and water damage is evident at skylight perimeter ceilings.

Reseal skylight and repair damage to interior finishes.

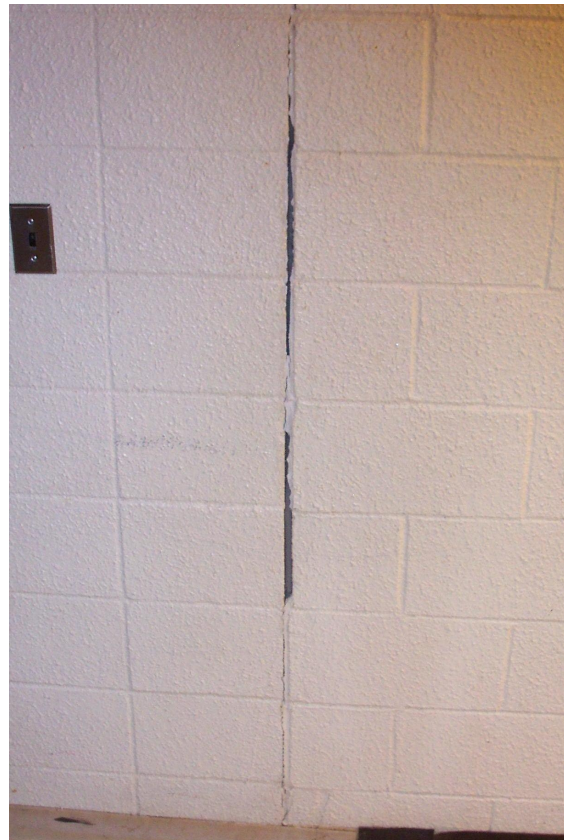
C1010.01.07 Framed Partitions (Wood Stud)

Wood stud framing is used in the 1998 theatre modernization room 1102.

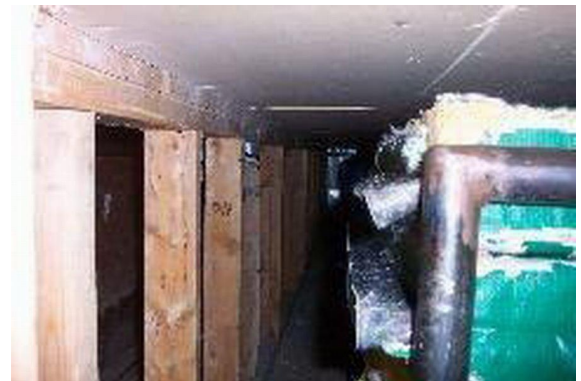
C1010.08 Other Partitions -Metal Stud

In the administration area in the 1962 building metal stud partitions with gypsum board are used as well as in the corridors of all building additions.

Replace gypsum wall board and metal studs with concrete block or provide protection with ceramic tile or a hard surface finish such as plastic laminate.

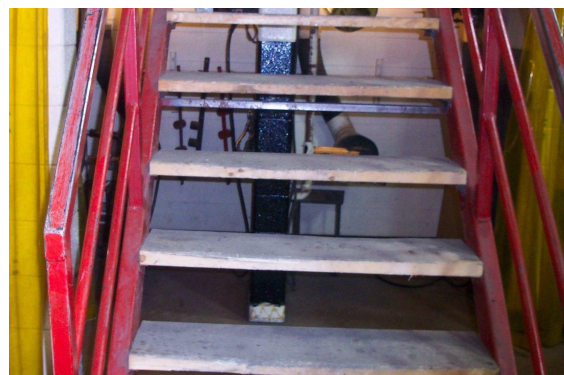
C2010.04 Wood Stair Construction - 1966

Wood stairs in corridors H102, H104, H105, and H106.

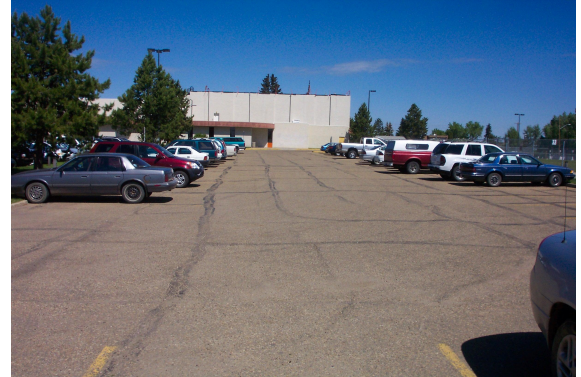
G2020.02.02 Flexible Paving Parking Lots(Asphalt)*

Asphalt parking lots

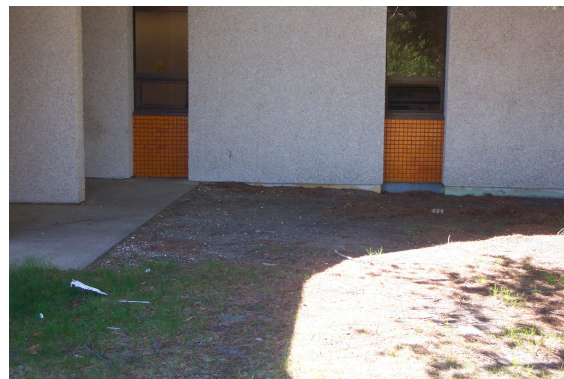
G2050.05 Trees, Plants and Ground Covers*

Large mature trees around the building.
