RECAPP Facility Evaluation Report

Northern Gateway Reg Div #10

Sunset House School

B4143A

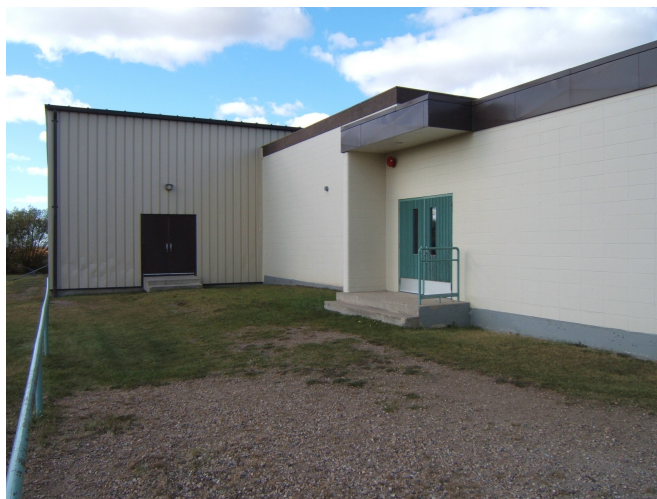
B1010.07 Exterior Stairs**

Cast-in-place concrete landings and stairs from gymnasium and south corridor exit of 1967 addition.
Wood framed landing at north corridor exit adjacent to portable classroom unit.

<u>Rating</u>	<u>Installed</u>	<u>Design Life</u>	<u>Updated</u>
4 - Acceptable	1967	40	MAR-07

Event: Lifecycle Replacement - Exterior Stairs

<u>Type</u>	<u>Year</u>	<u>Cost</u>	<u>Priority</u>
Lifecycle Replacement	2010	\$5,000	Low

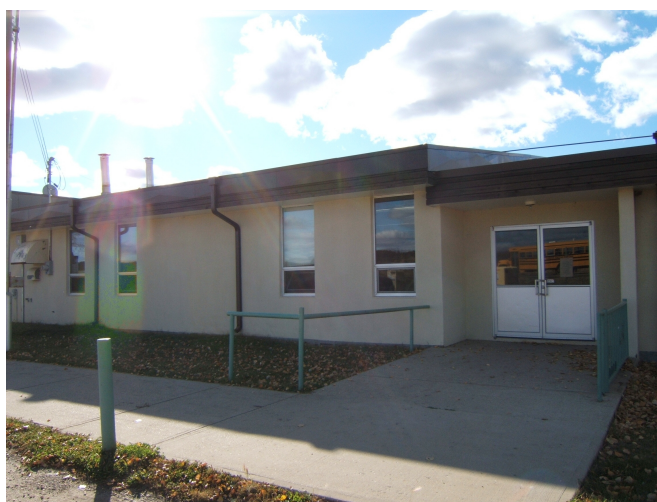
B2030.01.01 Aluminum-Framed Storefronts**

Aluminum glazed storefront an entry between original school and portable unit.

<u>Rating</u>	<u>Installed</u>	<u>Design Life</u>	<u>Updated</u>
4 - Acceptable	1994	30	MAR-07

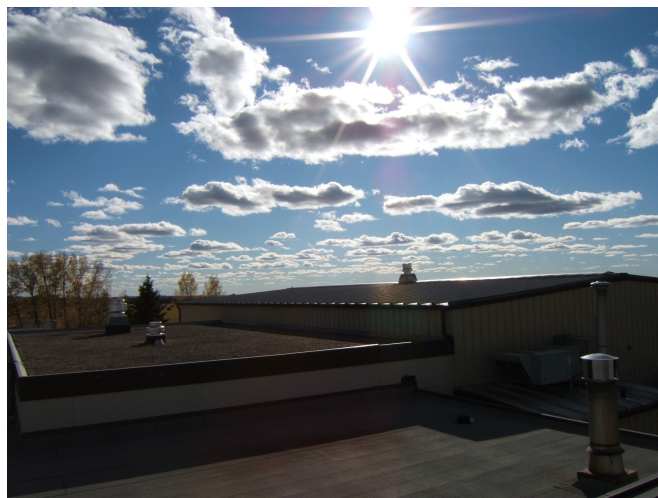
BUR assembly over food preparation space adjoining gymnasium.

<u>Rating</u>	<u>Installed</u>	<u>Design Life</u>	<u>Updated</u>
4 - Acceptable	1967	25	MAR-07

Event: Replace BUR assembly

<u>Type</u>	<u>Year</u>	<u>Cost</u>	<u>Priority</u>
Lifecycle Replacement	2010	\$10,000	Medium

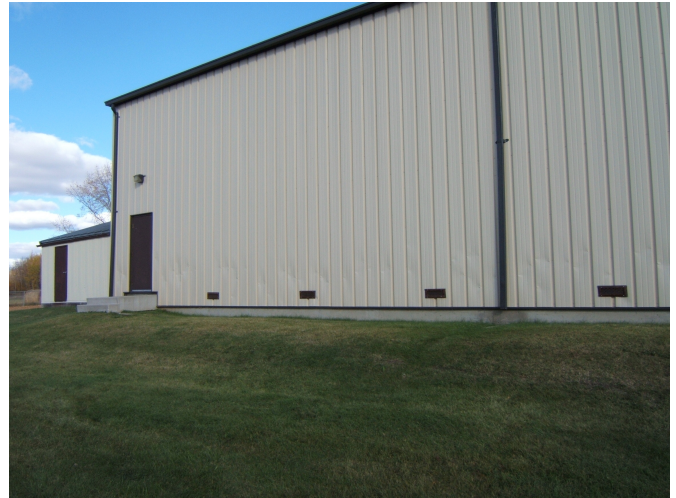
Paint finish scuppers and downspouts to 1967 addition.

<u>Rating</u>	<u>Installed</u>	<u>Design Life</u>	<u>Updated</u>
4 - Acceptable	0	30	MAR-07

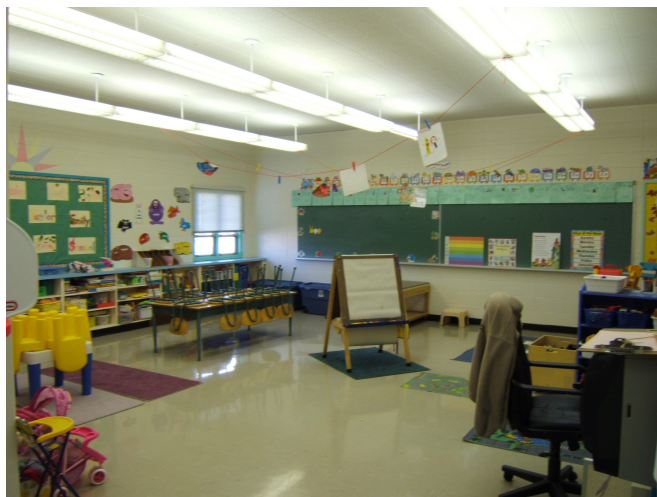
Some whiteboards, with chalkboards and tackboards.

<u>Rating</u>	<u>Installed</u>	<u>Design Life</u>	<u>Updated</u>
3 - Marginal	1967	20	MAR-07

Event: Install Whiteboards

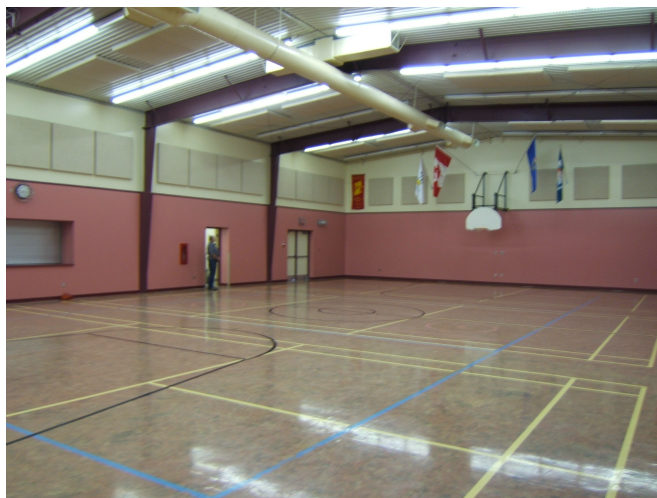
Surface applied acoustical panels to gymnasium walls.

<u>Rating</u>	<u>Installed</u>	<u>Design Life</u>	<u>Updated</u>
5 - Good	1994	20	MAR-07

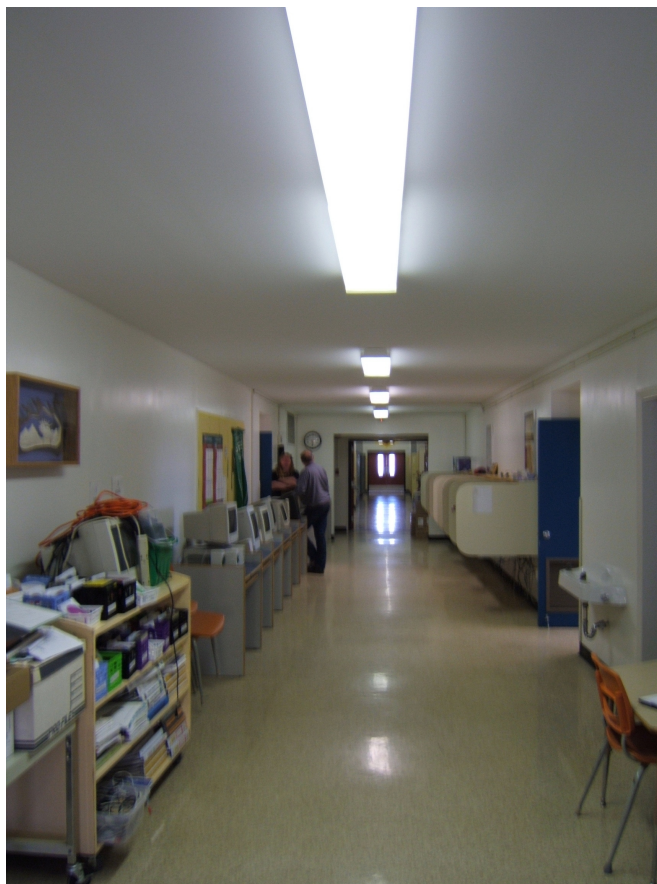
Classrooms equipped with paint finished open shelving with plastic laminate finished counters.
Corridor space contains custom fabricated plastic laminate finished computer stations.

<u>Rating</u>	<u>Installed</u>	<u>Design Life</u>	<u>Updated</u>
4 - Acceptable	0	35	MAR-07

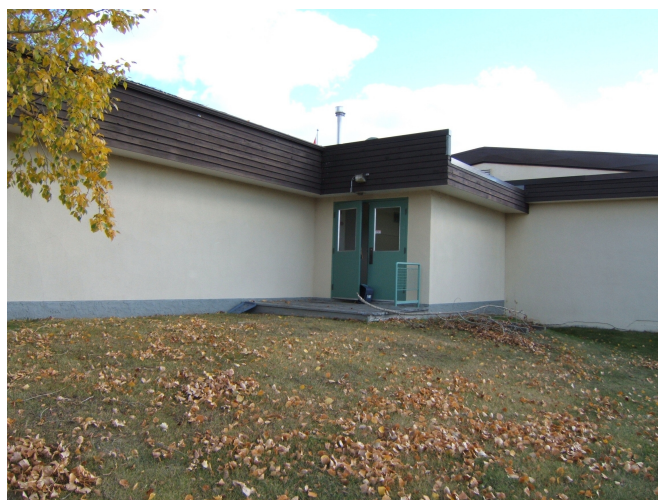
Power fed from main building into three phase 120/208V panel outside the single portable. Lighting consists of 12 4-lamp T12 fluorescent fixtures with magnetic ballasts. The cost of Life Cycle Replacement for the Lighting is \$2,500. It had been included in D5020.02.02.02.

<u>Rating</u>	<u>Installed</u>	<u>Design Life</u>	<u>Updated</u>
4 - Acceptable	0	0	MAR-07

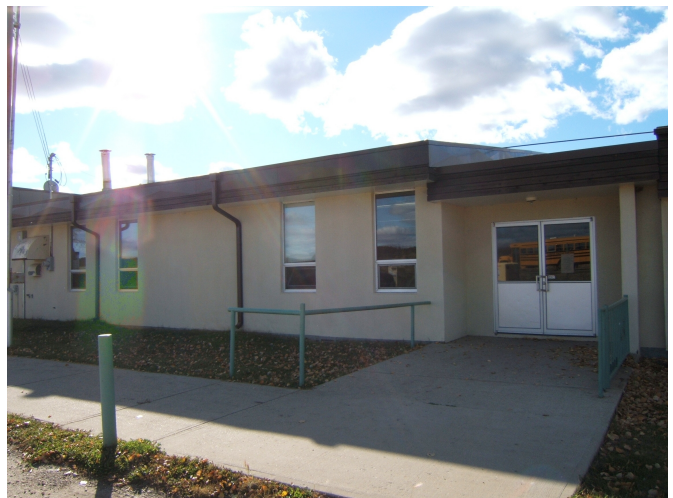
Concrete surfaced entry pad at main school entry and walkway to entry pad at link section.

<u>Rating</u>	<u>Installed</u>	<u>Design Life</u>	<u>Updated</u>
5 - Good	1994	15	MAR-07
