RECAPP Facility Evaluation Report

Buffalo Trail Regional Div #28

Wainwright High School

B4230A
Wainwright

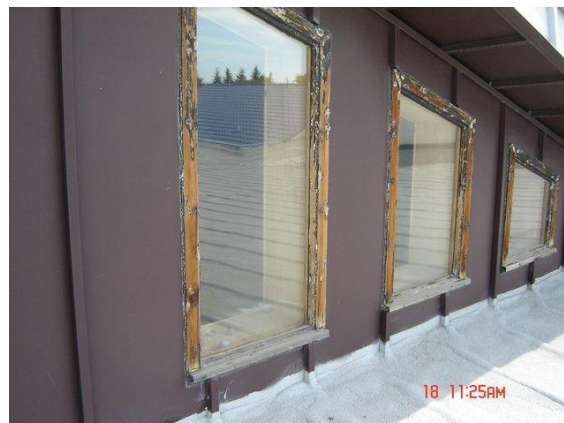
B2020.01.01.05 Wood Windows (Glass & Frame)**

<u>Rating</u>	<u>Installed</u>	<u>Design Life</u>	<u>Updated</u>
2 - Poor	0	35	JUN-05

Event: Replace deficient wood windows.

Concern:

Water entry and deteriorated wood noted on remaining wood windows in 1964 addition. Visible damage noted in classroom.

Recommendation:

Replace wood windows with PVC window system. Replacement of dormer windows to be scheduled with roof replacement on 1964 sloped metal roof.

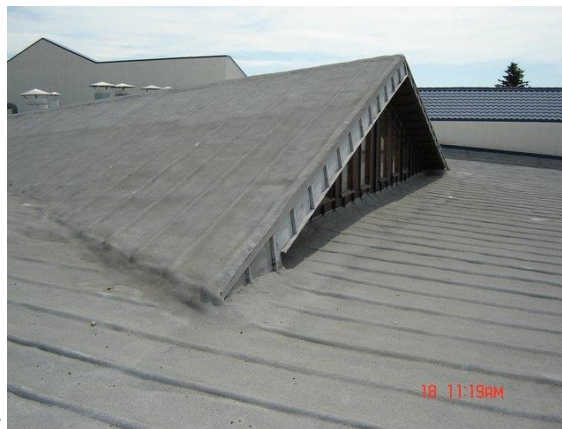
B3010.07 Sheet Metal Roofing**

<u>Rating</u>	<u>Installed</u>	<u>Design Life</u>	<u>Updated</u>
1 - Critical	0	40	JUN-05

Event: Replace steel roofing on 1964 addition.

Original pan and batten roofing evidenced leaking concerns, roof area was over sprayed with spray in place urethane foam and aluminized coating. Roof continues to leak and has significant ice damning problems. Water entry noted in several locations into underlying spaces. Frosting problems noted in plenum above acoustic suspended ceiling adjacent to music room. Plaster finish on ceiling contains asbestos materials and staining and loss of coating is a problem.

Remove foam and underlying steel roofing, replace deck, vapor retarder and install new insulation and SBS roofing system or standing seam metal roof. Scope of work to include new metal siding on cupola and dormer face.

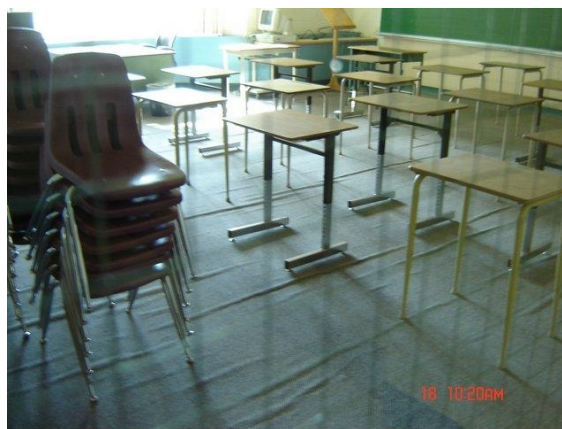
Event: 1960 wing - Carpet replacement in classrooms. (405 m2)

Worn and lifting sheet carpeting.

Remove and replace with commercial grade sheet carpet.

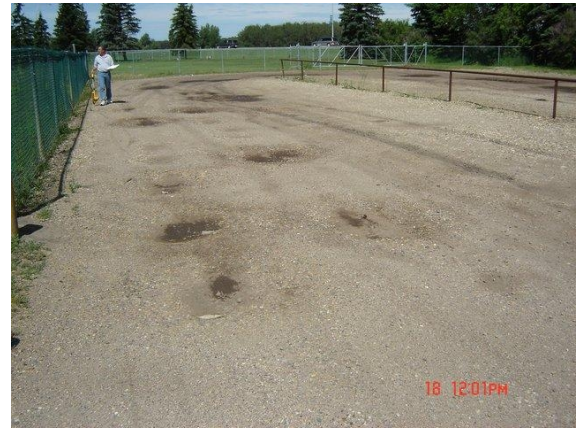
Event: Reconstruct failed pavement. (2125 m2)

Severe pot holing, alligating and improper compaction of substrate.
