RECAPP Facility Evaluation Report

John G Diefenbaker High School

B2686A

Evaluation Company: Asset Evolution Inc.
Evaluation Date: September 18 2007
Evaluator Name: Mario Plastina

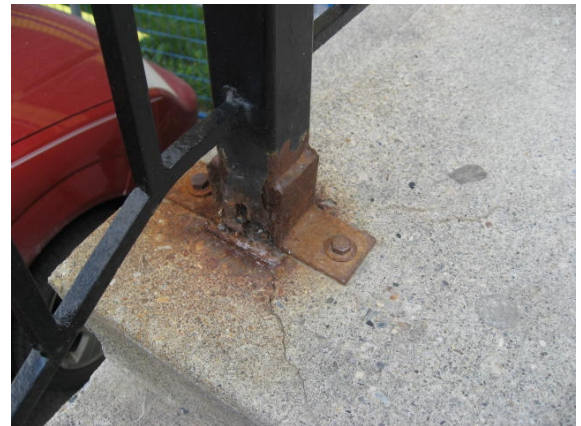
The handrails on the north stair are corroded in several isolated sections.

Event: **Repair and/or replace corroded sections of the handrail.**

Repair and/or replace corroded sections of the handrail & pickets.

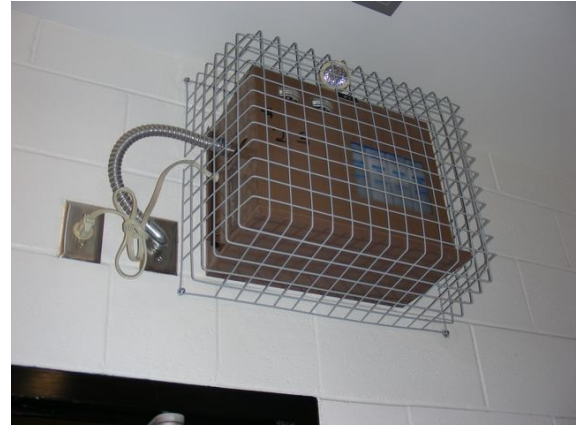
Life safety concern.
