# **RECAPP Facility Evaluation Report**

## **Calgary School District #19**

### **Bishop Pinkham Junior High School**

B2541A  
Calgary

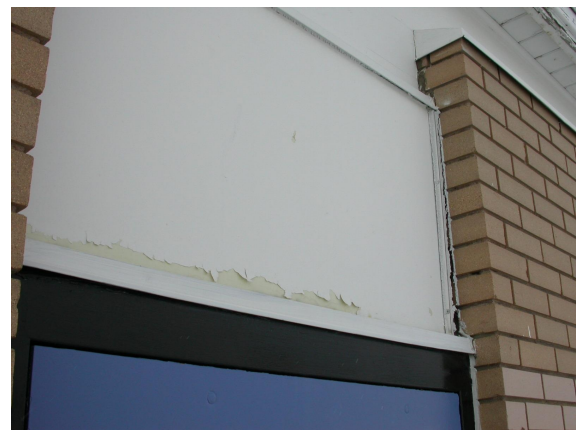
Joint sealers throughout are dry and have shrunk.

Caulking at exterior joints of building have shrunk. are cracked and weathered.

Remove all remaining caulking compound and replace.

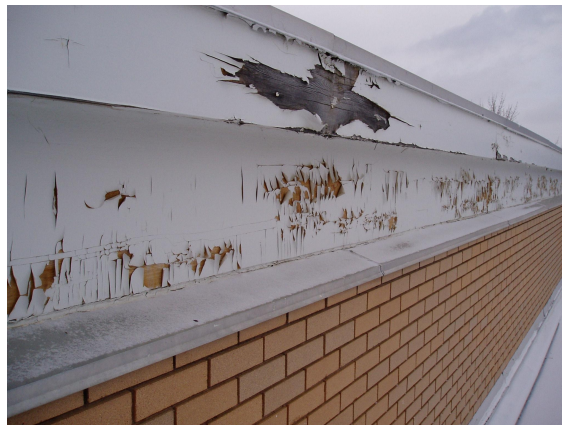
Painted surfaces are peeling, weathering and delaminating throughout

Clean painted wood fascia and install prefinished metal fascia over . Install prefinished metal soffit over wood entrance soffit. Clean and sand balance of wood surfaces and re-paint.

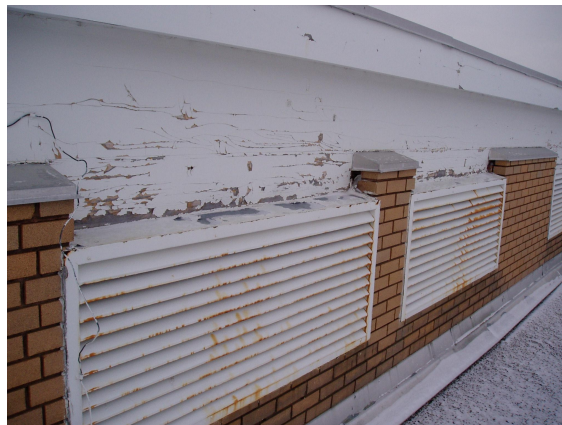
Galvanized louvres are rusting and peeling

Clean, sand, etch and refinish louvres

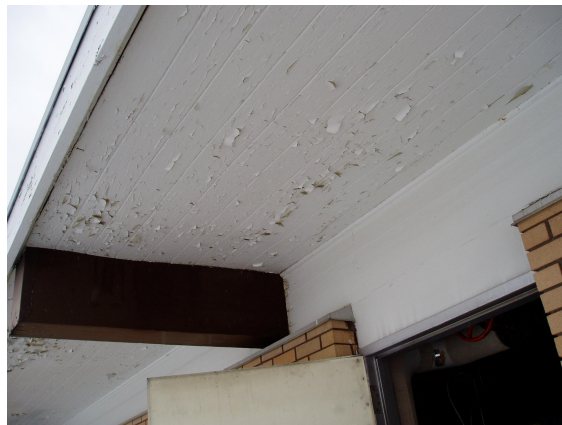
Painted wood soffits are peeling and are weathered.

Instal prefinished metal soffits at wood soffit locations

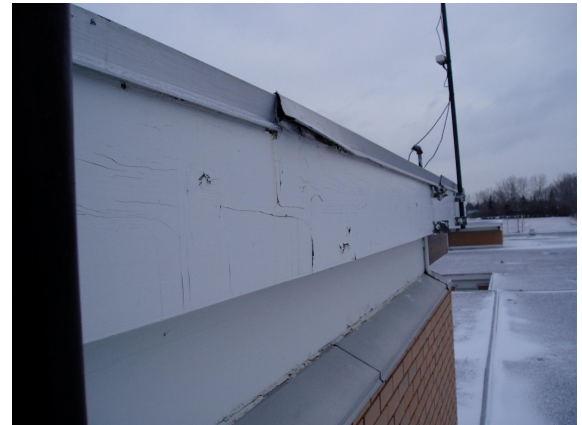
Cap flashing in several locations is damaged or lifted

Repair cap flashing

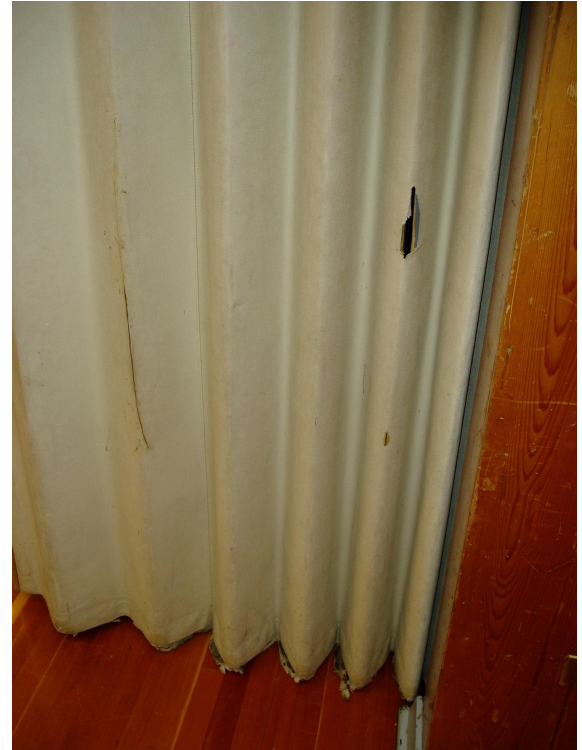
Stage accordion curtain is damaged and worn

Repair lower portion of curtain

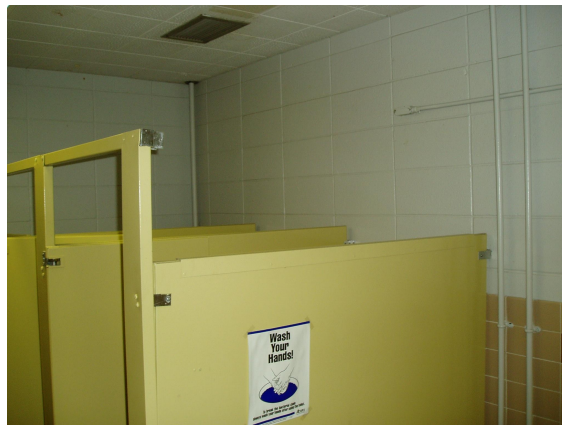
Several metal toilet and shower partitions are damaged

Repair as required or replace damaged toilet and shower partitions.

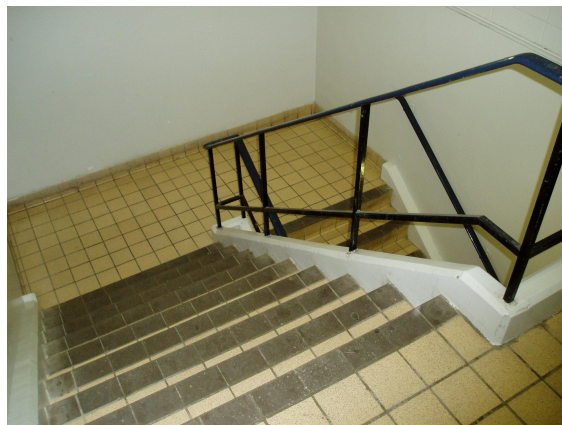
Stair handrail balustrade leading to boys change room are open through

Install birch plywood panels

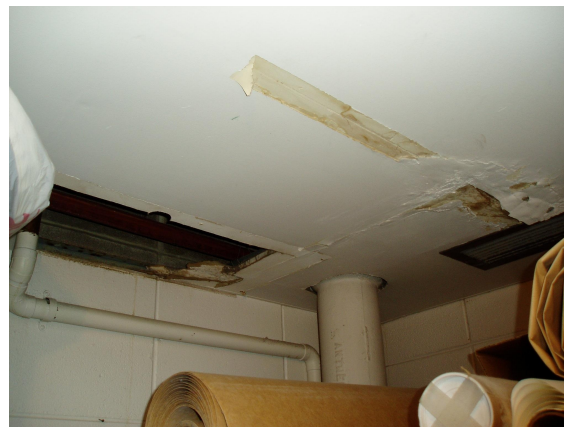
Gypsum board ceilings in numerous locations are stained and damaged

Repair gypsum board ceilings and repaint

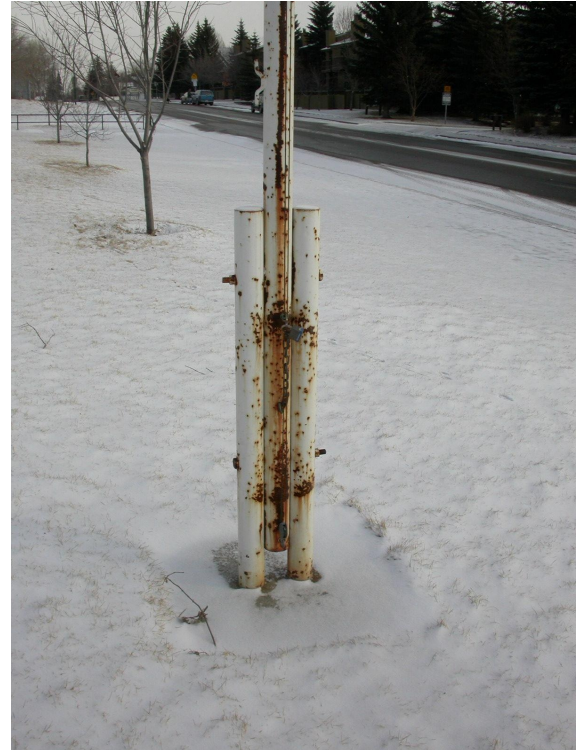
The painted steel flag pole is bent and rusted.

Replace the existing pole with an aluminum pole and concrete base.

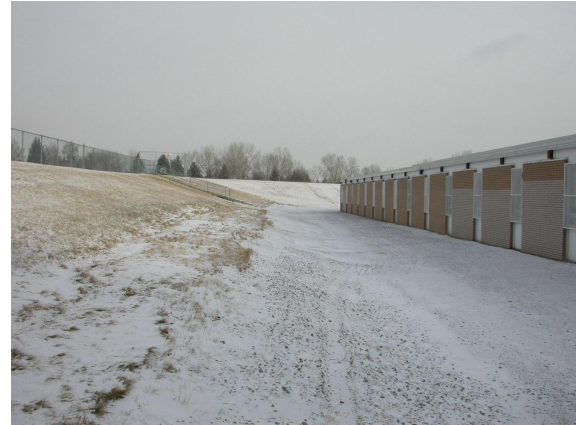
Grassed area on north side of school has been damaged by recent excavation activities, apparently due to the installation of a new storm water collection system.

Repair sod and gravel areas and make transition smooth.
