RECAPP Facility Evaluation Report

Branton Junior High School

B2547A

Calgary

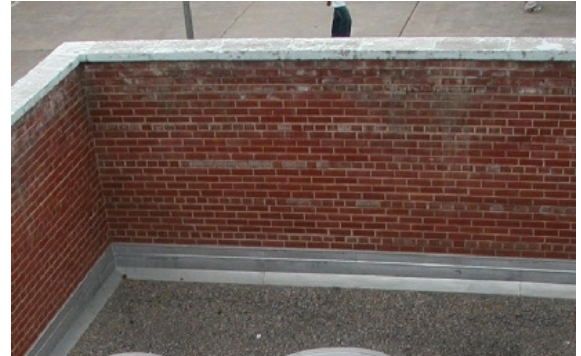
Event: Repair damaged brick.

Localized areas of damaged brick cladding, including deteriorated mortar joints was observed on the building exterior. This was mostly evident on the upper portions of the building, at roof level. No significant amount of spalling or cracked/loose brick was identified during the site visit.

Repair and re-point damaged brick components as necessary.

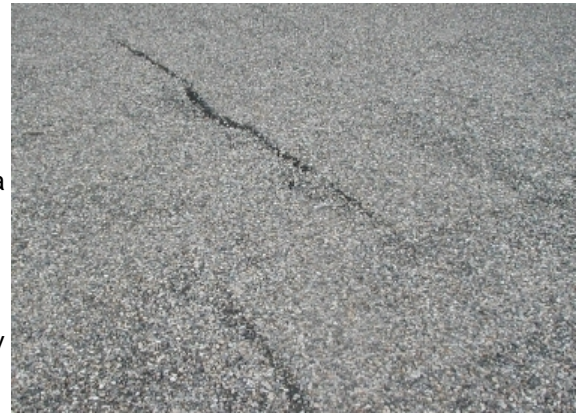
Event: Replace built-up roof membrane assembly.

The built-up roof membrane assembly was installed between 1984 and 1985. Site personnel reported no active roof leaks, however several stained ceiling panels were observed during a review of the building interior. Deficiencies encountered during a review of the built-up roofing included significant weathering of the gravel ballast, localized ridging and blistering of the roofing membrane, and scouring of the ballast along edges and corners of the roof surface. The roofing membrane generally appears to be approaching the end of its expected useful life.

Replace the built-up roof membrane assembly at the end of the five-year tactical planning window.

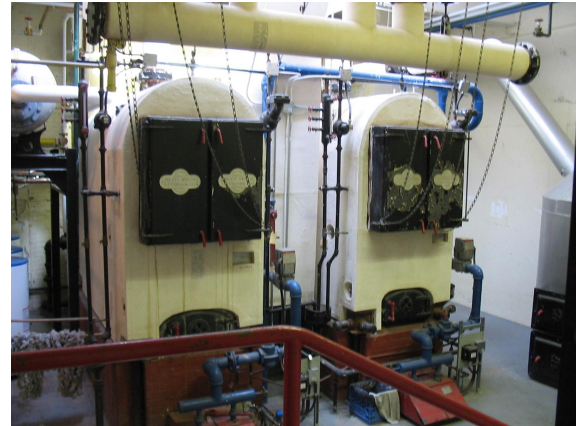
Event: Replace the original steam boilers

The boilers are original and individually cannot provide enough heat for the whole school in winter conditions.

Replace the boilers and accessories as a planned project.

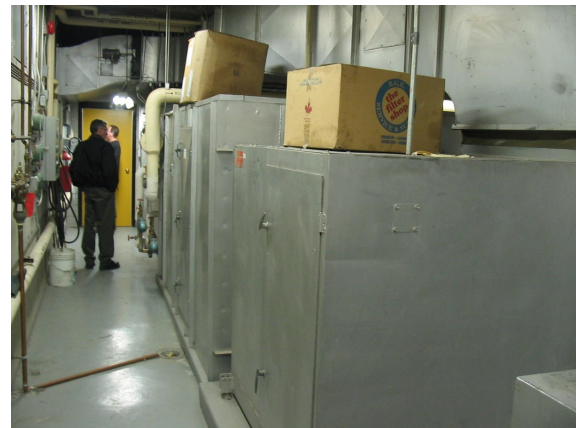
Event: Replace the 1967 addition's air handling unit

Replacement of the AHU within the next five years is anticipated.

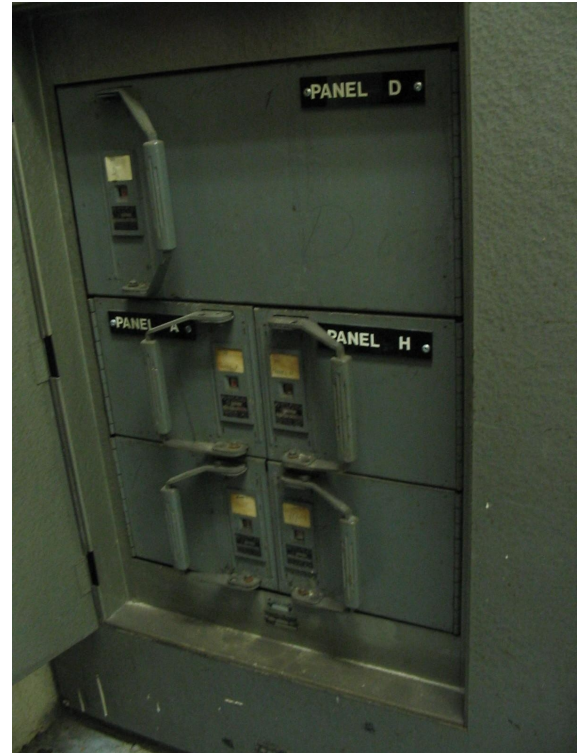
The building has a 120/208 Volt, 600 Amp electrical system. The main panel appears to have been an upgrade/replacement however much of the other distribution equipment is original.

Event: Replace original main distribution equipment.

Replace all main electrical distribution equipment that is original.

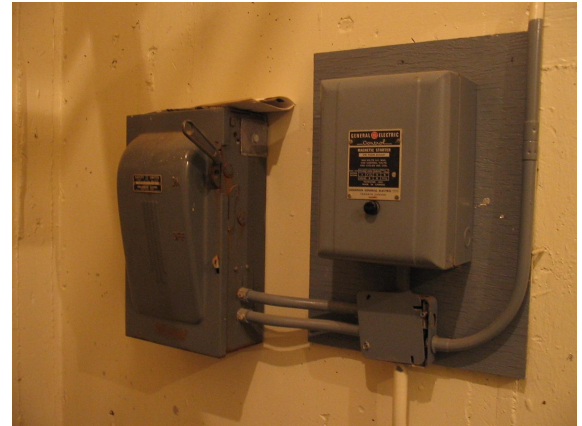
Event: Replace the original Motor Control Centres

Replace the remaining original motor controls.

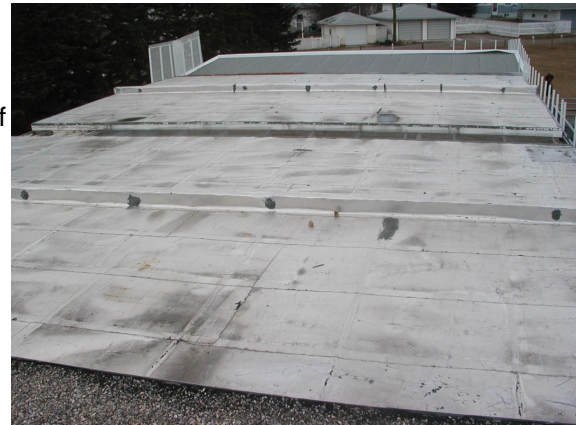
Event: Replace roofing membrane.

The roofing membrane over Portable Classroom 86/70 is of unknown vintage, however it is believed to have surpassed its expected useful life. Although no active leaks were identified during the assessment, evidence of former repairs was observed on the roofing surface.

Replace the roofing membrane in the latter portion of the tactical planning window.

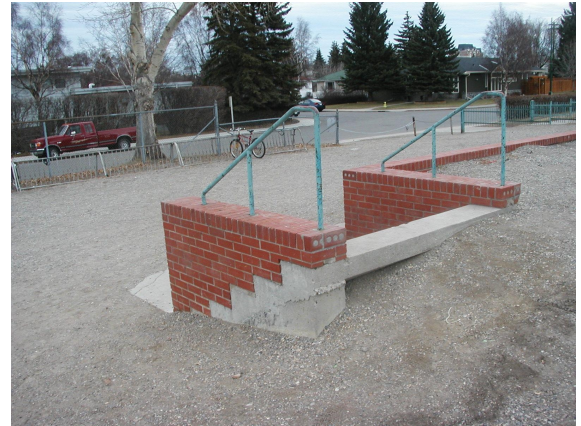
A set of concrete stairs with brick retaining wall enclosures is situated at the northeast corner of the property. The stairs provide access between two areas of the site at different grades, however the location and configuration of the stairs would suggest that the topography in this area has changed since the building was constructed. As a result, rather than use the concrete stairs, a pedestrian need only walk around them and walk up a small incline to achieve a similar result (see attached photo). Furthermore, the soil at the top of the staircase has eroded, creating a potential tripping hazard with the uppermost step of the concrete stairs.

Remove the concrete stairs and adjust the brick retaining walls in the immediate area to suit the local topography of the site.
