# RECAPP Facility Evaluation Report

Edmonton RCSSD #7

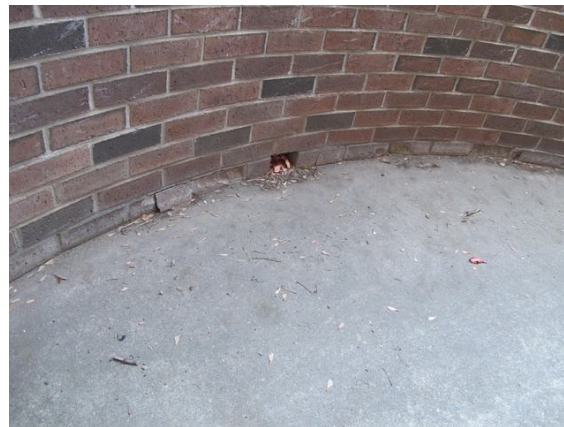
Movement of concrete slab opposite the west elevation of the school

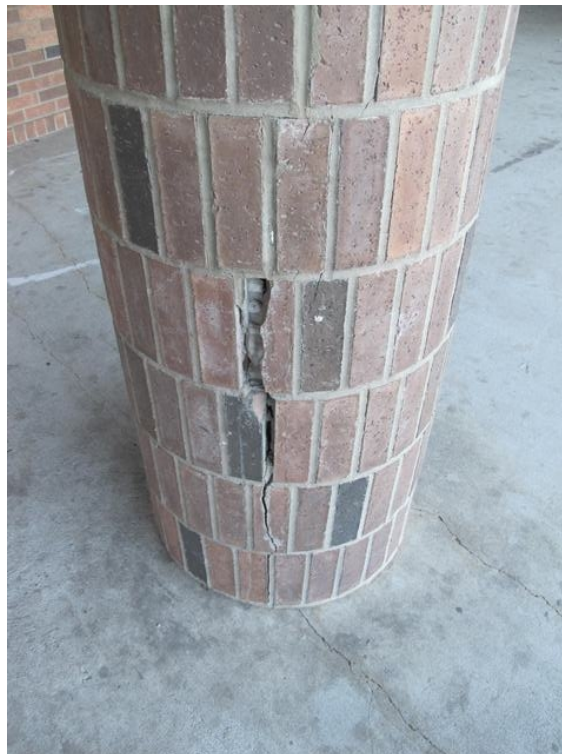
Cracked columns opposite the main entrance.

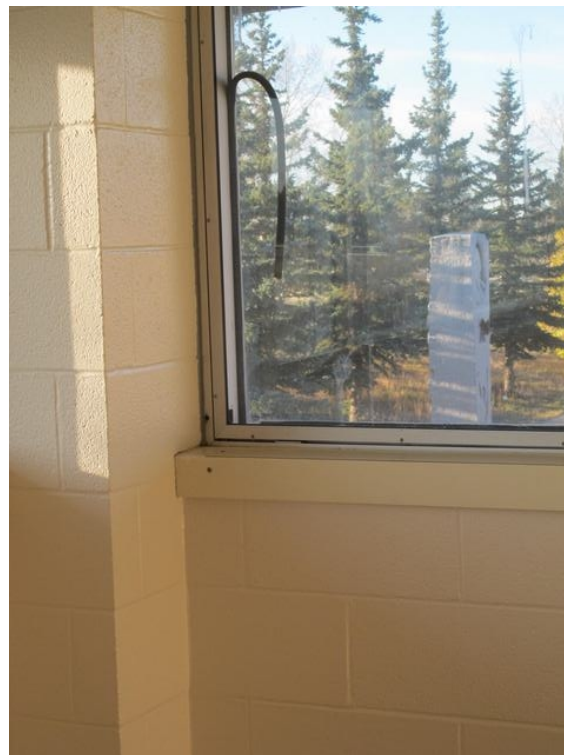
Failed window gasket observed in several locations

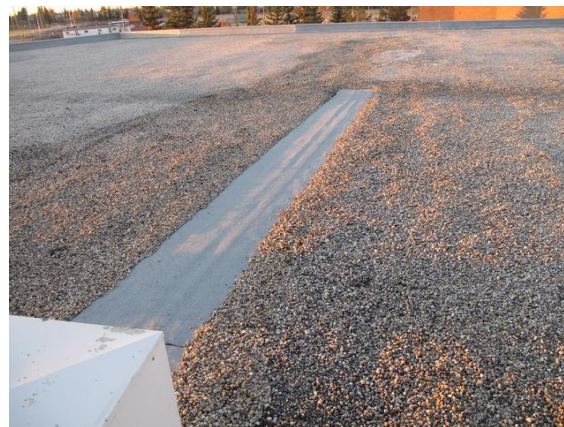
Ongoing repair on the upper roof areas.

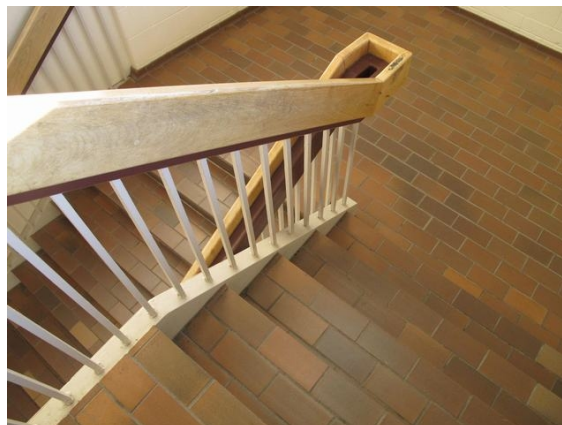
Deteriorated finish on wood handrail in all stairwells

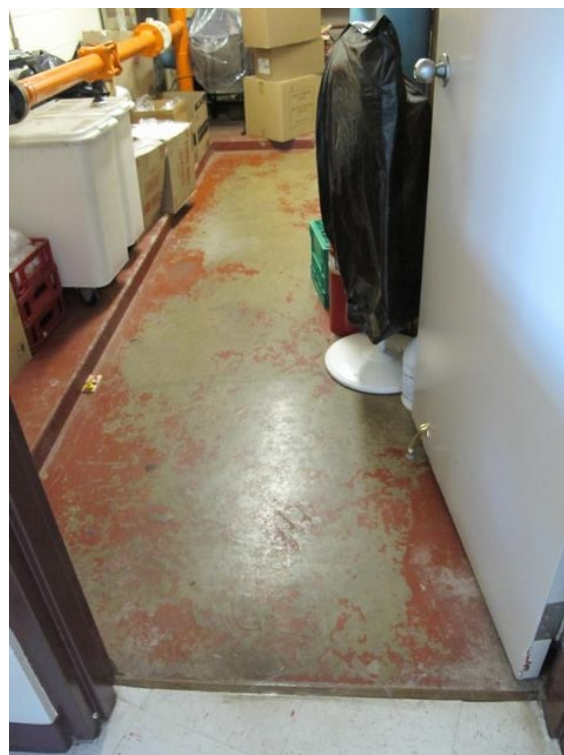
Deteriorated paint finish in the meter room.

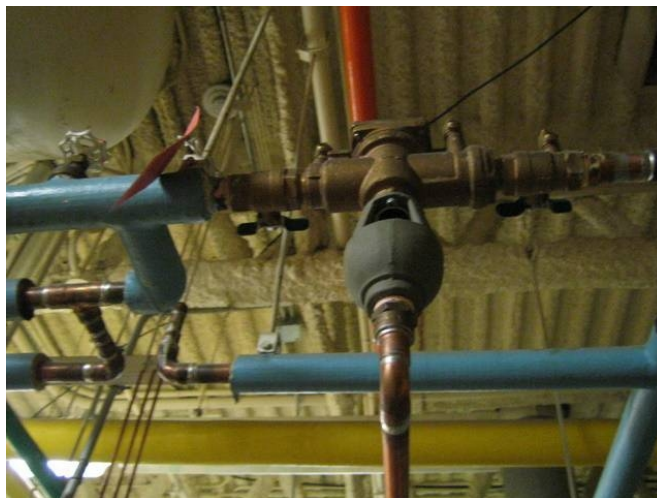
Backflow preventer.JPG

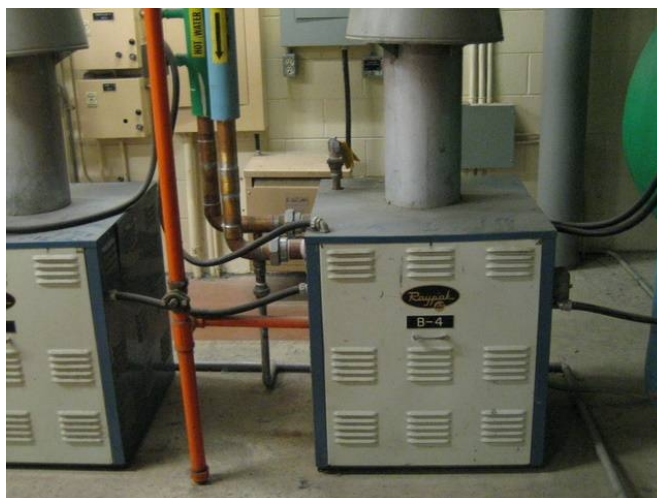
<b><u>Rating</u></b>	<b><u>Installed</u></b>	<b><u>Design Life</u></b>	<b><u>Updated</u></b>
4 - Acceptable	1982	20	MAR-12

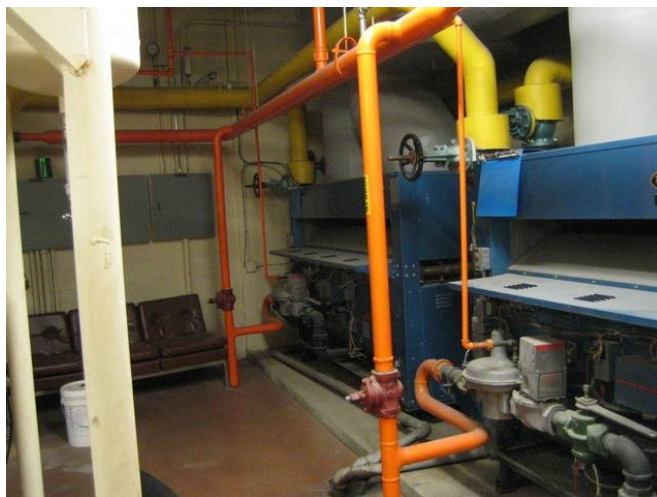
<u>Rating</u>	<u>Installed</u>	<u>Design Life</u>	<u>Updated</u>
4 - Acceptable	1982	35	MAR-12

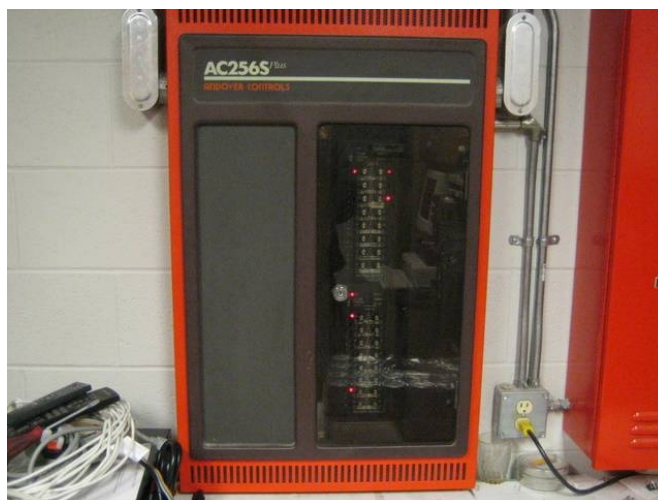
<u>Rating</u>	<u>Installed</u>	<u>Design Life</u>	<u>Updated</u>
3 - Marginal	1991	20	MAR-12

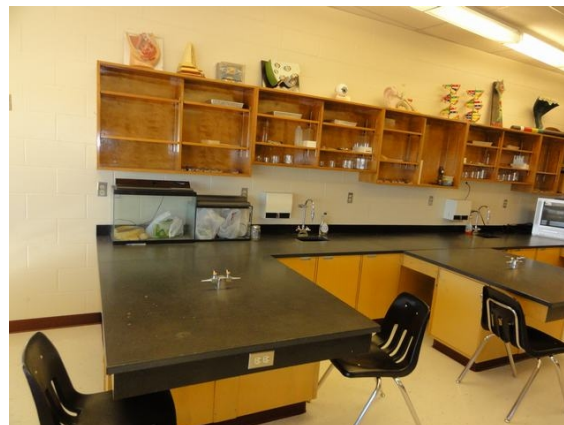
Receptacles within 1m of sink location are not GFI type.

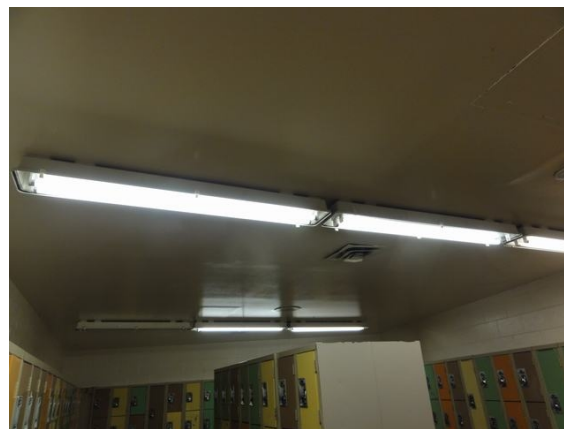
Lenses missing on fluorescent lighting fixtures.

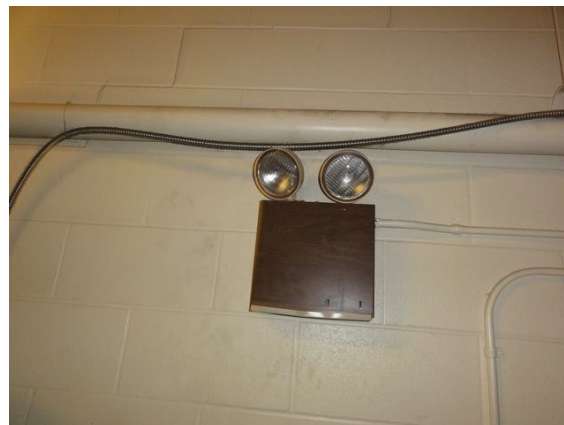
Aged emergency lighting battery unit in generator room.

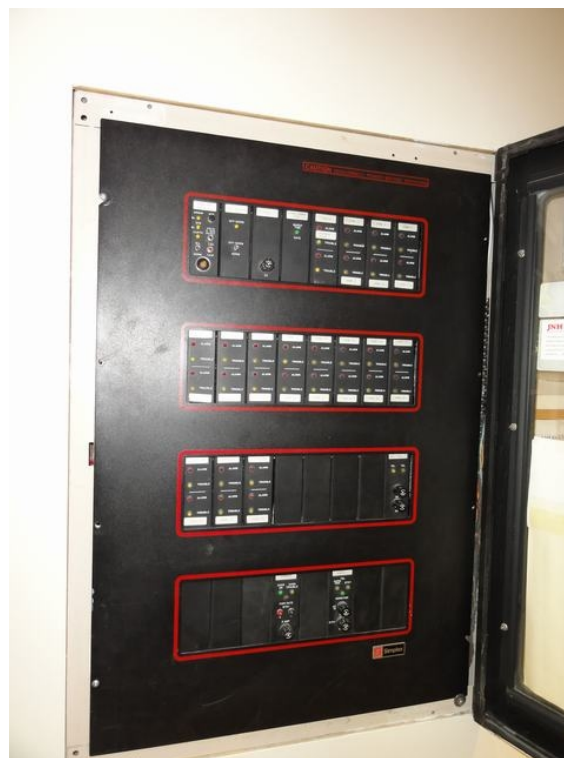
Aged Simplex 2100 fire alarm control panel in administration area.

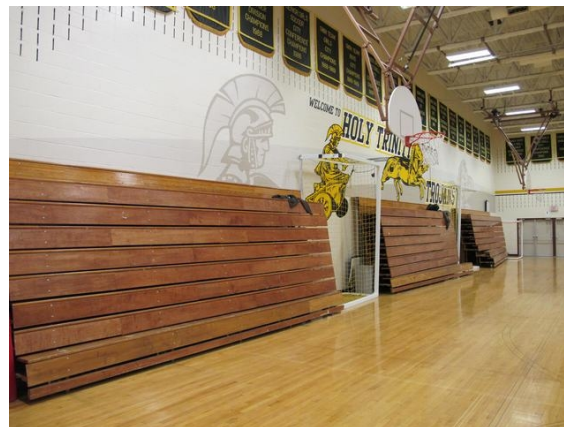
Re-tractable wood bleachers in gymnasium.
