RECAPP Facility Evaluation Report

Father Michael Troy Junior High School

B5101A
Edmonton

Evaluation Company: KOLIGER SCHMIDT architect engineer
Evaluation Date: January 30 2014
Evaluator Name: Steve Horvath KOLIGER SCHMIDT
 architect engineer
Evaluation FCR: -1%

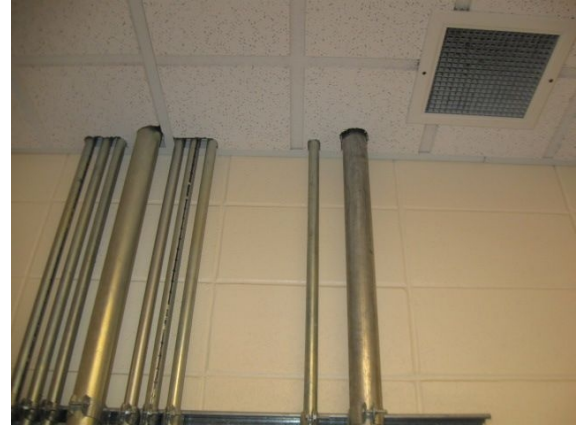
<u>Rating</u>	<u>Installed</u>	<u>Design Life</u>	<u>Updated</u>
3 - Marginal	2003	0	APR-14

Fire stopping missing where conduits and pipes pierce suspended ceiling at several areas.

Firestopping missing where conduits pierce ceiling tiles.

Event: **Install fire stopping at 30 locations.**

Install appropriate firestopping and defective areas.

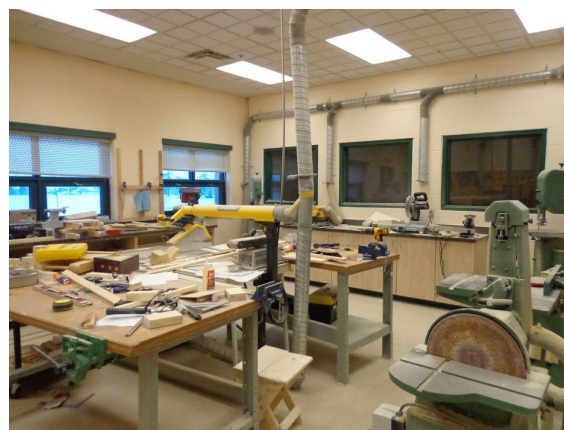
Dust collection outlets in wood working room.

Recommendation:

<u>Type</u>	<u>Year</u>	<u>Cost</u>	<u>Priority</u>
Failure Replacement	2014	\$15,555	Medium
