RECAPP Facility Evaluation Report

Edmonton School District No. 7

Greenfield School

B3138A
Edmonton

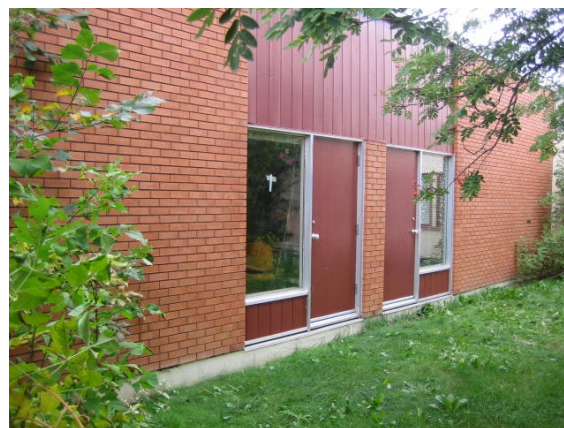
The exterior doors from classrooms 12, 13, 35 and 36 are aged and worn and have operational problems especially during colder months when the doors stick.

Given the age of the doors and the continued maintenance required, replacement is recommended.

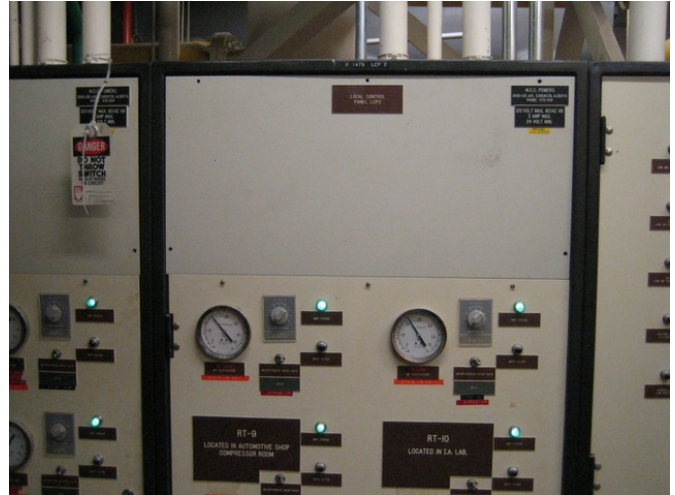
Pneumatic controls are used for thermostats, valve and damper actuators. Signals are also sent to the BMS system.

<u>Rating</u>	<u>Installed</u>	<u>Design Life</u>	<u>Updated</u>
4 - Acceptable	1968	40	JAN-07

Event: Replace Controls

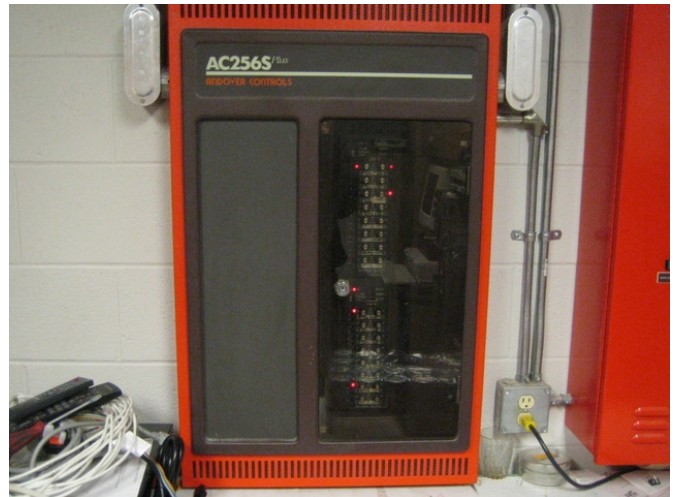
The BMS is an Andover DDC system and is used to control the building remotely. The DDC system is connected to the existing pneumatic devices in the field such as thermostats, pressure sensors, and damper actuators.

<u>Rating</u>	<u>Installed</u>	<u>Design Life</u>	<u>Updated</u>
5 - Good	2000	25	JAN-07

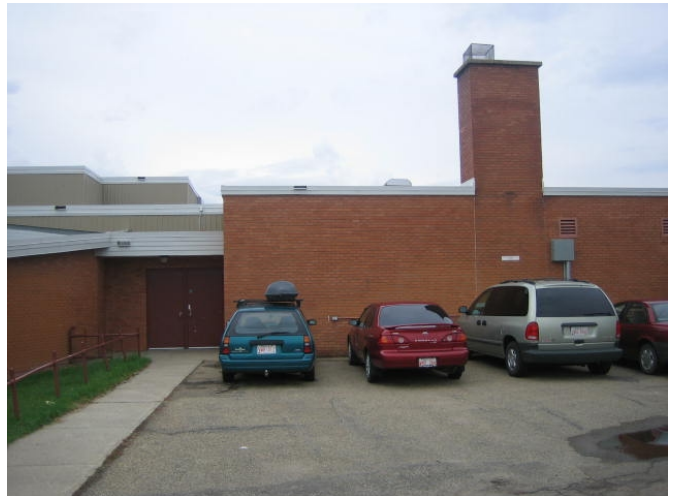
Vehicle parking lots are constructed with flexible asphalt pavement and can be found on the south and east sides of the facility.

<u>Rating</u>	<u>Installed</u>	<u>Design Life</u>	<u>Updated</u>
4 - Acceptable	1998	10	JAN-07

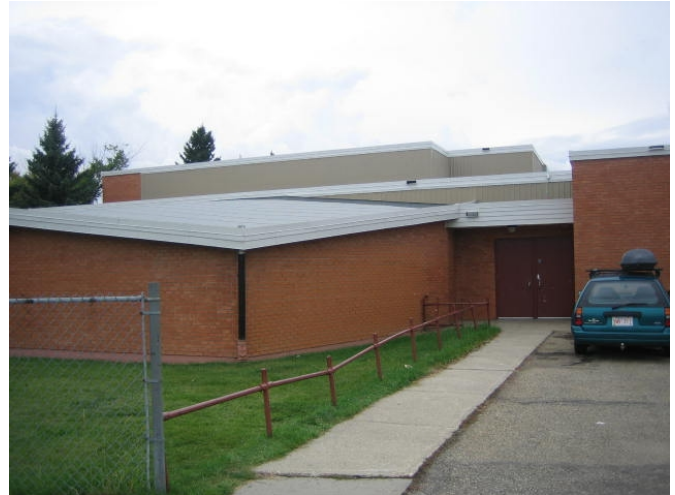
Both chain link fencing and low rise pipe rail fencing are found on the site.

<u>Rating</u>	<u>Installed</u>	<u>Design Life</u>	<u>Updated</u>
4 - Acceptable	1998	30	JAN-07

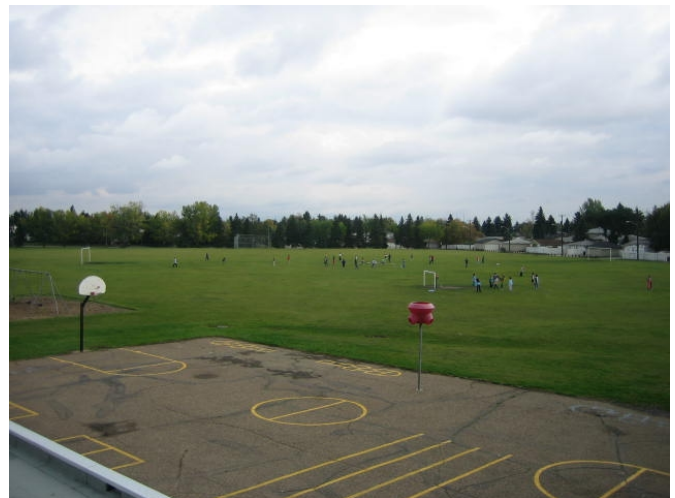
Asphalt paved basketball court surface is found on site. Adjacent soccer fields have grass surface. Playground surfaces are sand covered.

<u>Rating</u>	<u>Installed</u>	<u>Design Life</u>	<u>Updated</u>
4 - Acceptable	1998	25	JAN-07

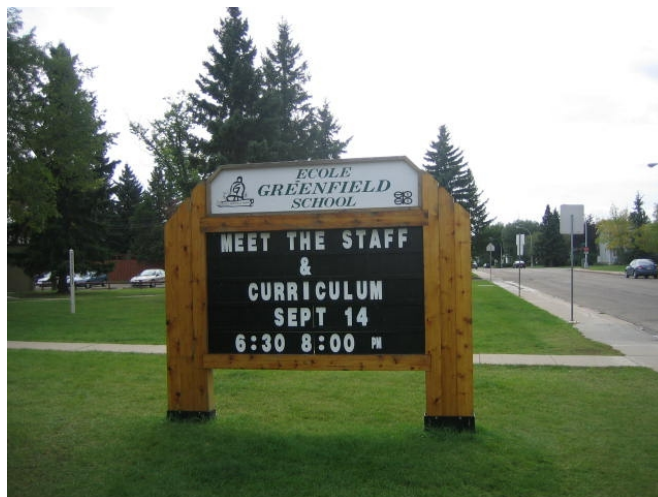
Large wooded sign and cast metal sign can be found on the front yard and wall of the facility respectively.

<u>Rating</u>	<u>Installed</u>	<u>Design Life</u>	<u>Updated</u>
5 - Good	1998	25	JAN-07
