RECAPP Facility Evaluation Report

Greenview Elementary School

B3139A
Edmonton

Evaluation Company: VFA Canada Corporation
Evaluation Date: September 13 2006
Evaluator Name: David S. Greeley, P.Eng.

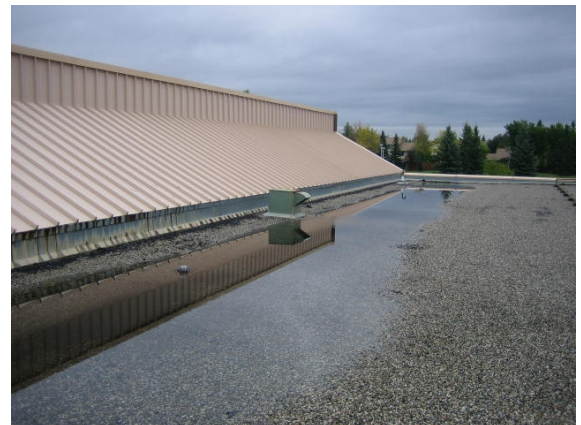
Event: Replace Built Up Roof

<u>Type</u>	<u>Year</u>	<u>Cost</u>	<u>Priority</u>
Lifecycle Replacement	2010	\$265,900	Low

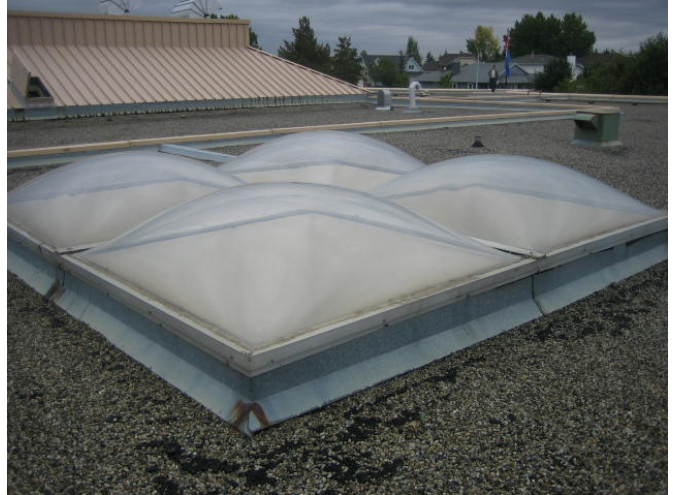
B3020.01 Skylights - Greenview Elementary School B3139A**

There are four domed shaped skylights on the roof top.

<u>Rating</u>	<u>Installed</u>	<u>Design Life</u>	<u>Updated</u>
4 - Acceptable	1980	20	MAR-07

Event: Replace Rooftop Skylights (Four)

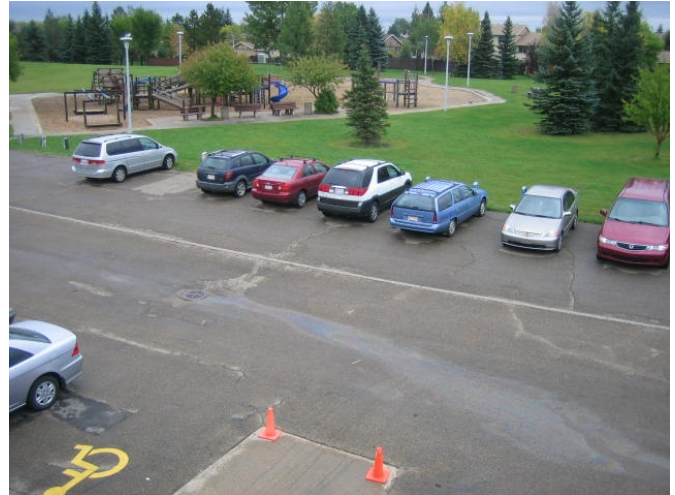
G2020.06.04 Pavement Markings*

Pavement markings limited to handicap parking stall marking.

<u>Rating</u>	<u>Installed</u>	<u>Design Life</u>	<u>Updated</u>
3 - Marginal	1980	25	MAR-07

Event: Apply Parking Lot Pavement Markings

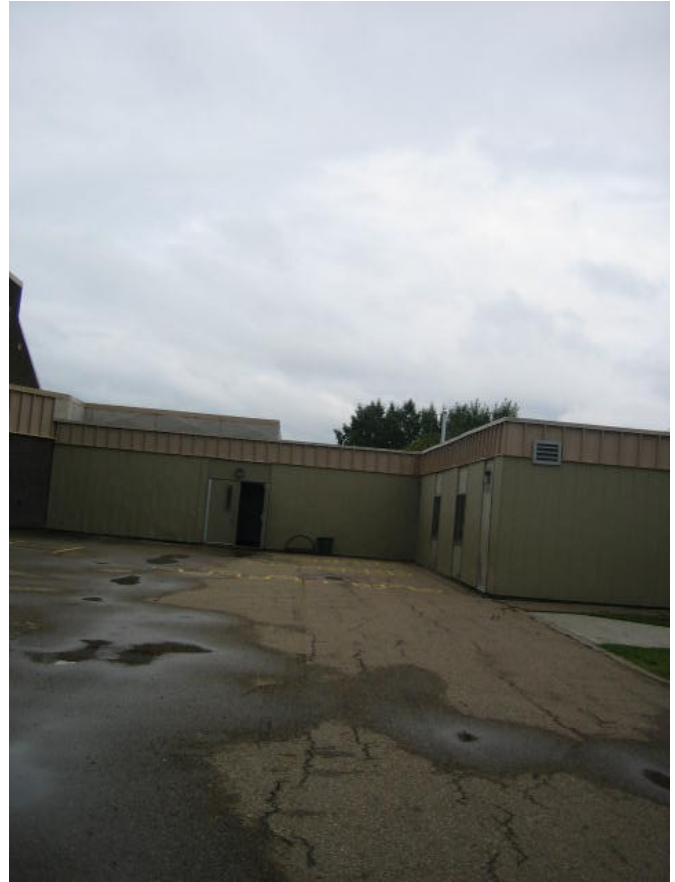
Asphalt surface around the school is well drained.

<u>Rating</u>	<u>Installed</u>	<u>Design Life</u>	<u>Updated</u>
4 - Acceptable	1990	10	MAR-07

Event: Replace Asphalt Pedestrian Pavement(1100m2)
