RECAPP Facility Evaluation Report

Kameyosek Community School

B3175A
Edmonton

Evaluation Company: Koliger Schmidt architect engineer
Evaluation Date: June 8 2007
Evaluator Name: Mario Macchione

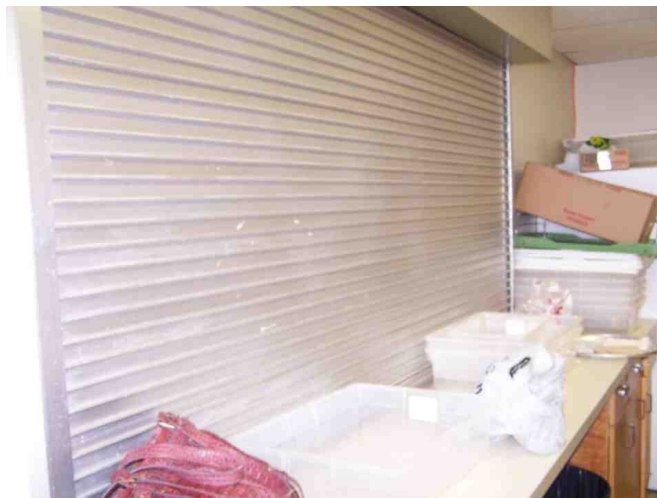
Kitchen serving Ancillary Rooms

Metal rolling shutter.

<u>Rating</u>	<u>Installed</u>	<u>Design Life</u>	<u>Updated</u>
4 - Acceptable	1977	25	MAR-08

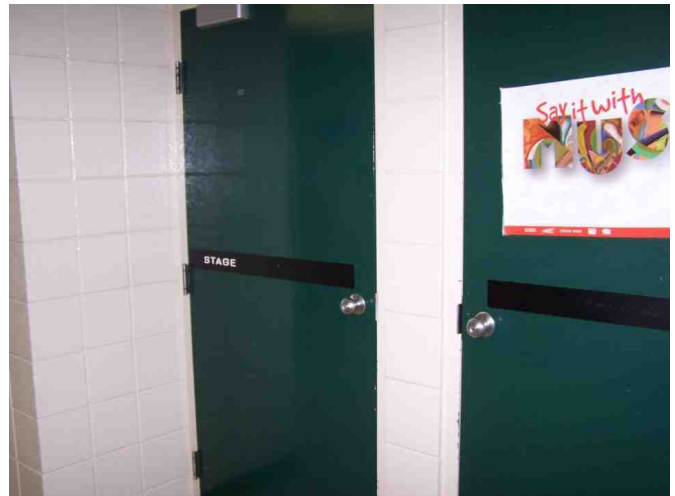
Typical room signage.

Signage on doors.

<u>Rating</u>	<u>Installed</u>	<u>Design Life</u>	<u>Updated</u>
4 - Acceptable	1977	0	MAR-08

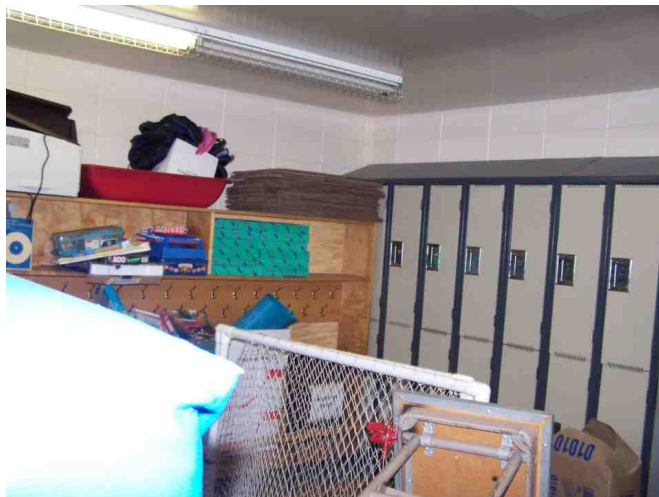
Lockers in dressing rooms

Steel lockers.

<u>Rating</u>	<u>Installed</u>	<u>Design Life</u>	<u>Updated</u>
4 - Acceptable	1977	30	MAR-08

Event: Replace 200 Lockers

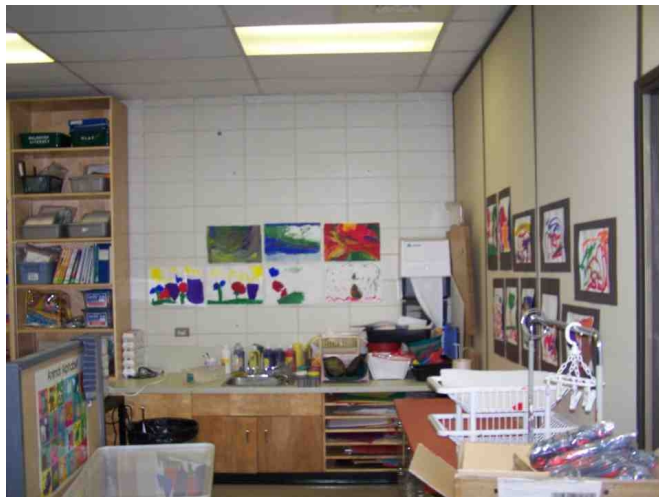
100_7981.JPG

Wall mounted upper and lower cabinets.

<u>Rating</u>	<u>Installed</u>	<u>Design Life</u>	<u>Updated</u>
4 - Acceptable	1977	35	MAR-08

Event: Replace Classroom casework (80 linear meters).

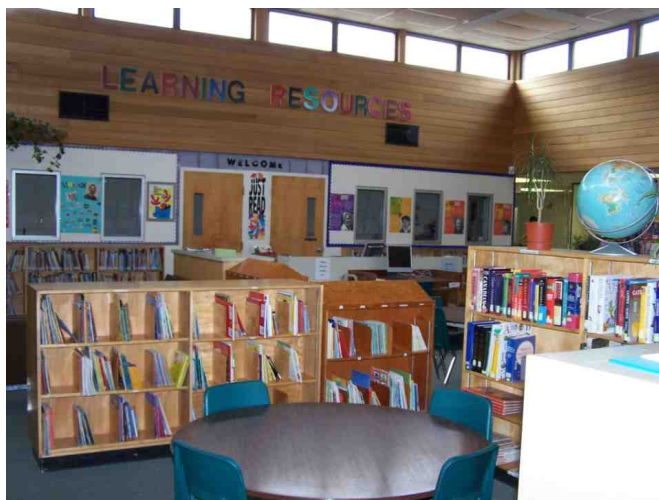
Library shelving units.

<u>Rating</u>	<u>Installed</u>	<u>Design Life</u>	<u>Updated</u>
4 - Acceptable	1977	35	MAR-08

Event: Replace Library Casework (30 linear meters).

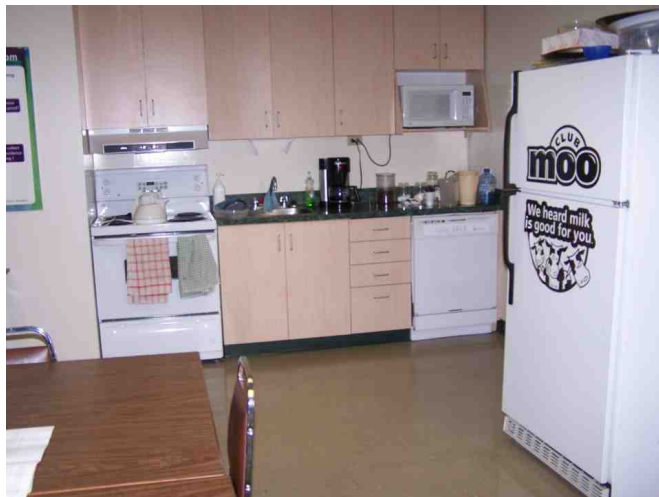
Kitchen - staff room

Kitchen Millwork - Staff Room, wall mounted cabinets.

<u>Rating</u>	<u>Installed</u>	<u>Design Life</u>	<u>Updated</u>
4 - Acceptable	1977	35	MAR-08

Event: Replace Kitchen Millwork (17 lin. m).

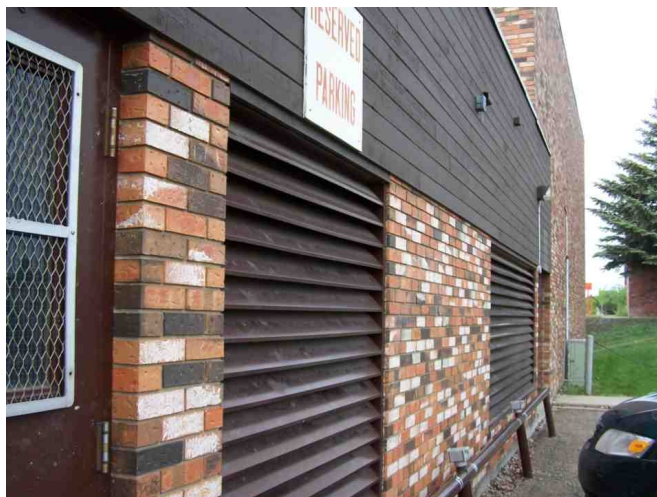
Painted pipe railings and concrete wheel stops at the property line.

<u>Rating</u>	<u>Installed</u>	<u>Design Life</u>	<u>Updated</u>
4 - Acceptable	1977	0	MAR-08

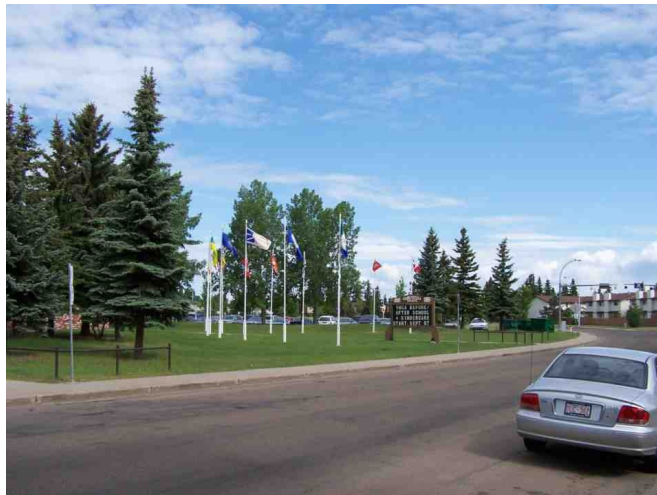
Wood free standing sign in the yard and metal letters fixed to building.

<u>Rating</u>	<u>Installed</u>	<u>Design Life</u>	<u>Updated</u>
4 - Acceptable	1977	0	MAR-08

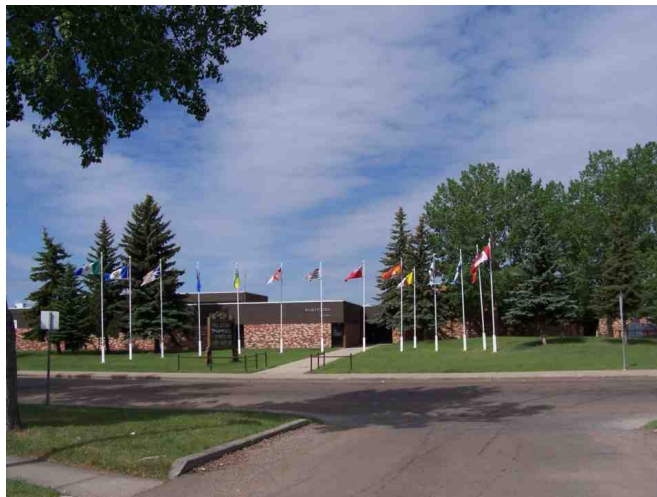
G2040.08 Flagpoles - ***Painted Steel Poles**

<u>Rating</u>	<u>Installed</u>	<u>Design Life</u>	<u>Updated</u>
4 - Acceptable	1977	0	MAR-08

**Event: Install 14 Flag Poles and Concrete Bases****Recommendation:**

Install 14 aluminum flag poles and concrete bases.
