# **RECAPP Facility Evaluation Report**

**Edmonton School District No. 7**

**Killarney Junior High School**

**Evaluation Company:** Koliger Schmidt architect engineer  
**Evaluation Date:** June 28 2007  
**Evaluator Name:** Mario Macchione

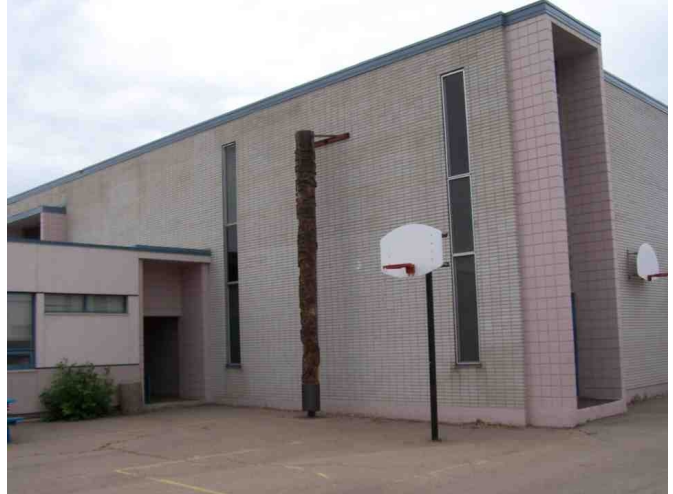
Concrete block construction with EIFS and stucco system on top.  
Painted concrete block and brick veneer.

<u>Rating</u>	<u>Installed</u>	<u>Design Life</u>	<u>Updated</u>
4 - Acceptable	1967	0	MAR-08

Concrete block with brick veneer - 1967 Section.

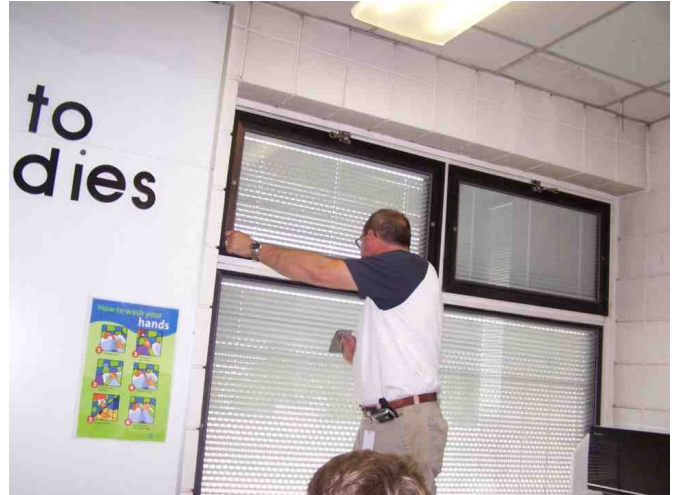
Aluminum windows - double glazed with integral blinds.

<u>Rating</u>	<u>Installed</u>	<u>Design Life</u>	<u>Updated</u>
4 - Acceptable	1967	40	MAR-08

1967 Windows with integral blinds.

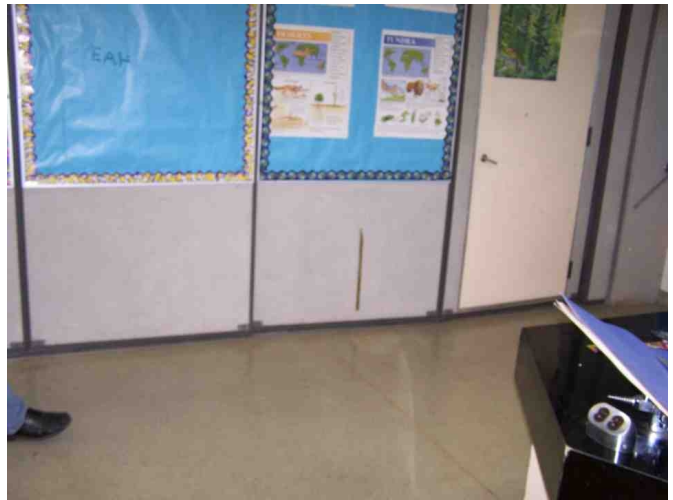
100\_8993.JPG

Demountable partition used to divided Science Rooms in 1957 section.

<u>Rating</u>	<u>Installed</u>	<u>Design Life</u>	<u>Updated</u>
4 - Acceptable	1980	0	MAR-08

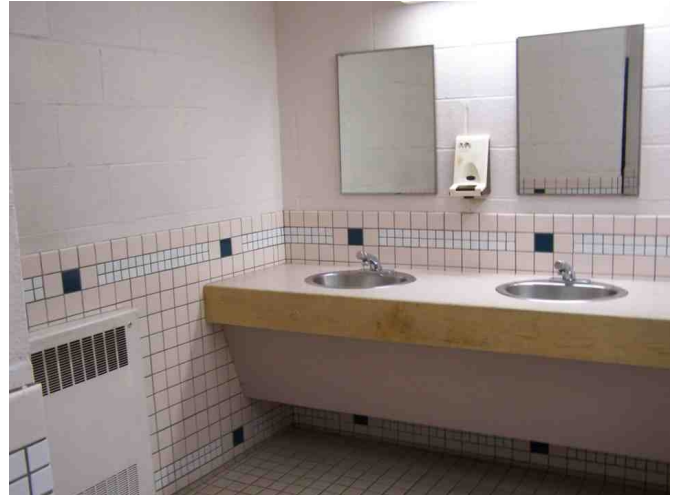
Ceramic wall tiles used on lower portion of washroom walls.

<u>Rating</u>	<u>Installed</u>	<u>Design Life</u>	<u>Updated</u>
4 - Acceptable	1993	40	MAR-08

Ceramic tile in washroom - typical.

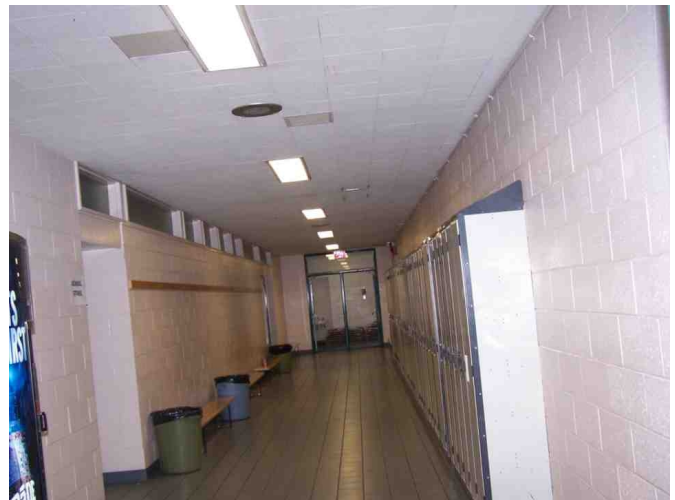
Ceramic and mosaic tile used in the washrooms.

<u>Rating</u>	<u>Installed</u>	<u>Design Life</u>	<u>Updated</u>
4 - Acceptable	1993	50	MAR-08

Ceramic floor tile in hallways - typical.

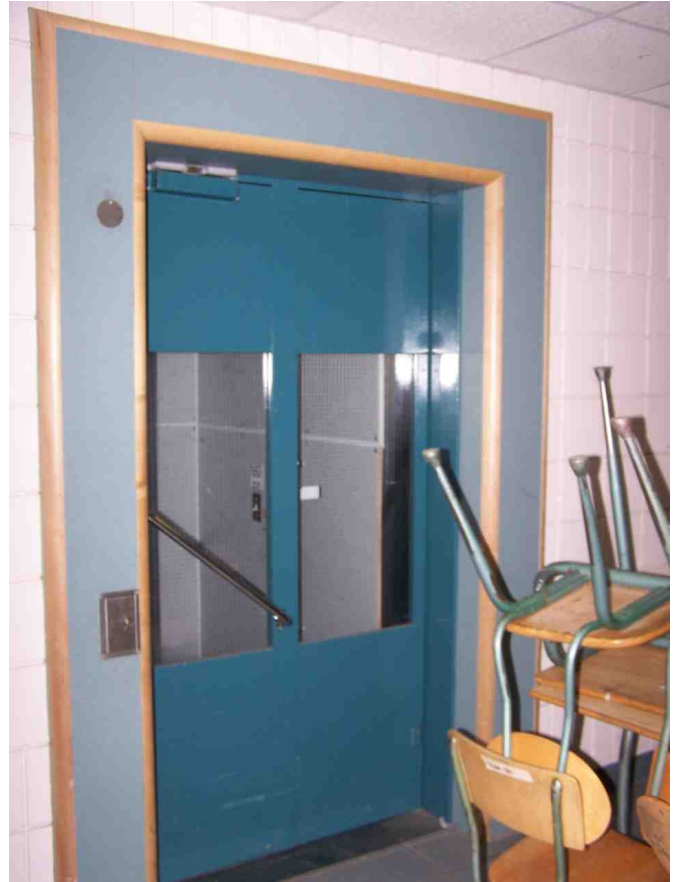
A small 1-2 person elevator has been installed in the two storey 1967 section to provide barrier free access.

<b><u>Rating</u></b>	<b><u>Installed</u></b>	<b><u>Design Life</u></b>	<b><u>Updated</u></b>
4 - Acceptable	1993	30	MAR-08

Barrier free elevator.

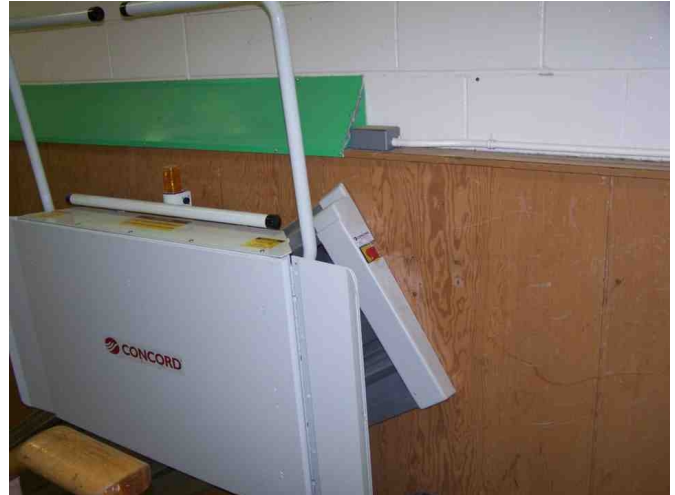
Stair lift at stair accessing the sunken main gymnasium.

<b><u>Rating</u></b>	<b><u>Installed</u></b>	<b><u>Design Life</u></b>	<b><u>Updated</u></b>
4 - Acceptable	1993	25	MAR-08

Stair lift at stair to access the main gymnasium.

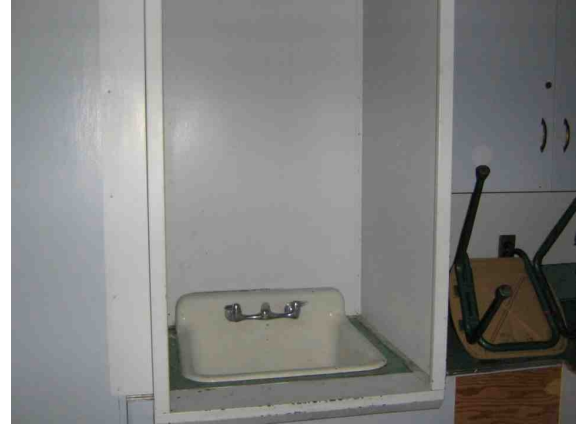
Existing cast iron sink.

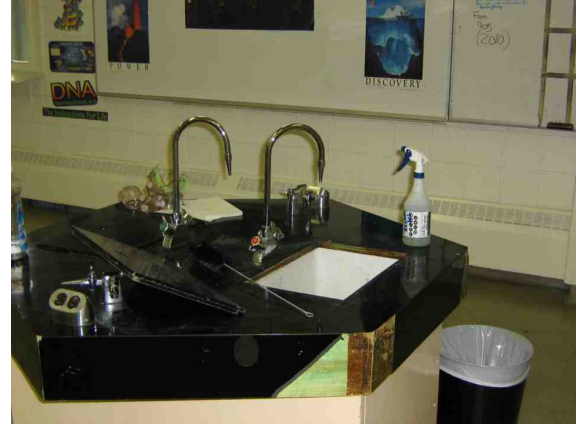
Typical science room sink.

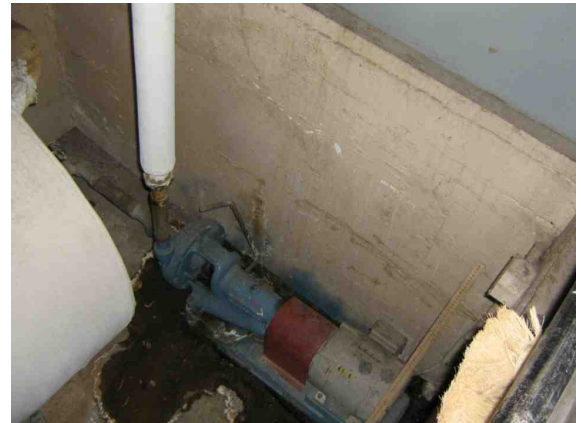
Domestic water circulation pump.

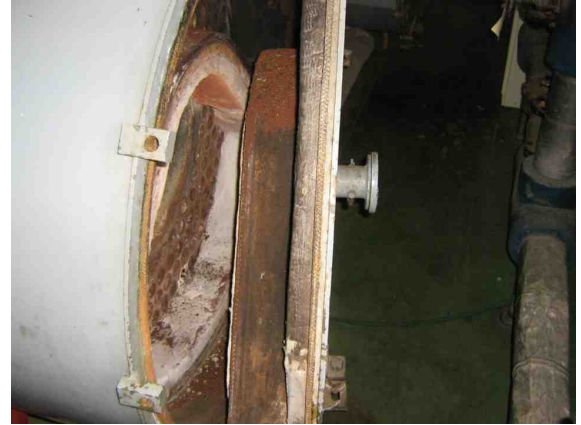
Boiler door open.

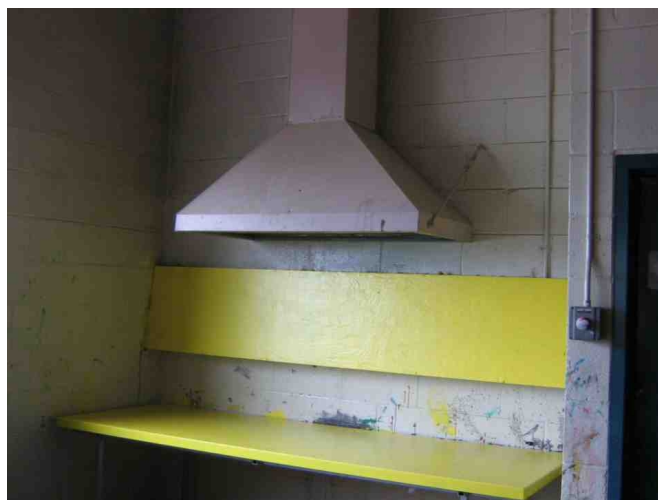
The industrial arts has a bench with a paint exhaust hood.

<u>Rating</u>	<u>Installed</u>	<u>Design Life</u>	<u>Updated</u>
4 - Acceptable	1959	30	MAR-08

Exhaust paint fume hood.

**Event:** Replace the fan for the paint fume hood.

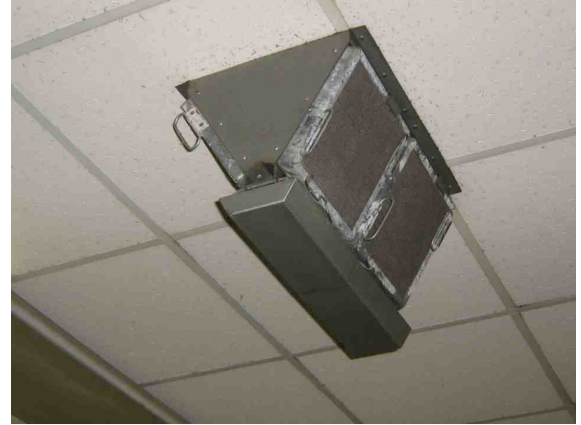
Existing home economics exhaust.

**Event: Replace general exhaust fan.****Concern:**

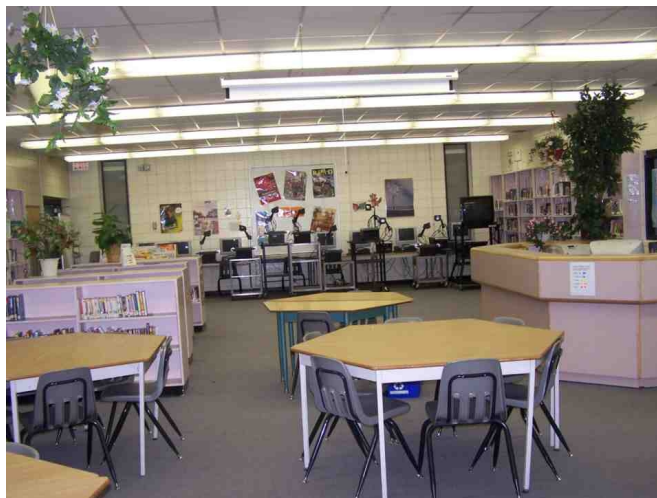
Library

Books stacks, computers, etc.

<u>Rating</u>	<u>Installed</u>	<u>Design Life</u>	<u>Updated</u>
4 - Acceptable	1967	0	MAR-08

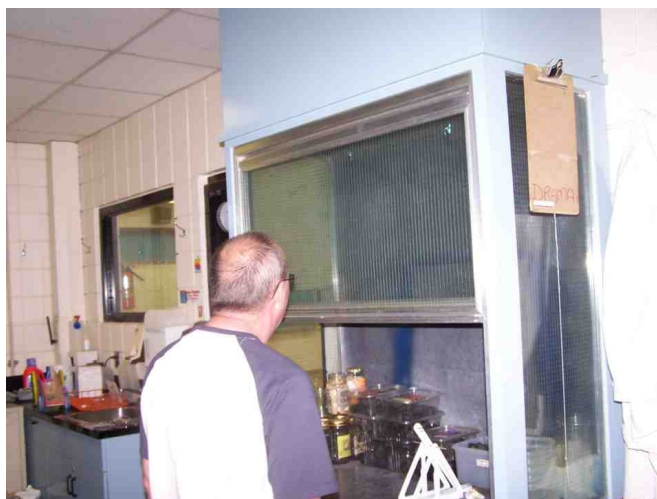
Fumehoods, general lab equipment; scales, microscopes etc., Kiln

<u>Rating</u>	<u>Installed</u>	<u>Design Life</u>	<u>Updated</u>
4 - Acceptable	1959	0	MAR-08

Fumehood in 1959 section

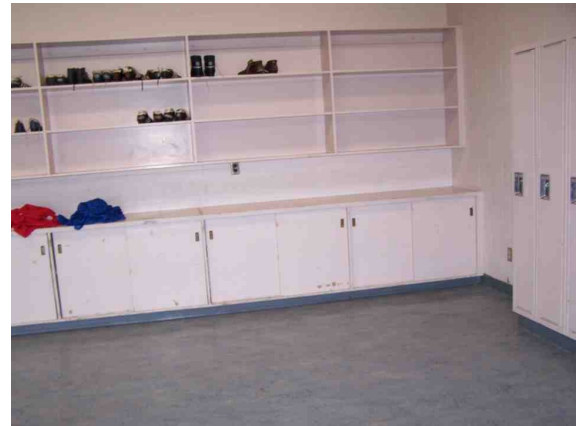
Perimeter wall -base cabinets and upper shelving.

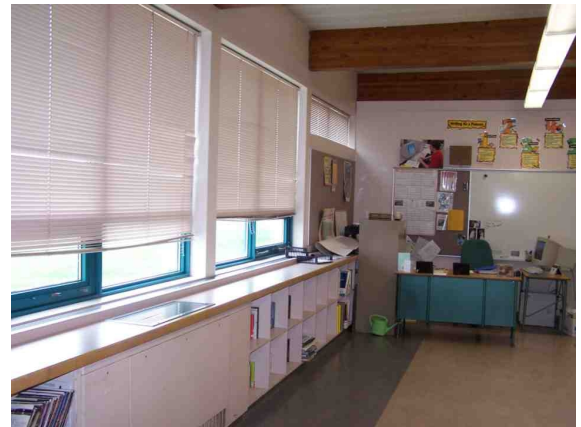
Open shelving units.

**Event: Repair (75 Linear Meters) Refinish Open Shelving Units****Concern:**
