# **RECAPP Facility Evaluation Report**

### **Kirkness Elementary School**

B3185A  
Edmonton

**Evaluation Company:** A&E Architectural & Engineering Group Inc.  
**Evaluation Date:** November 7 2007  
**Evaluator Name:** Vic Maybroda

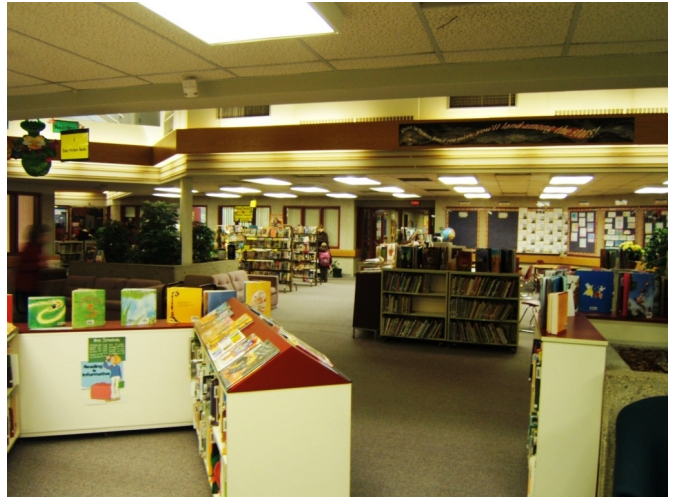
Stand-alone library shelving

<u>Rating</u>	<u>Installed</u>	<u>Design Life</u>	<u>Updated</u>
5 - Good	2003	0	MAR-08

Partial view of centrally located library.
