# RECAPP Facility Evaluation Report

## Edmonton School District No. 7

### L. Y. Cairns School

**Evaluation Company:** A&E Architectural and Engineering Group Inc.

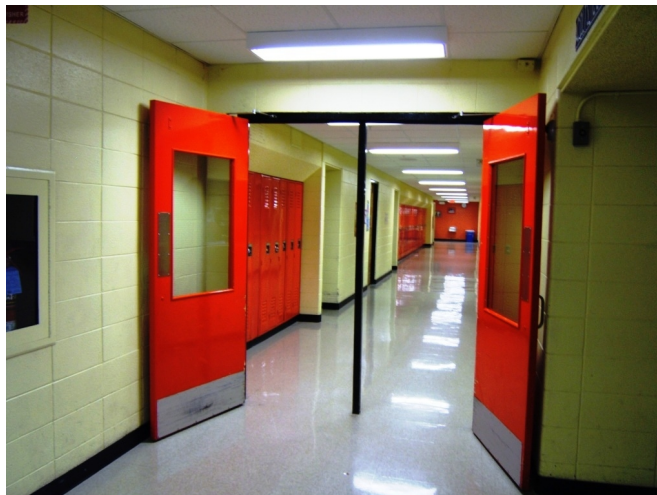
Painted metal doors with glazing units in painted metal frames.

Fire doors complete with magnetic door holders and glazing units.

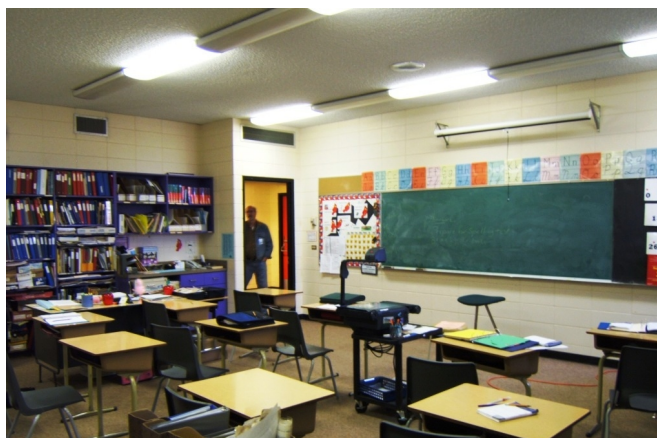
Teaching spaces contain both green and white boards (replaced in 2003) plus traditional fabric covered tack boards.

Classroom with green boards.

**Event: Replace approximately 20-1200 x 2400mm Green Boards**

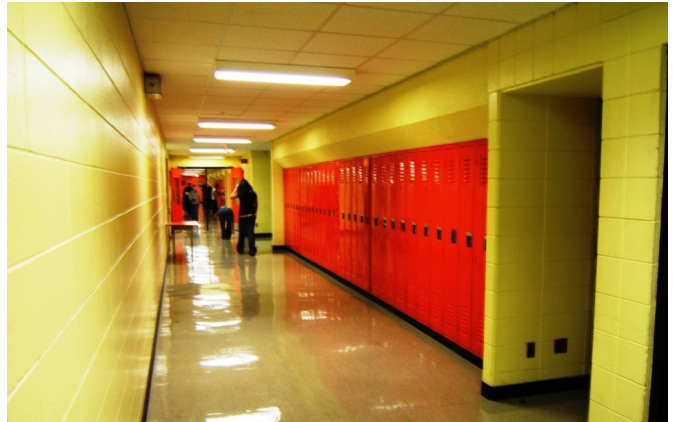
Prefinished full height lockers located in corridors.

View of corridor lockers.

**Event: Replace 365 Lockers**

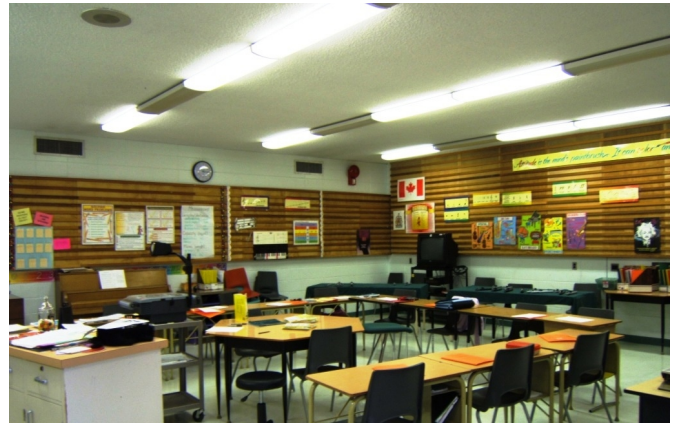
Stained wood paneling located in isolated teaching spaces.

Stained wood acoustical paneling.

**Event: Refinish 60 sq. M Wood Paneling**

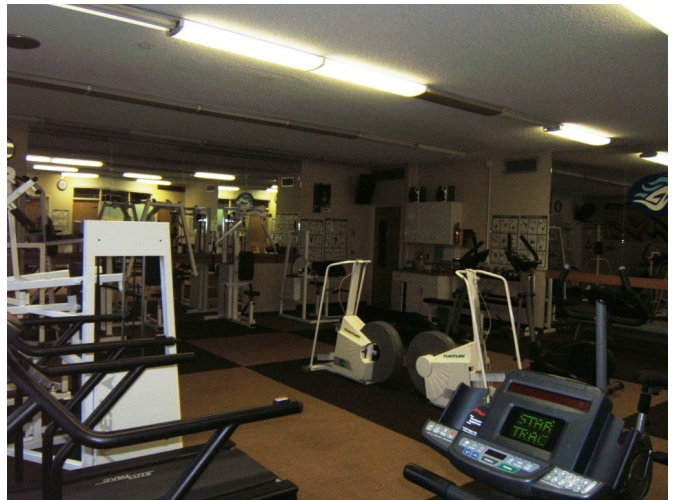
Weight training and exercise room and student games room equipped with pool tables.

Weight training and exercise room.

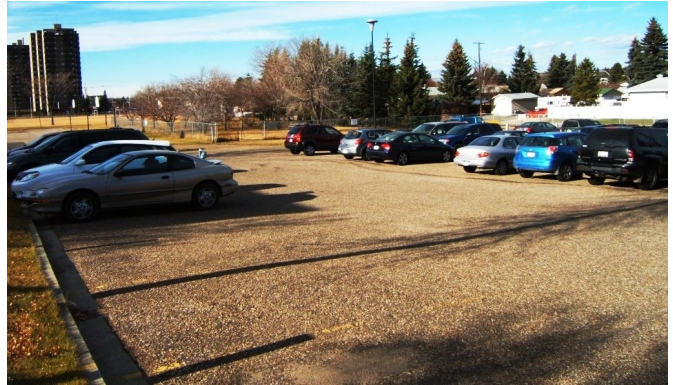
Asphalt surfaced visitor parking area in front of school. Similar element exists for rear staff parking area and upper asphalt parking area adjacent to vocational areas.

**Event: Replace 1275 sq M Asphalt Parking Areas**
