# RECAPP Facility Evaluation Report

## Lansdowne Elementary School

B3190A  
Edmonton

**Evaluation Company:** A&E Architectural & Engineering Group Inc.  
**Evaluation Date:** November 9 2007  
**Evaluator Name:** Vic Maybroda

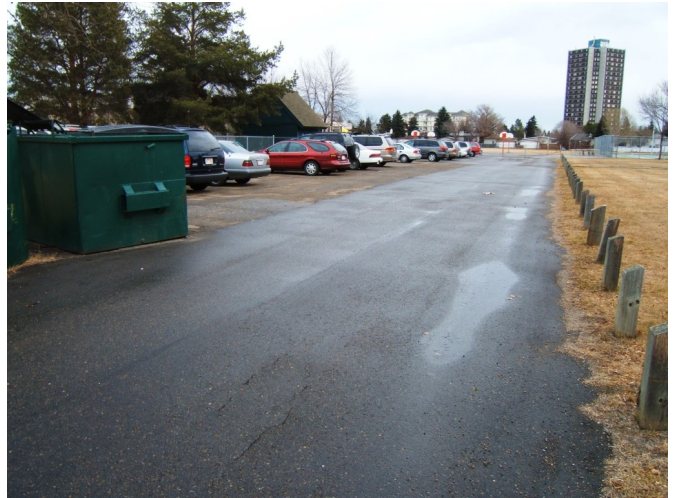
**S7 SITE****G2020.02.02 Flexible Paving Parking Lots(Asphalt) - \*\***

<u>Rating</u>	<u>Installed</u>	<u>Design Life</u>	<u>Updated</u>
4 - Acceptable	1968	25	MAR-08

**Event:** **Replace 220 sq. M Flexible Paving Parking Lots(Asphalt)\*\***

<u>Type</u>	<u>Year</u>	<u>Cost</u>	<u>Priority</u>
Lifecycle Replacement	2012	\$16,588	Unassigned

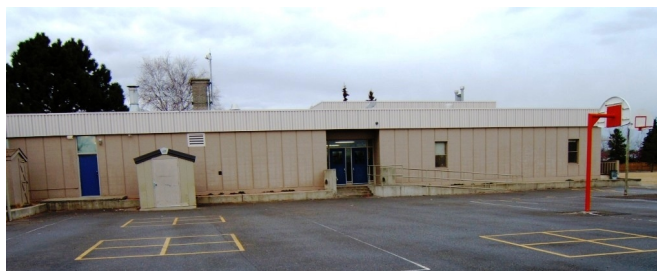
Concrete steps and ramps.

<u>Rating</u>	<u>Installed</u>	<u>Design Life</u>	<u>Updated</u>
4 - Acceptable	1968	0	MAR-08

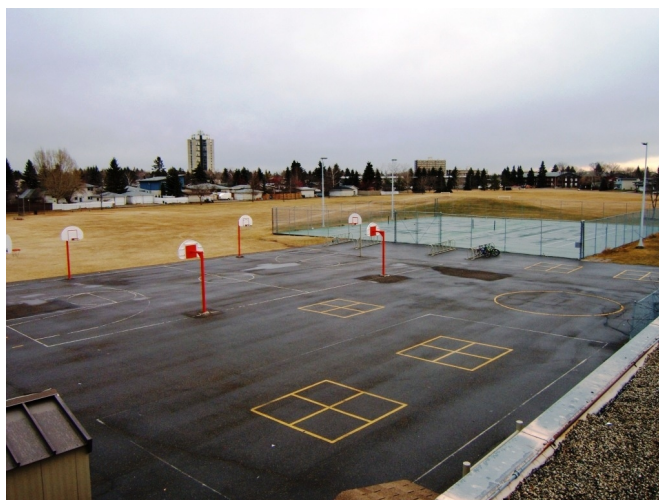
Asphalt surfaced play spaces.

<u>Rating</u>	<u>Installed</u>	<u>Design Life</u>	<u>Updated</u>
4 - Acceptable	2003	25	MAR-08

**Event: Replace 360 sq. M Athletic and Recreational Surfaces\*\***

<u>Type</u>	<u>Year</u>	<u>Cost</u>	<u>Priority</u>
Lifecycle Replacement	2028	\$27,170	Unassigned
