RECAPP Facility Evaluation Report

Lauderdale Elementary School

B3191A
Edmonton

Evaluation Details	
Evaluation Company:	A&E Architectural & Engineering Group Inc.
Evaluation Date:	October 30 2007
Evaluator Name:	Vic Maybroda

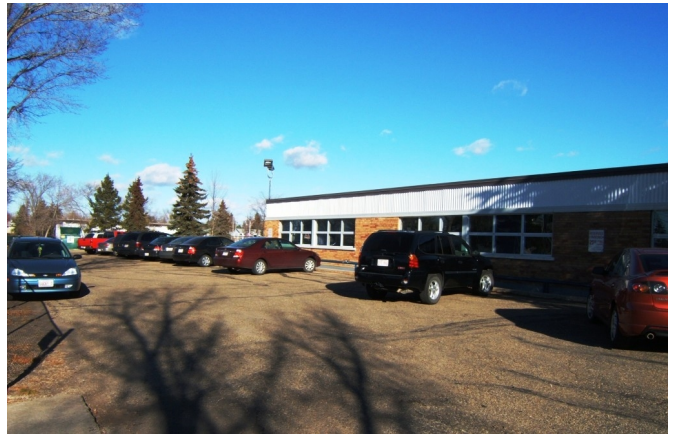
G2020.02.02 Flexible Paving Parking Lots(Asphalt) - **

<u>Rating</u>	<u>Installed</u>	<u>Design Life</u>	<u>Updated</u>
4 - Acceptable	1964	25	MAR-08

Event: Replace 730 sq. M Flexible Paving Parking Lots(Asphalt)**

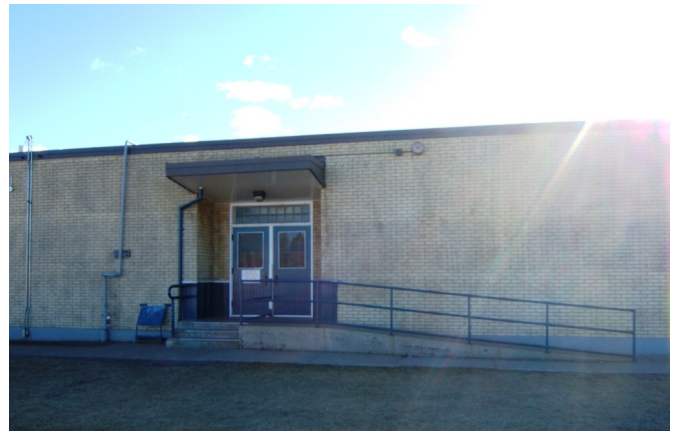
Concrete stairs and ramp to north entry of 1964 addition.
Concrete stairs to entry of 1953 section.

<u>Rating</u>	<u>Installed</u>	<u>Design Life</u>	<u>Updated</u>
4 - Acceptable	1964	0	MAR-08

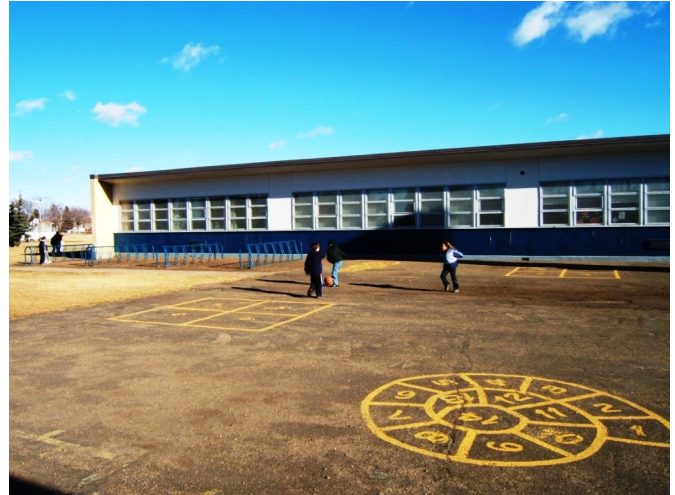
G2040.03 Athletic and Recreational Surfaces - **

<u>Rating</u>	<u>Installed</u>	<u>Design Life</u>	<u>Updated</u>
4 - Acceptable	1964	25	MAR-08

Event: Replace 70 sq M Athletic and Recreational Surfaces**
