# **RECAPP Facility Evaluation Report**

**McKernan Elementary / Junior High School**

B3213A  
Edmonton

<b>Evaluation Details</b>	
<b>Evaluation Company:</b>	A&E Architectural & Engineering Group Inc.
<b>Evaluation Date:</b>	October 26 2007
<b>Evaluator Name:</b>	Vic Maybroda

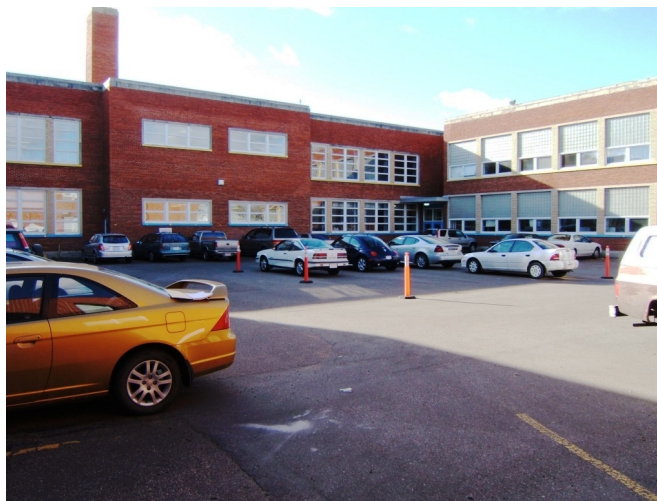
Located as an internal courtyard between the three school sections and non expandable.

<u>Rating</u>	<u>Installed</u>	<u>Design Life</u>	<u>Updated</u>
4 - Acceptable	2002	25	MAR-08

**Event: Replace 1200 sq. M Flexible Paving Parking Lots(Asphalt)\*\***

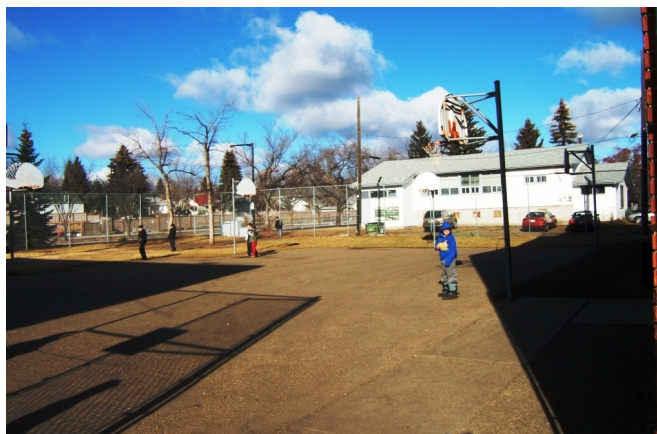
Asphalt surfaced play area adjacent paved laneway and parking lot,

<u>Rating</u>	<u>Installed</u>	<u>Design Life</u>	<u>Updated</u>
4 - Acceptable	1989	25	MAR-08

**Event:** Replace 310 sq. M Athletic and Recreational Surfaces\*\*
