RECAPP Facility Evaluation Report

Edmonton School District No. 7

Braemar School

B5467A
Edmonton

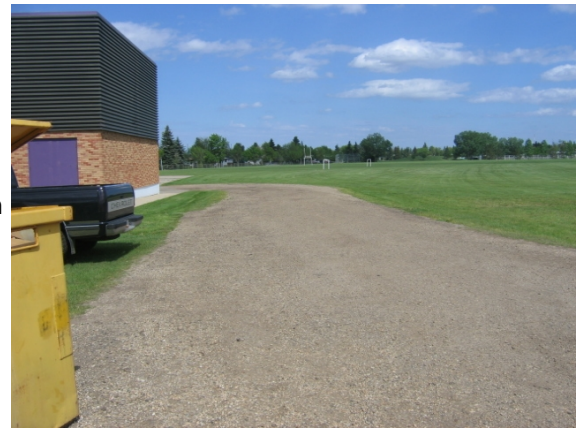
**G2010.05 Roadway Curbs and Gutters***

There are no parking curb bumper pads provided on site.

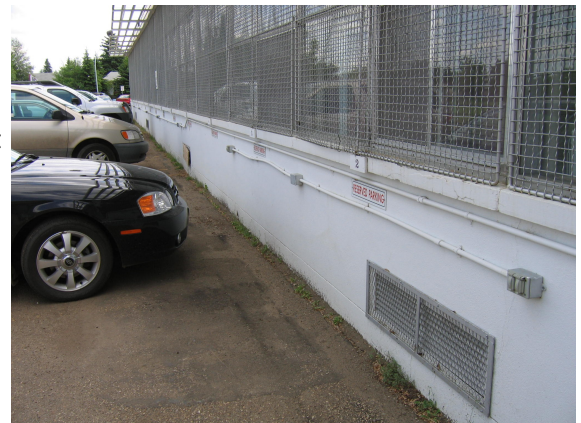
G2020.02.01 Aggregate Parking Lots (Gravel)**

A gravel paved parking lot is located west of the building.

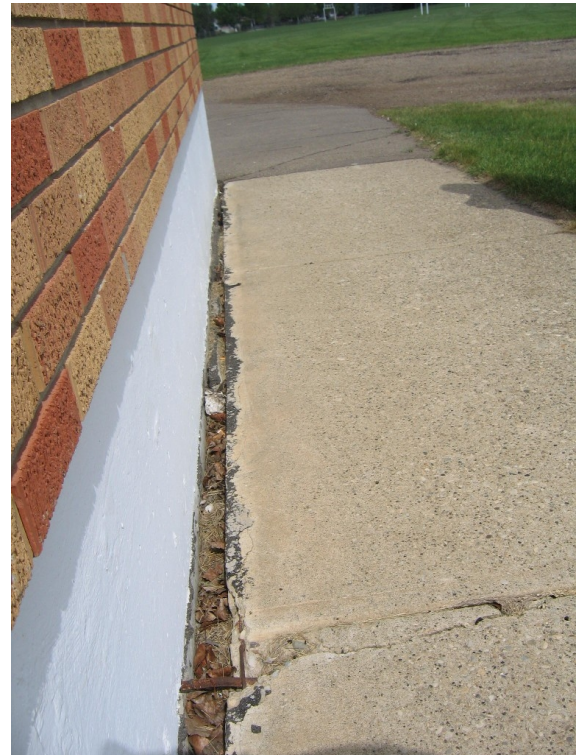
**G2030.06 Exterior Steps and Ramps***

Concrete step at the entrance and concrete ramp at the Auditorium Gymnasium.
