School Name:	Holy Cross			School Code:	203	
Location:	15120 - 104 avenue Edmonton, Alberta T5P 0R5			Facility Code:	2007	
Region:	Central			Superintendent:	Dr. Dale W. Ripley	
Jurisdiction:	Edmonton RCSSD No. 40			Contact Person:	Mr. Garnet McKee	
				Telephone:	(780) 453-4500 (Garnet)	
Grades:	K-IX			School Capacity:	Total 880	
Building Section	Year of Compl.	No. of Floors	Gross Bldg Area (Sq.M.)	Type of Construction (i.e., structure, roof, cladding)	Description of Mechanical Systems (incl. major upgrades)	Comments/Notes
Original Building	1963	2	3351.8	Masonry/B.U.R.	Perimeter hot water heating; separate ventilation systems; gas-fired furnaces serve heating & ventilation for 1972 Gymnasium.	
Additions/ Expansions	1968 1972	1 2	2312.9 1500.0	Masonry/B.U.R. Masonry/B.U.R.		
					Evaluator's Name:	George Brandt
					& Company:	Henderson Inglis Partridge

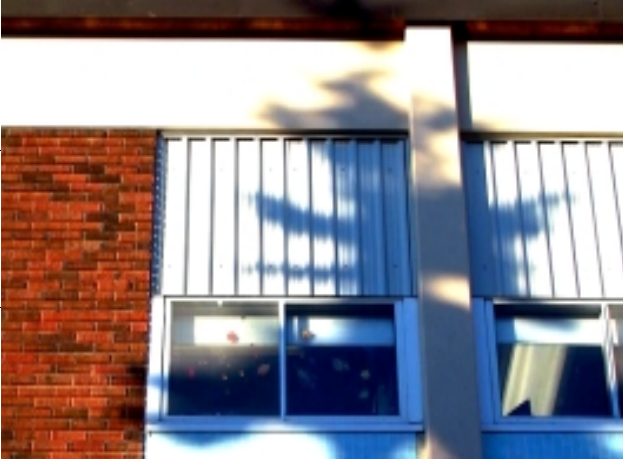
<p>Window Panels - Ceramic Tile & Metal Siding (HC3)</p>	<p>Window Panels - Stucco (HC9)</p>
<p>Exterior Wall Finishes</p>	<p>Painting required for the exposed concrete structure and concrete blockwork at the east and north sections of the school. Panels of ceramic tile and metal siding (photo HC3 above) on the east walls are cracked, missing tile and showing signs of age. These should be replaced with a low maintenance material such as stucco (which is on the balance of the school - photo HC9 above) to give the building a more unified appearance</p>
