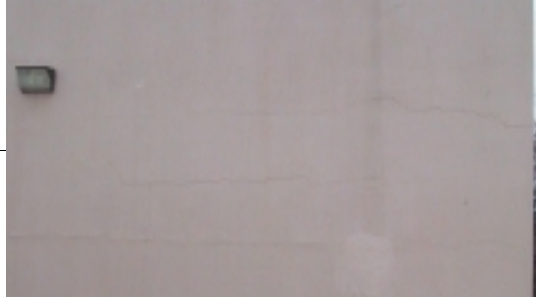
<p>School Server in Mech./Storage Rm. (FLG5)</p>

Cracking Stucco on Gym (FLG6)
(FLG5)	Server in Fan Room seems less than ideal location.	
(FLG6)	Cracked stucco finish on West side of Gym.
