RECAPP Facility Evaluation Report

Edmonton School District No. 7

North Edmonton Elementary School

B3232A
Edmonton

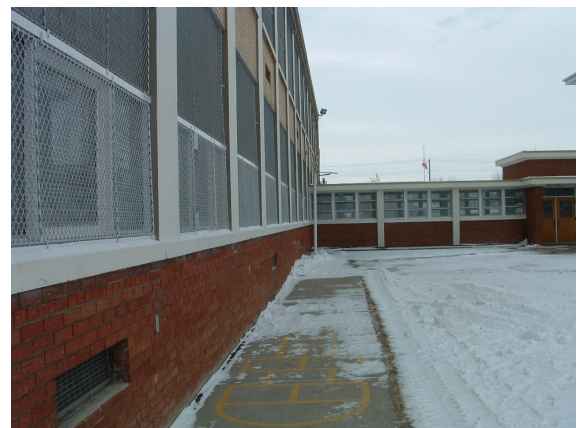
(1955) Two long concrete sidewalks, one on the north side (leading from the building to 129 Avenue) and another on the south side (leading from the building to 128 Avenue. Concrete sidewalks along the south sides of the 1917 building and 1995 addition. A wide concrete sidewalk at the existing main entrance at NE corner of the 1955 addition.

<u>Type</u>	<u>Year</u>	<u>Cost</u>	<u>Priority</u>
Repair	2008	\$3,000	Medium
