School Name:	St. Michael				School Code:	222
Location:	10545 - 92 street Edmonton, Alberta T5H 1V1				Facility Code:	2026
Region:	Central				Superintendent:	Dr. Dale W. Ripley
Jurisdiction:	Edmonton RCSSD No. 40				Contact Person:	Mr. Garnet McKee
					Telephone:	(780) 453-4500 (Garnet)
Grades:	K-VI				School Capacity:	Total 450
Building Section	Year of Compl.	No. of Floors	Gross Bldg Area (Sq.M.)	Type of Construction (i.e., structure, roof, cladding)	Description of Mechanical Systems (incl. major upgrades)	Comments/Notes
Original Building	1946	1	1277.6	Framed/B.U.R. T & G	Steam heating system; exhaust ventilation heating & ventilation serves gym	Boilers recently replaced.
Additions/ Expansions	1949 1953 1957 1962 1970	1 1 1 1 1	177.6 177.6 1192.0 500.7 187.1	Framed/B.U.R. T & G Framed/B.U.R. T & G Framed/B.U.R. T & G Framed/B.U.R. Framed/B.U.R.	1949; 1958; 1968: Steam heating; exhaust ventilation. 1970: Roof top (gas-fired) heating & ventilation to serve library

Evaluator's Name:	Bill Vance
					& Company:	Henderson Inglis Partridge

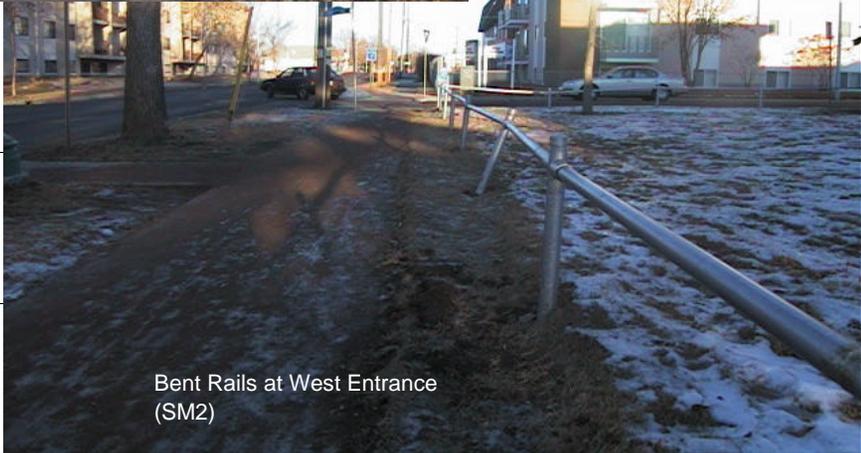
(SM3)	<p>Temporary Sign at Entrance (SM3)</p> <p>Temporary/Rental Sign seems inappropriate</p>
(SM2)	<p>Bent railings at front of school.</p>

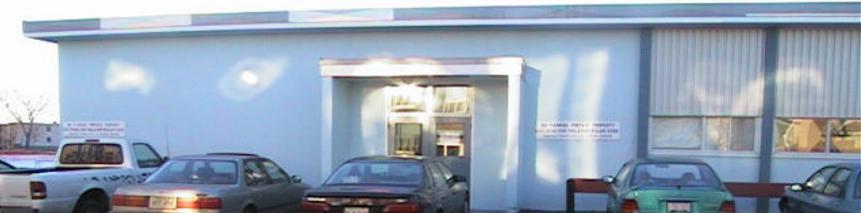
Evaluation Component/ Sub-Component	Additional Notes and Comments	
(SM4) Entrance/Exit feeds directly into parking without buffer.

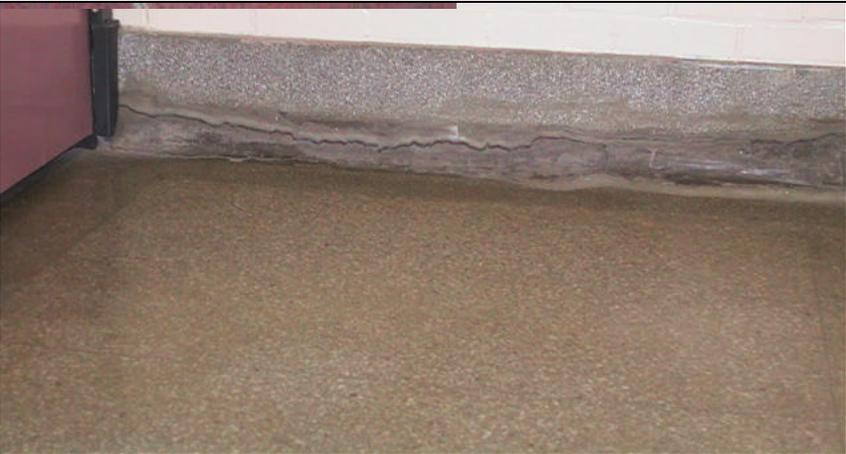
<p>Cracking/Settlement at South West Entrance (SM8)</p>

<p>(SM8) (SM9) Cracking in floors may be the result of settlement which occurred some years ago.</p>
