<b>Upgrading/ Modernization</b> (identify whether minor or major)	1984  1992  1998		14.9			-Minor Modernization to Science Prep. Rm. #128. -Minor Modernization renovate main floor Staff Washroom & Work Room. -Minor Modernization correct the over heating problem in C.R. #108 & #208.
<b>Portable Struct.</b> (identify whether attached/perman. or free-standing/ relocatable)						
<b>List of Reports/ Supplementary Information</b>	See Section 8 for complete list.

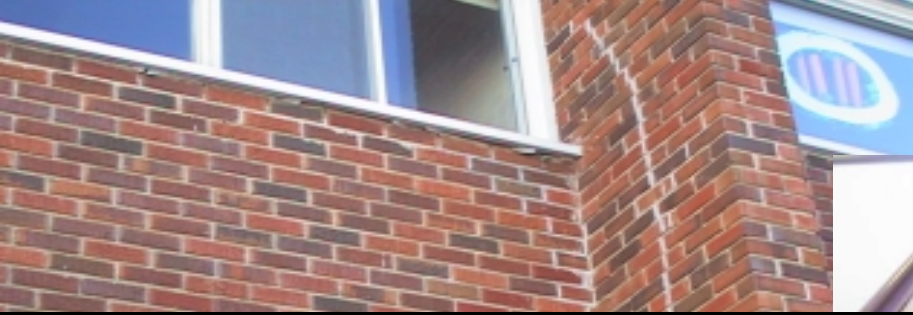
(SJ5)	<p>Glass Block at Library (Former Gymnasium) (SJ5)</p> <p>Original Glass Block in former gymnasium has mortar joints which look as though they may be a source of air/water infiltration.</p>
