School Facility Evaluation Project
Part IV - Additional Notes and Comments

School Name:	St. Jerome				School Code:	36
	Location:	3310 - 107 avenue Edmonton, Alberta T5W 0C7				Facility Code:	1979
	Region:	Central				Superintendent:	Dr. Dale W. Ripley
	Jurisdiction:	Edmonton RCSSD No. 40				Contact Person:	Mr. Garnet McKee
						Telephone:	(780) 453-4500 (Garnet)
	Grades:	K-VI				School Capacity:	Total 200
	Building Section	Year of Compl.	No. of Floors	Gross Bldg Area (Sq.M.)	Type of Construction (i.e., structure, roof, cladding)	Description of Mechanical Systems (incl. major upgrades)	Comments/Notes
	Original Building	1970	1	1845.3	Masonry/B.U.R	Hot water heating to classroom ventilators along perimeter; separate ventilation system for interior classrooms & gymnasium	
	Additions/ Expansions						
						Evaluator's Name:	Bill Vance
						& Company:	Henderson Inglis Partridge

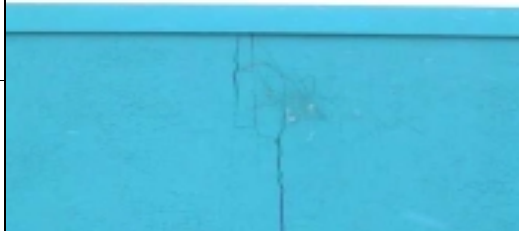
<p>Cracked Stucco Fascia (SJE3)</p>

(SJE2)	<p>Garbage Bins at Main School Entrance (SJE2)</p> <p>Garbage Bins make for an unattractive entrance.</p>	
(SJE3) (SJE4)	<p>Exterior stucco band cracking in a number of locations.</p>

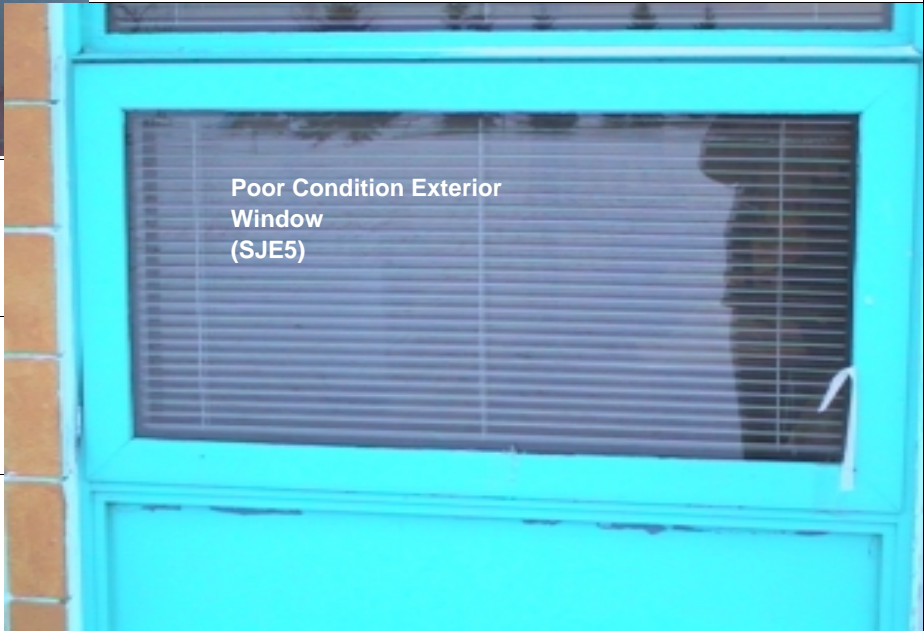
(SJE5)(SJE6)	Loose window seals evident at a number of locations.
