RECAPP Facility Evaluation Report

Sturgeon Composite High School

B3816A

Evaluation Company: Wilson Architects Ltd.
Evaluation Date: May 6 2006
Evaluator Name: J. R. Irlam

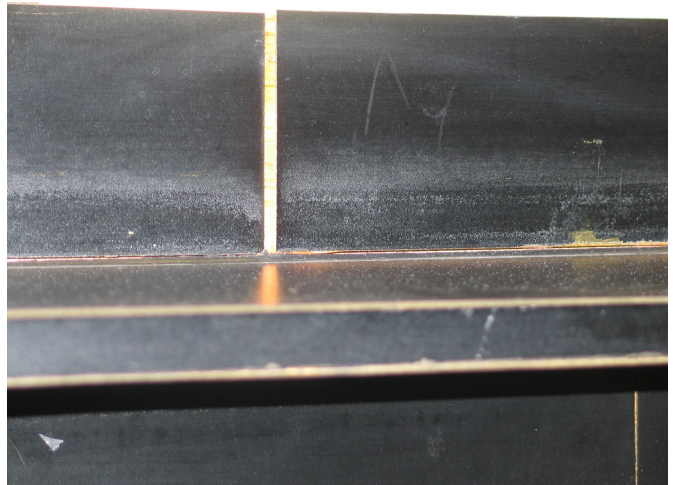
The fixed casework consists of study carrels in the library, book shelves in the classrooms and library as well as lab benches in the science rooms.

<u>Rating</u>	<u>Installed</u>	<u>Design Life</u>	<u>Updated</u>
4 - Acceptable	1977	35	NOV-06
