# RECAPP Facility Evaluation Report

## Winterburn Elementary / Junior High School

B3367A  
Edmonton

**Evaluation Company:** Koliger Schmidt  
**Evaluation Date:** December 1 2004  
**Evaluator Name:** Mr. Mario Macchione

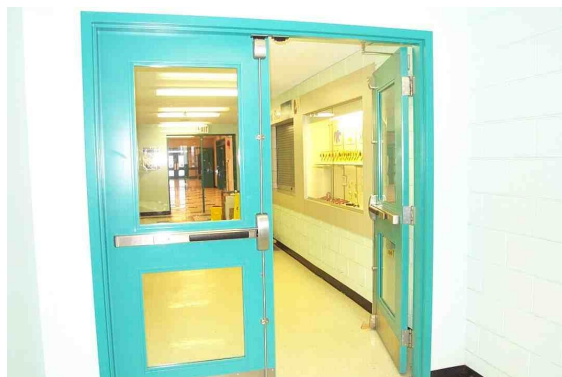
**Event:** 1957 building- Replace door assembly and hardware.

Replace door assembly with a properly rated system, appropriate hardware and replace threshold with a more appropriate sized one. Reuse existing hold open hardware.

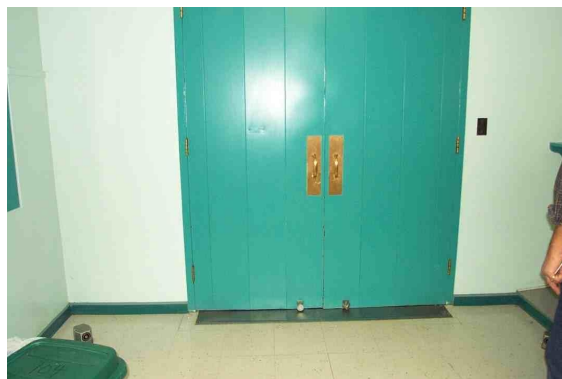
**Event:** 1959 building- Acquire about fire rated labels for door assembly.

Replace door assembly with a properly rated system and appropriate hardware but reuse hold open devices.

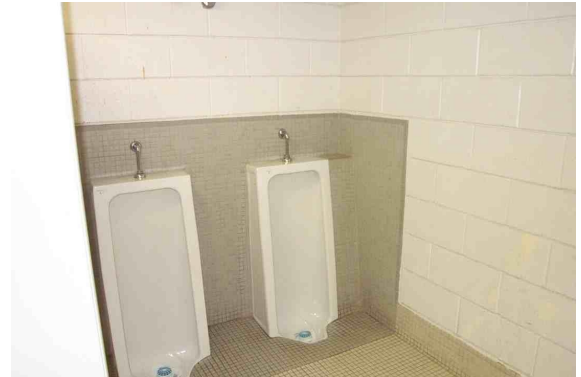
**Event:** Replace tiles around urinals in boys washrooms.

1957 building- Boys washroom- replace tiles around urinal.

1971 building- Boys washroom- replace tile around urinal.

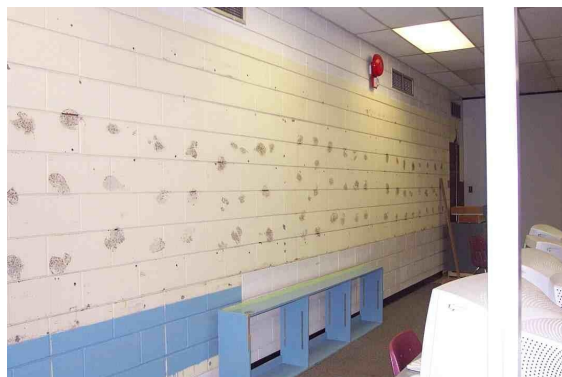
Concrete block wall in computer room ANC 138 use to have chalkboards on the back wall and have since been removed but the glue that held the boards on has not. Also remove partial demountable wall and replace with drywall and paint. The demountable partition was put up because it use to be a second entrance to the room.

Remove old glue, repair wall and repaint, including the partial demountable wall.

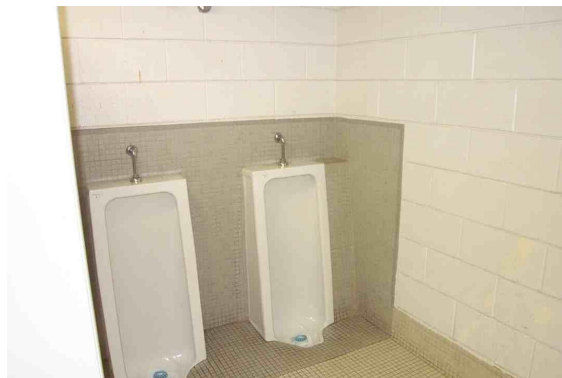
**Event: Replace tiles in boys and girls washrooms.**

1957 building- Boys washroom- replace tiles around urinal.  
 1971 building- Boys washroom- Replace tile floor and floor around urinal. Girls washroom- Replace tile flooring and base match to tile in newer addition.  
 (approx 45 m<sup>2</sup>)

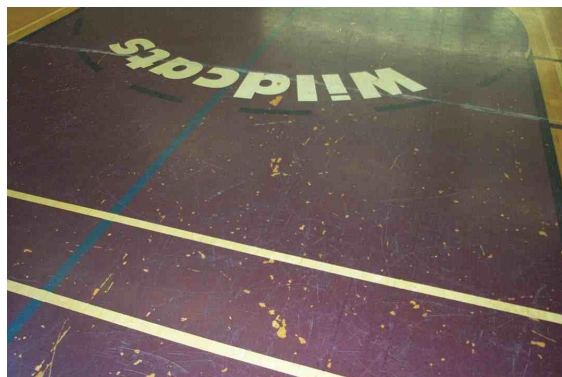
Gym flooring finish is wearing down and painted lines are chipped.
