## Asset Assessment Report

### Thickwood Public Health Building B6658A

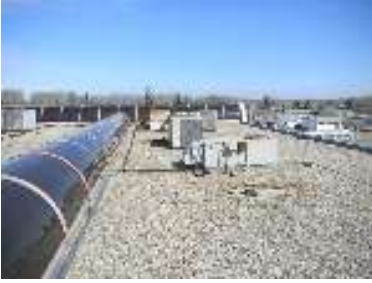
Doomed skylights installed in middle of roof section to provide natural light to upper corridors.

<u>Details</u>	<u>Values</u>
Short Title	Replace Skylights (55m x 1.2m)
Cost	\$215,094.00
Start Year	2015
Impact	Unassigned
Probability	Unassigned
Budget Type	Unspecified
Event Status	Not Approved

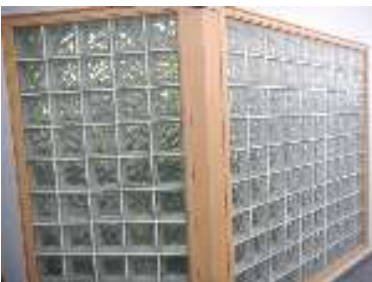
Glass block wall used on upper level.
