RECAPP Facility Evaluation Report

Edmonton School District No. 7

Brander Gardens Elementary School

B3063A
Edmonton

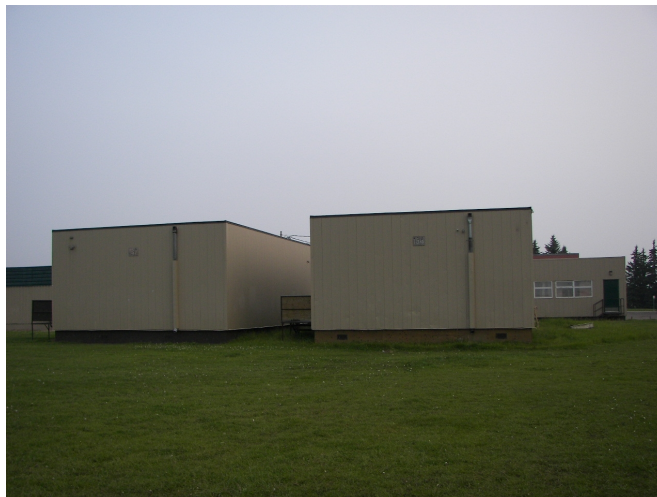
(1989) Portables (197 and 194) - South Elevation.

Recommendations for future action for individual Portables include: repair metal siding; provide concrete splashpads.

Event: Repair metal siding (30 sq.m.); provide concrete 3 splashpads.
